TRI-STATE SMART HOME SOLUTIONS LLC

## INSPECTION REPORT

1234 Main Street  
Gallipolis, OH 45631

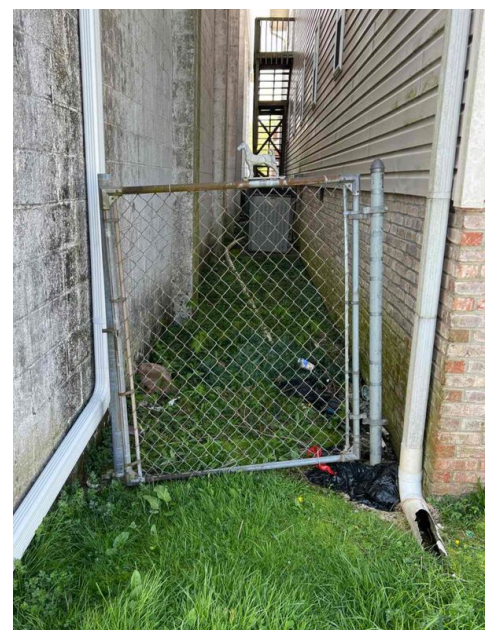
Recommend fully securing the area between the two buildings. It is evident that this area is used by unwanted guests and there are many disposed of items in this area.

Between Buildings, Recommend Securing

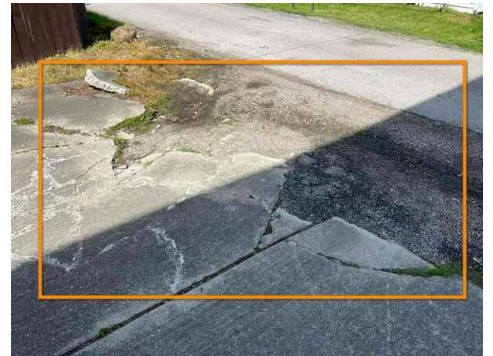
At the rear of the parking lot, the concrete is deteriorated and cracking.

Parking Lot Deterioration

Contact a qualified driveway contractor.

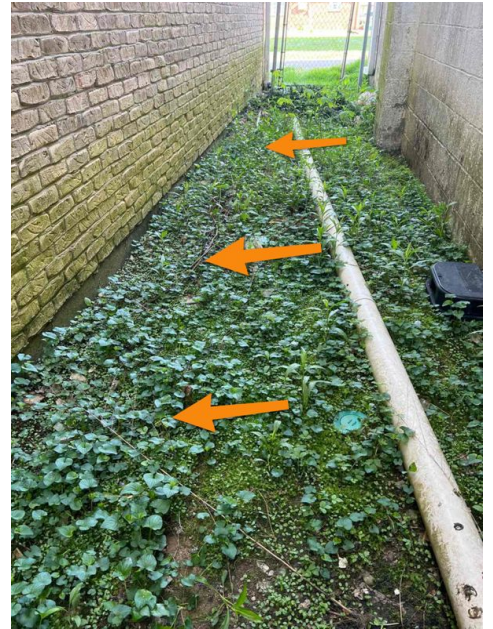
The area between the buildings is sloping toward this building. This is causing rainwater to drain into the crawlspace. (There is also a downspout draining to this area)

Negative Grading Between Buildings

Contact a qualified landscaping contractor

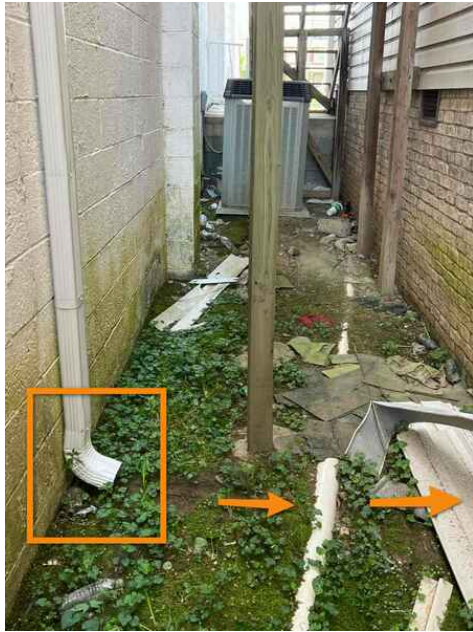
See pictures for specific gutter and downspout items identified.

Downspout Drains on Ground Between Buildings

Contact a qualified gutter contractor

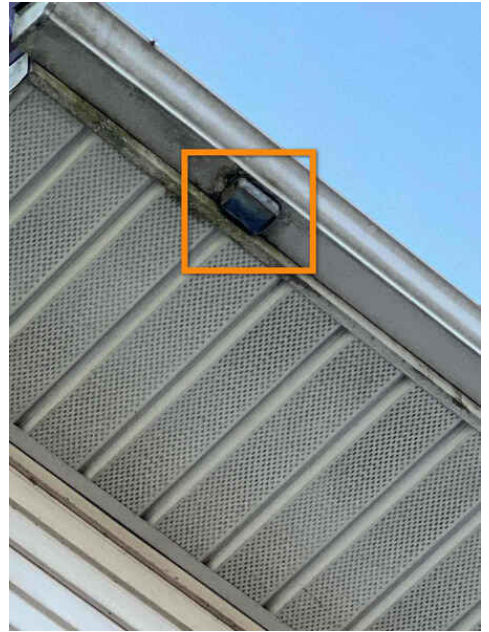
Downspouts Missing, Left Side of Building (x2)

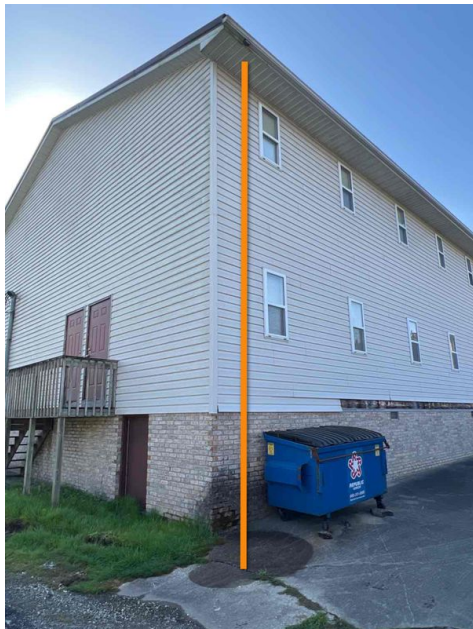
Left Side of Building, Downspout Missing

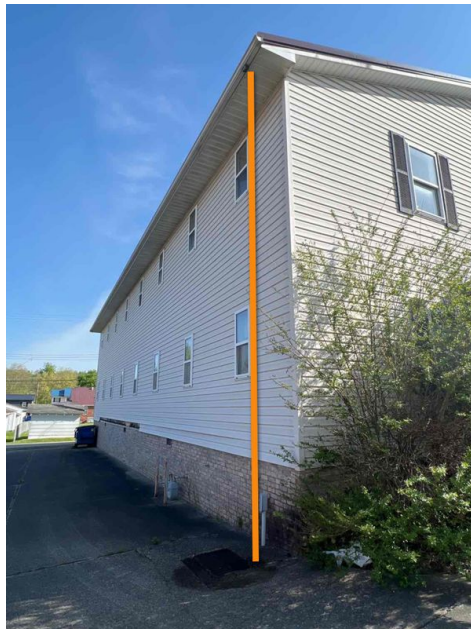
Left Side of Building, Downspout Missing

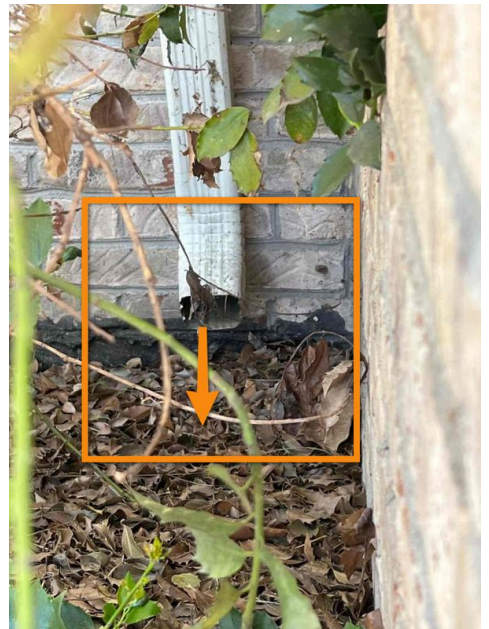
Front Porch, Downspout Drains on Ground

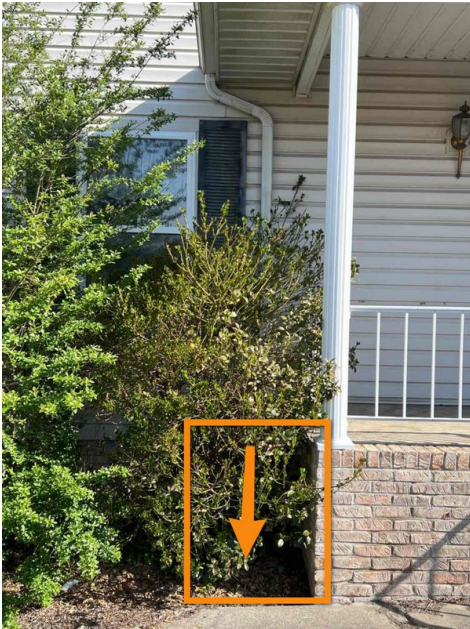
Front Porch, Downspout Drains on Ground

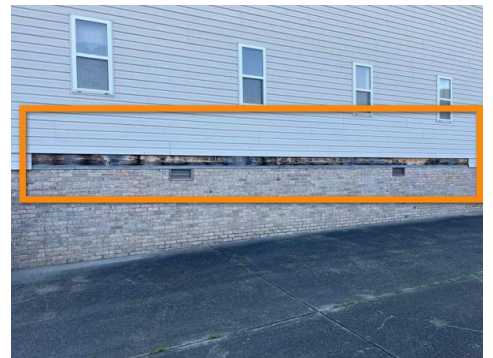
The following items were observed with the siding. See pictures for description and location.

Left Side of Building, Missing Siding

Contact a qualified siding specialist.

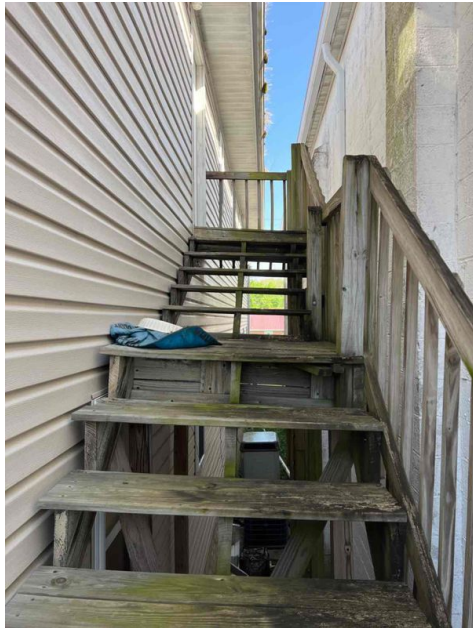
The normal life expectancy of an exposed wooden deck/steps is 15 to 25 years if properly maintained. The side and rear steps on the building appear to be beyond 25 years old and have not been well maintained. They are showing signs of general deterioration, wood rot, insect damage, etc.

Side Steps, Nearing End of Life

Recommend further evaluation by a licensed and qualified deck contractor to determine whether repair or replacement is appropriate. Use with caution until this evaluation and their recommendations are complete.

Contact a qualified deck contractor.

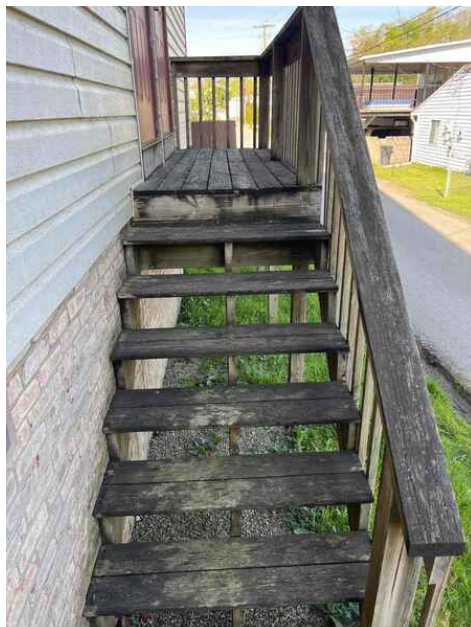
Rear Steps, Nearing End of Life

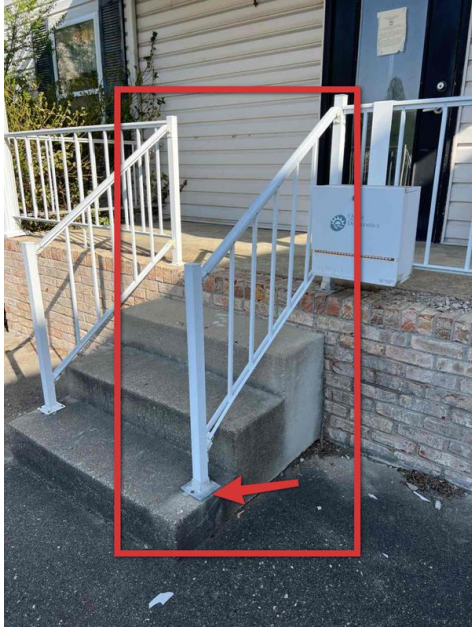
The safety handrailing identified in the pictures is not secure and may not support the weight of a person if they fell against it. Use with caution until this is corrected.

Front Steps, Handrail Not Secure

Contact a qualified professional.

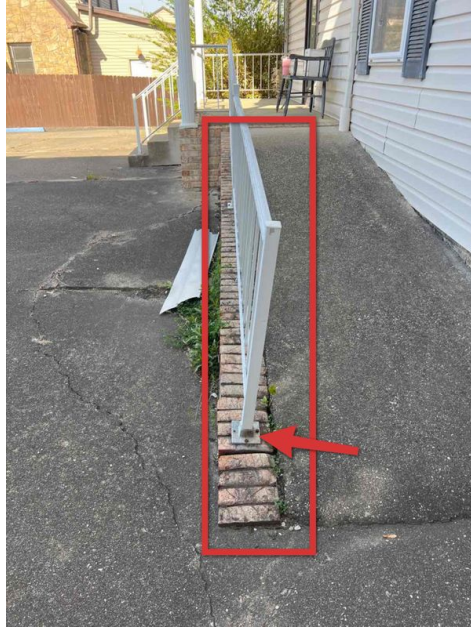
Front Ramp Handrail, Not Secure

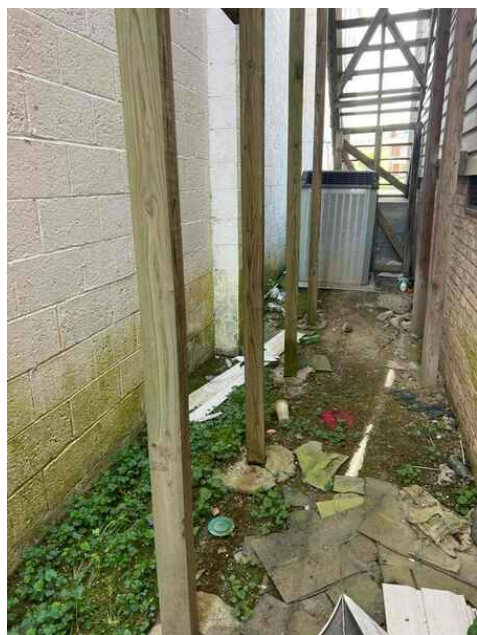
- 1) They are unstable and no longer level
- 2) Several of the support posts are starting to rot at the bottom
- 3) The steps are supported by 4x4 posts. The upper landing is 20 feet off of the ground. This height exceeds the recommended height for 4x4 posts.

Side Steps, 4x4 Posts in Use

Recommend engaging a qualified deck construction contractor to evaluate further. Use these steps with caution, if necessary, with caution until made safe for use by a qualified professional.

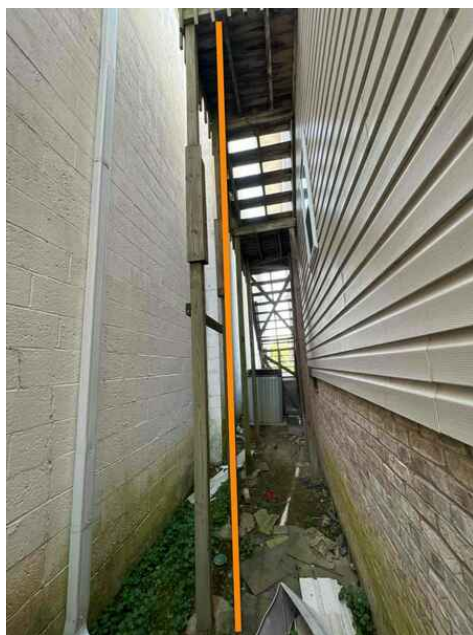
Side Steps 20 Feet Tall, Height Exceeds 4x4 Post Height Recommendations

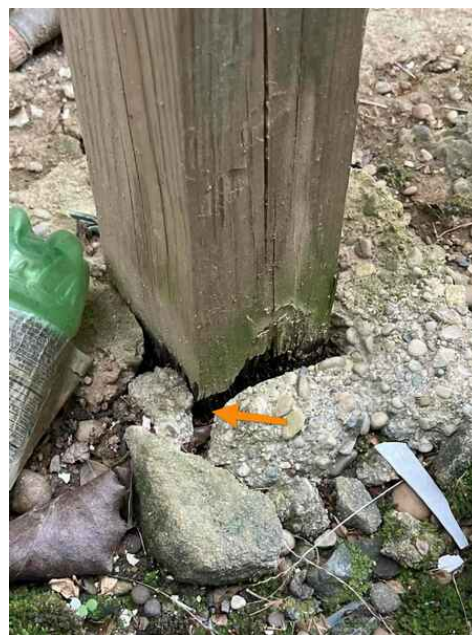
Side Steps, Rotting Post - Example

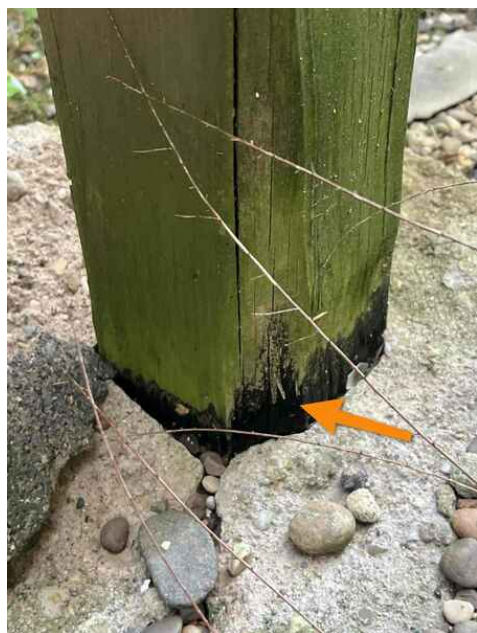
Side Steps, Rotting Post - Example

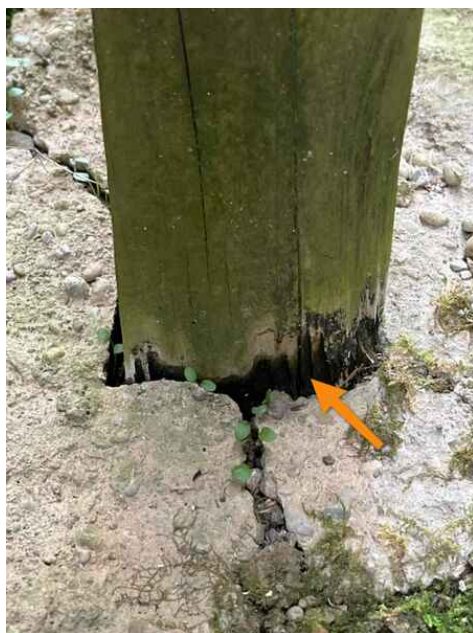
Side Steps, Rotting Post - Example

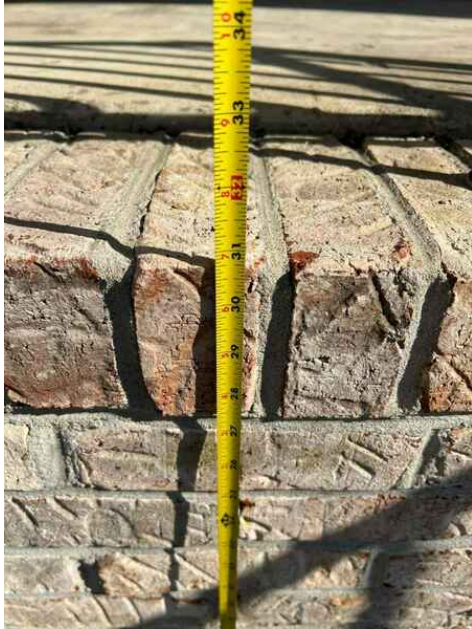
The handrail/ safety rail on the front porch, porch steps, and ramp are too low. The current railings are 32" tall. For commercial applications, the recommended minimum height is 42".

Front Porch Floor Height 30" Plus

Contact a qualified professional.

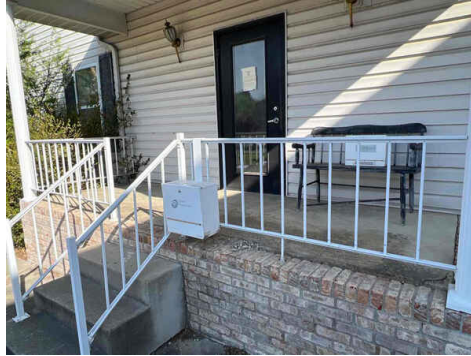
Front Porch Railing Height,  
Recommend 42"

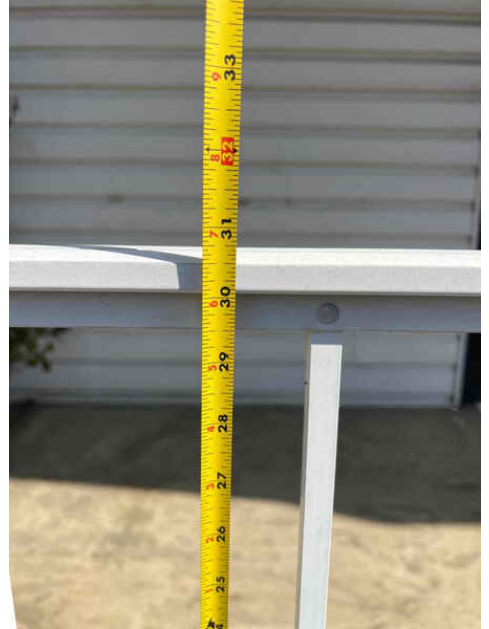
Front Porch Railing Height,  
Recommend 42"

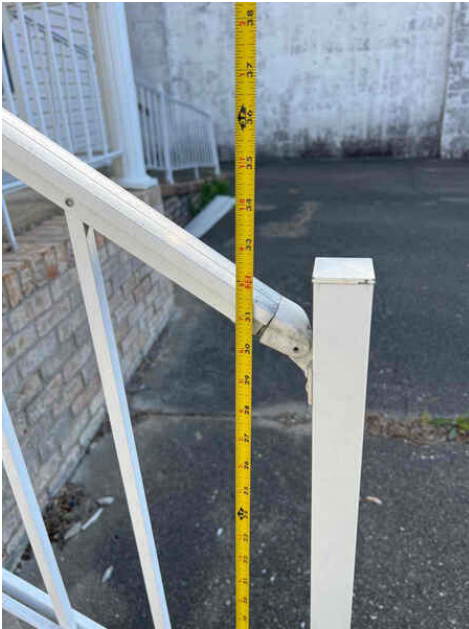
Front Porch Railing Height, Recommend 42"

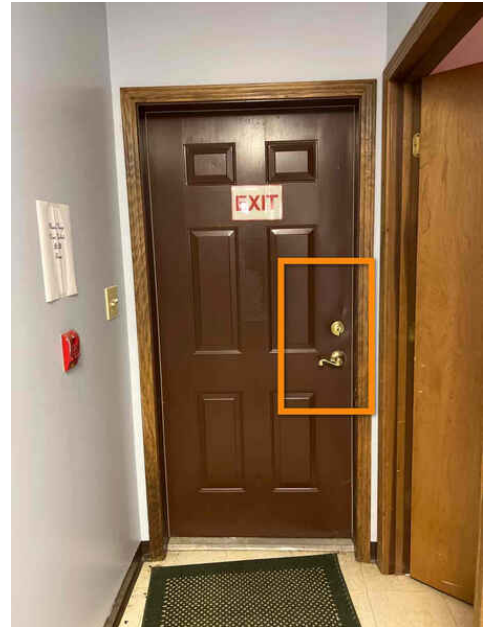
The rear door to the building could not be opened without potential damage to the deadbolt. The deadbolt does not open and close smoothly.

Rear Door, Deadbolt Issues

Contact a qualified door repair/installation contractor.

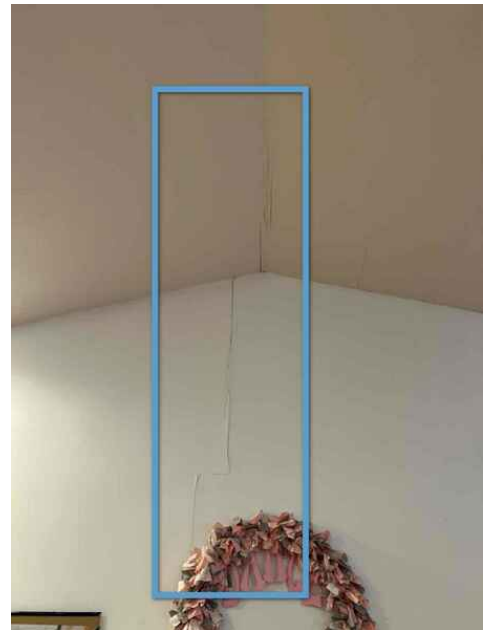
In the dance hall area, there are wall and ceiling cracks in one area. There is no visible evidence of any structural concerns with these cracks. Recommend repairing and monitoring for future cracking.

2nd Floor Dance Hall, Ceiling/ Wall Cracks

Contact a qualified drywall contractor.

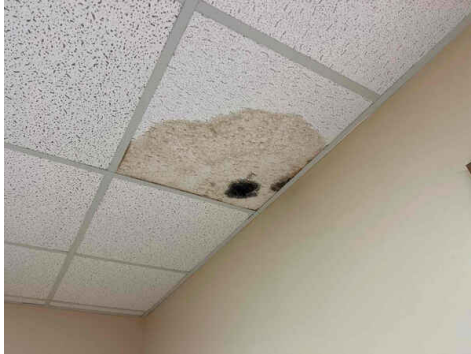
There are ceiling stains in several locations. Some of the more prevalent areas are in the pictures below. All readily accessible stains were tested with a moisture meter, they were all dry at the time of the inspection.

Center Lab, Ceiling Stain (Mold), Dry When Tested

Contact a qualified drywall contractor.

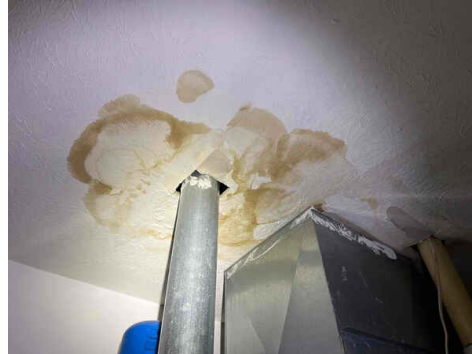
Right Utility Room, Ceiling Stains, Dry When Tested

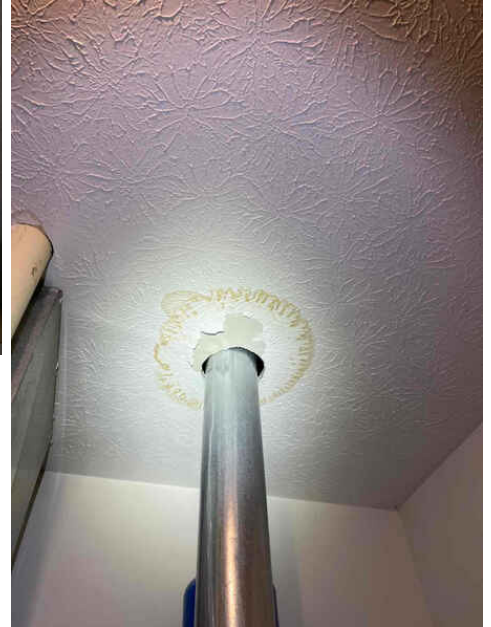
Left Utility Room, Ceiling Stains, Dry When Tested

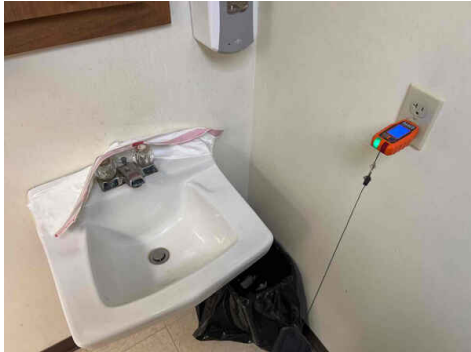
**There is no GFCI protection in any location in the building.**

Example Bathroom - GFCI Protection Missing - All Bathrooms

Contact a qualified electrical contractor.

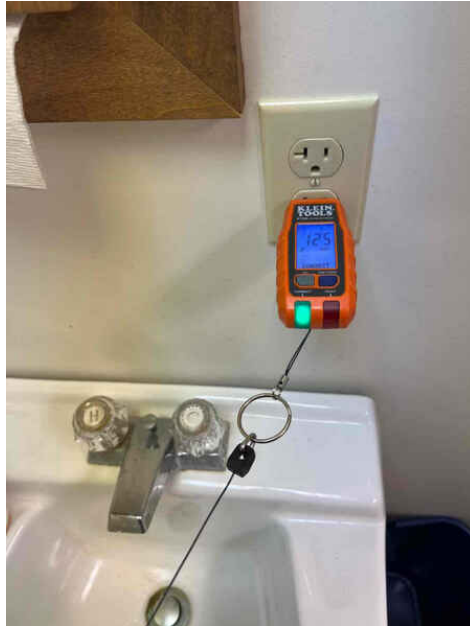
Example Bathroom - GFCI Protection Missing - All Bathrooms

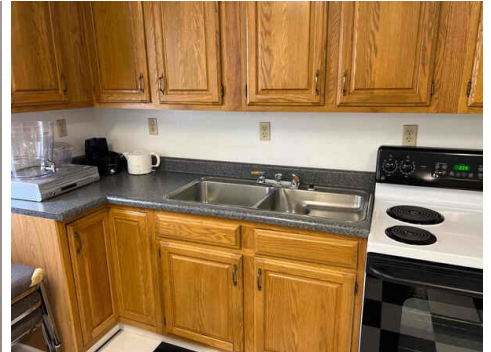
2nd Floor Kitchen Area - GFCI Protection Missing

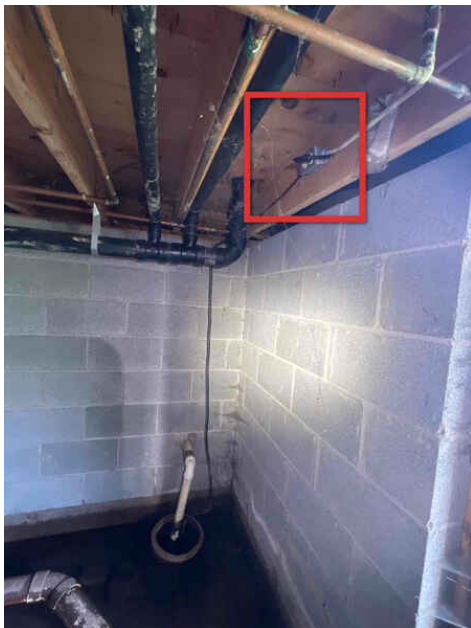
Crawlspace, GFCI Protection Missing

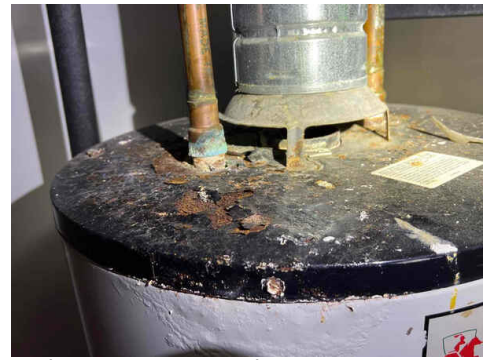
Corrosion was noted on the exterior of the hot water tank. Recommend a qualified plumber evaluate for repair/replacement.

Right Hot Water Tank, Corrosion

Contact a qualified plumbing contractor.

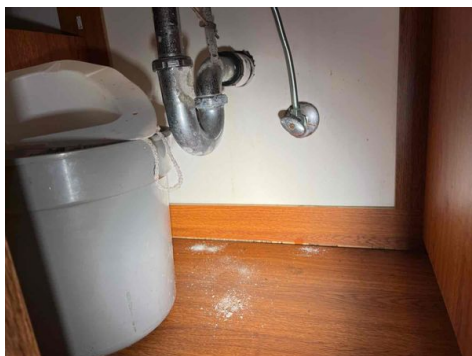
Left Hall Bathroom

The drain piping identified in the pictures shows evidence of having leaked in the past. The pipes were dry at the time of the inspection. However, they do not appear to have been repaired and may leak again. Recommend a qualified and licensed plumber further evaluate and repair. (Representative/ Sample Pictures)

Contact a qualified plumbing contractor.

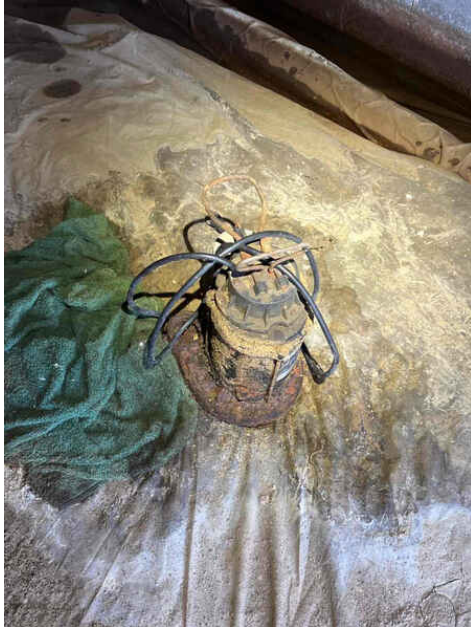
The sump pump in the crawlspace is not working. This is leading to an extensive amount of water in the crawlspace. In addition, the discharge of the sump pump is immediately outside the building. This will cause some of the water to return to the crawlspace, defeating its purpose.

Old Sump Pump Present

Contact a qualified plumbing contractor.

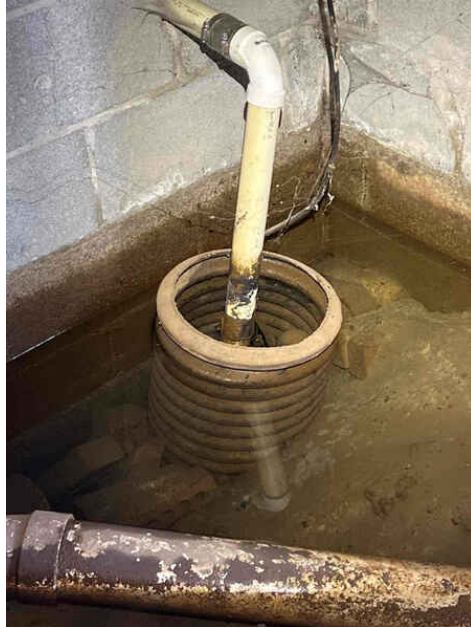
Sump Pump, Not Working

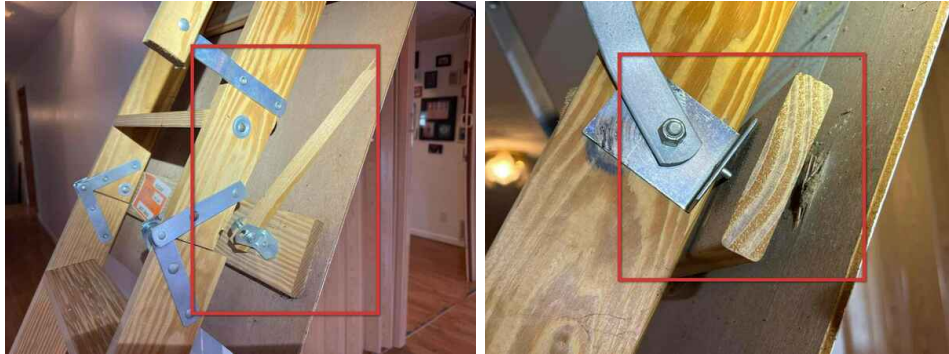
The stairs to the attic do not function correctly and are unsafe to use. Recommend engaging a qualified professional to further evaluate and repair. Use with caution until repairs are made.

Attic Stairs Damaged, Use With Caution    Attic Stairs Damaged, Use With Caution

Contact a qualified professional.

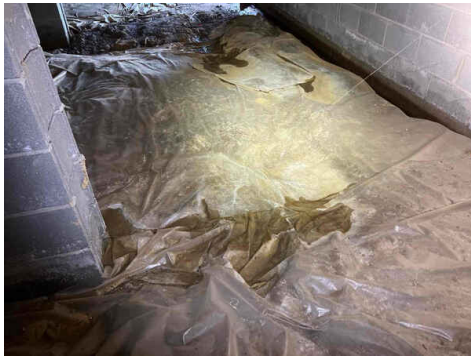
High moisture levels are present in the crawlspace. The moisture is due to the following:

Crawlspace - Example of Standing Water

Recommend resolving these items and any additional items in this report that are causing water to enter the crawlspace.

Contact a qualified waterproofing contractor

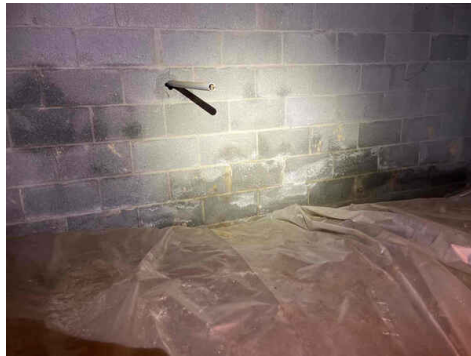
- **Water Intrusion** - Due to the negative grading, gutter, and downspout items identified in this report, water enters the crawlspace. The soil is wet in most areas and the inside of the concrete foundation walls are also wet in some areas.
- **Inadequate Crawlspace Ventilation** - Recommend opening all crawlspace vents and leaving them open all year.

Example of Moisture Thru Block, From Downspouts and Negative Grading

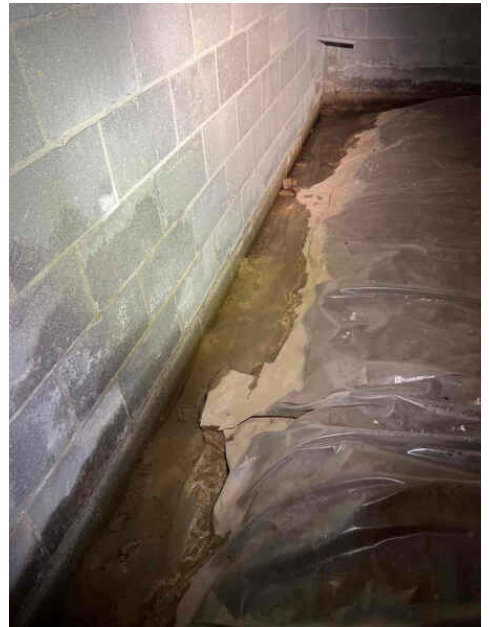
Crawlspace - Example of Standing Water

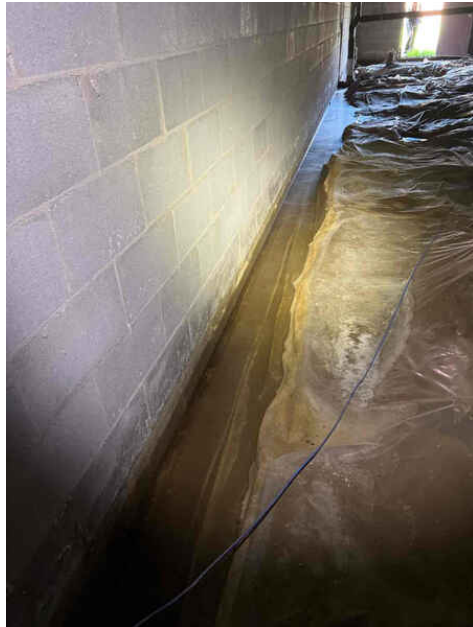
Crawlspace - Example of Standing Water

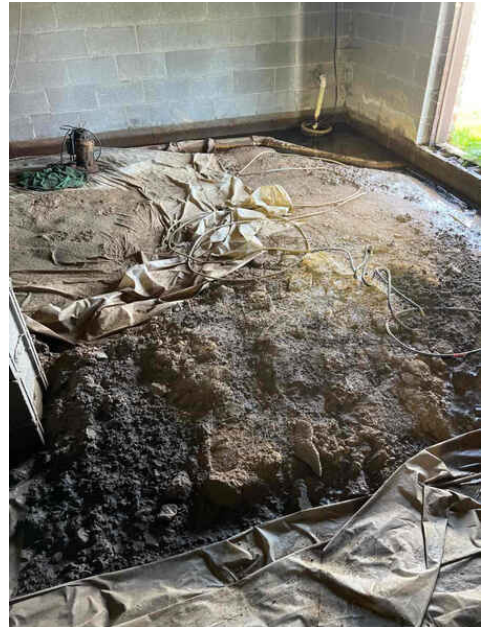
Crawlspace, Muddy Conditions, High Moisture

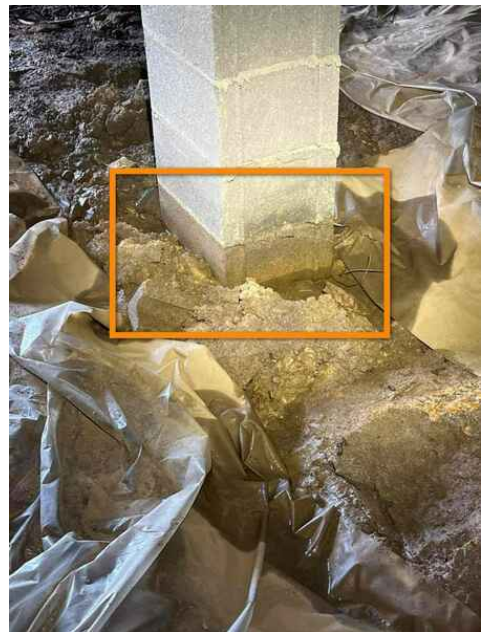
In the crawlspace, some of the floor structure support pillars are standing in water. This can cause the settling of these pillars over time with the weight of the building upon them. Resolving the water intrusion issues and drying out the crawlspace is the best course of action to stabilize these pillars and reduce the likelihood of future foundation or floor structure issues.

Example - Crawlspace Floor Support Pillar, Standing in Water

Contact a qualified professional.

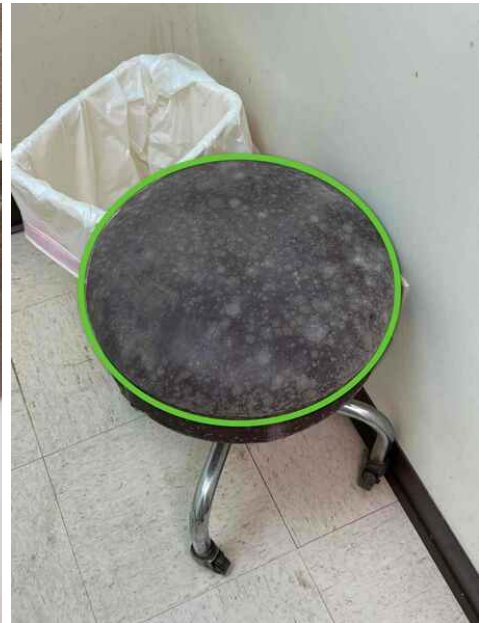
There is evidence of fungal growth in the form of potential mold in the sample areas identified in the pictures.

Potential Mold - Inside Example

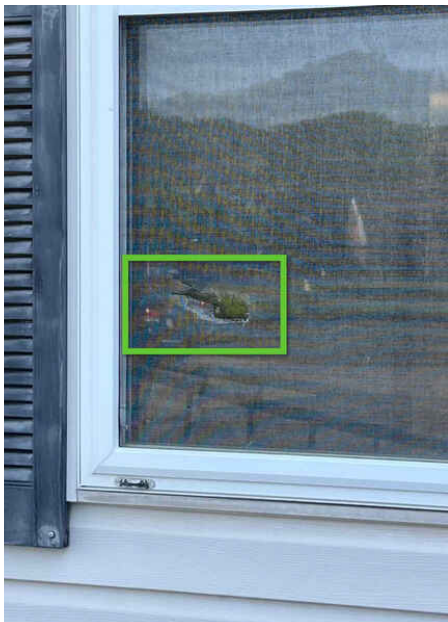
Front of Building, Both Windows Have Torn Screens

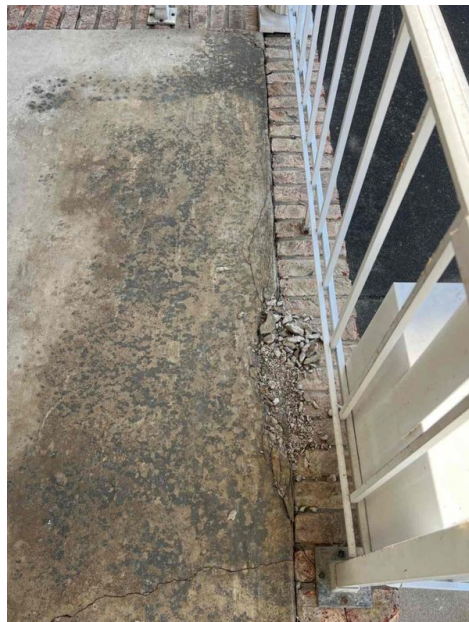
Front Porch, Concrete Deterioration

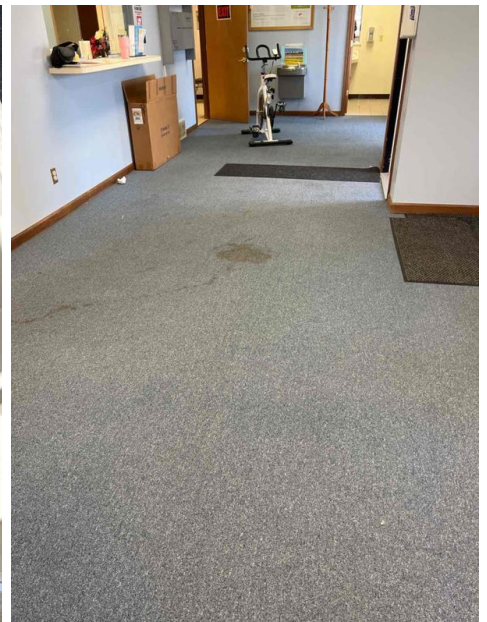
Lobby Carpet Needs Cleaning

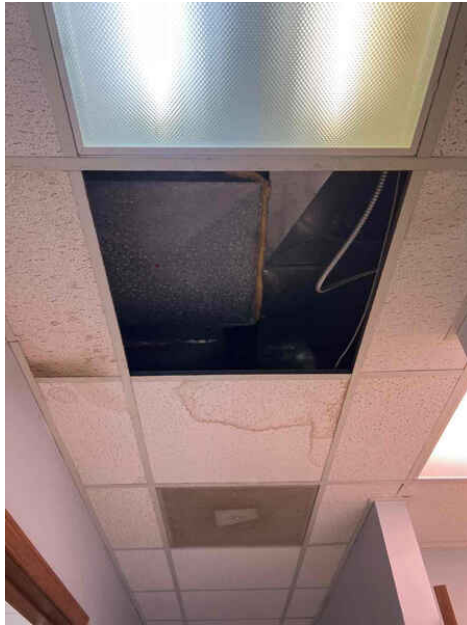
Left Hallway, Ceiling Tile Missing (Below Left Furnace)

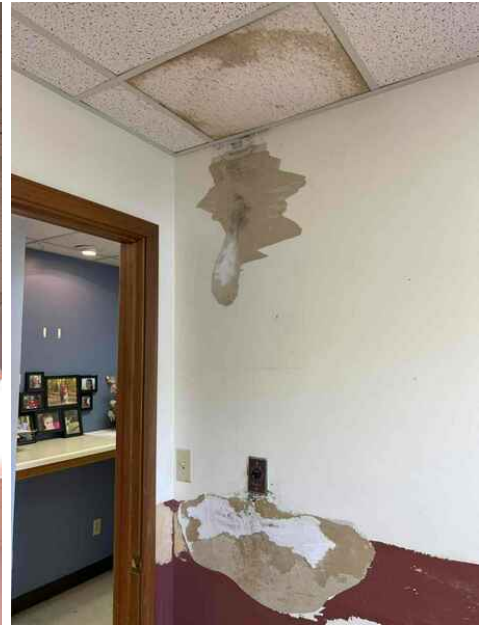
Below Left Furnace, Ceiling and Wall Damage from Water

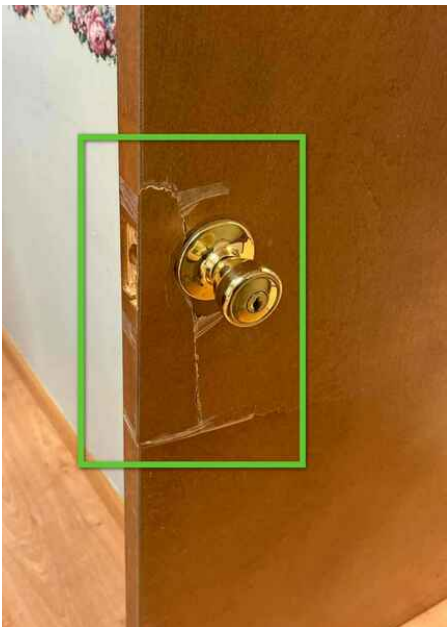
Dr Office Door Damage

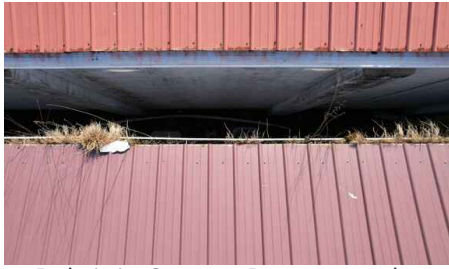
Debris in Gutters, Recommend Cleaning
