TRI-STATE SMART HOME SOLUTIONS LLC

INSPECTION REPORT

1234 Main Street
Gallipolis, OH 45631

07/31/2023 9:00AM

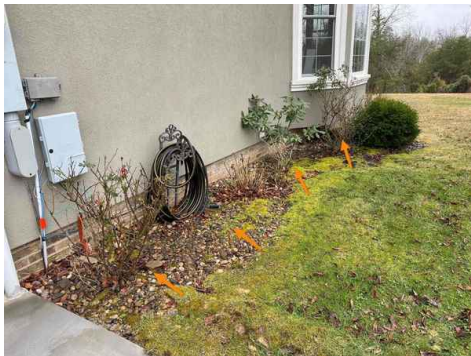
- 1) This is causing active water intrusion into the crawlspace.
- 2) If not addressed, this can lead to potential foundation issues.

Right Side of House, Negative Grading - Example

The yard and landscaping should slope away from the house to prevent these conditions in the future, ideally 6 inches of drop in the first 10 feet.

Recommend engaging a landscaping or excavation company to further evaluate (Representative/ Sample Pictures)

Contact a qualified landscaping contractor

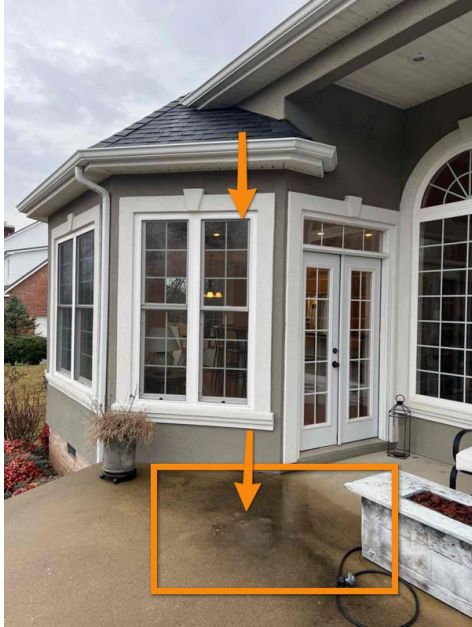
Rear Patio, Gutters Overflow

Contact a qualified gutter contractor

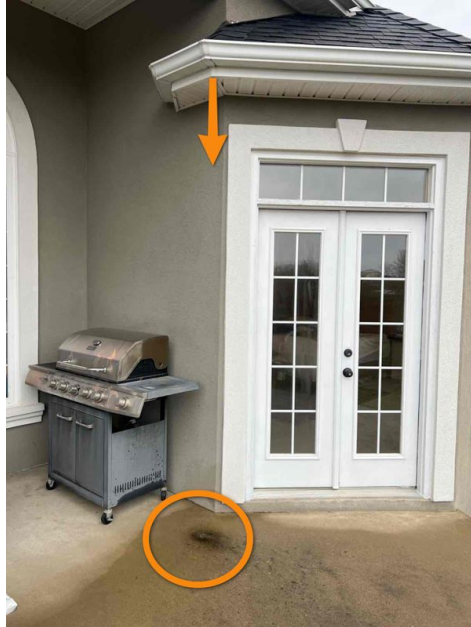
Rear Patio, Gutters Leaking

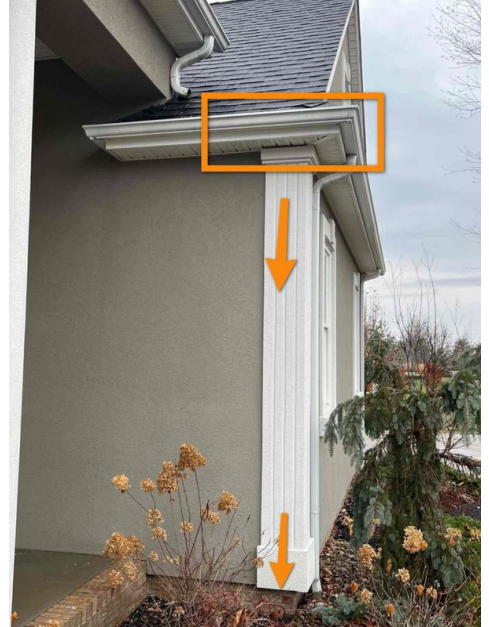
Front of House, Gutters Overflow

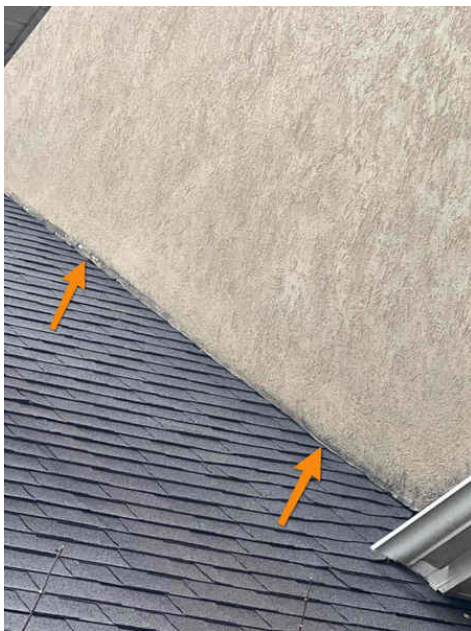
In all areas where the stucco siding is in contact with the roof, there is no air gap to allow the roof to drain and dry without some of the water absorbing into the siding material. This can quickly deteriorate the siding and cause staining.

In the shady areas of the roof, there is also moss growing. This can lead to roof leaks and accelerate stucco siding deterioration.

Front of House, Left Side of Large Dormer, Siding In Contact With Shingles

Recommend engaging a qualified siding contractor that has extensive experience with stucco siding (which is less common in this area) to evaluate further.

Contact a qualified siding specialist.

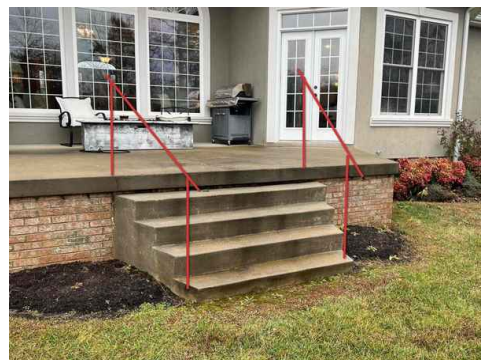
The steps identified in the pictures do not have proper handrails and guardrails. These rails are recommended due to the height of the steps and the risk of falling, for both adults and children.

Rear Patio, Steps Missing Handrails

Contact a qualified carpenter.

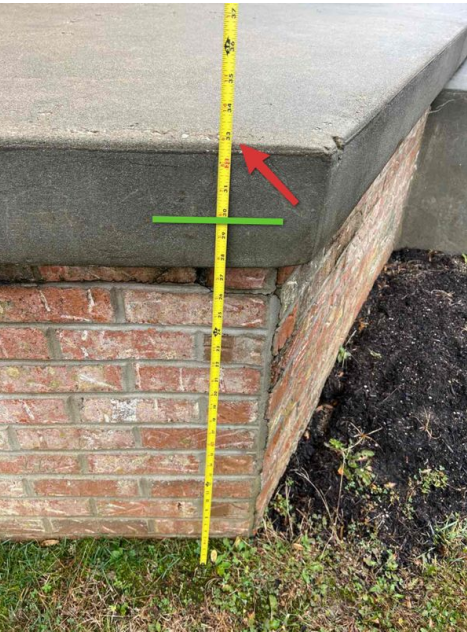
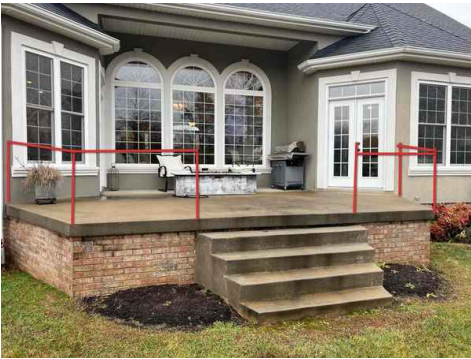
The safety handrailing is missing on the rear patio. A safety handrail is recommended if the patio is 30" or higher. This patio exceeds this height. Recommend a qualified and licensed contractor to further evaluate and repair. Use with caution until this is corrected.

Rear Patio, Missing Safety Railings

Contact a qualified deck contractor.

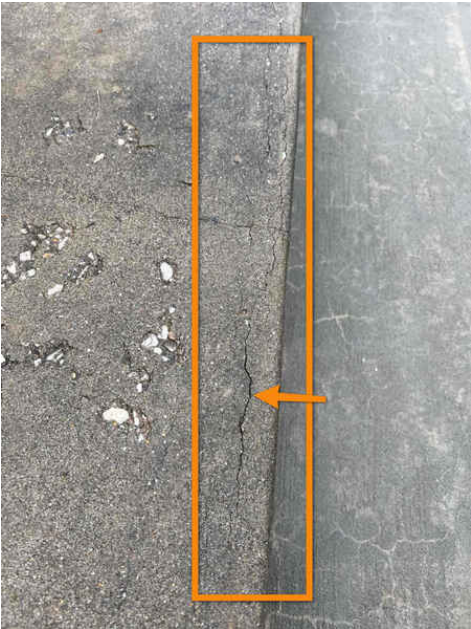
The concrete on the rear patio is deteriorating. It appears the original concrete was improperly mixed and sealed after pouring. This is largely a cosmetic issue. However, if not addressed, the concrete will continue to crack and the steps will deteriorate further.

Rear Patio, Concrete Cracking

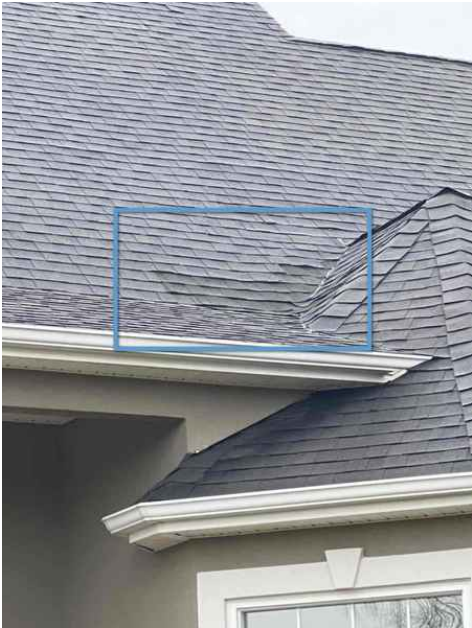
There is evidence of shingle replacement at the rear of the house above the master bedroom.

- 1) The repairs appear to have been completed by a qualified professional.
- 2) There is evidence in the master bedroom of ceiling repairs and painting.
- 3) All areas were dry at the time of the inspection.

Rear of House, Evidence of Roof Repairs

Recommendation
Recommend monitoring.

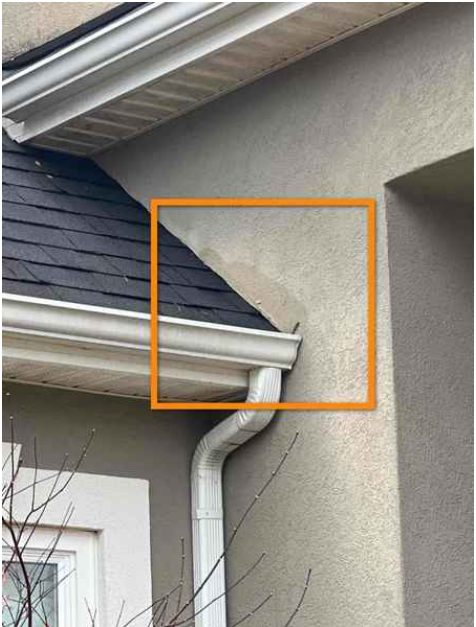
At the front of the house, in the area identified in the picture, the kick-out flashing is missing.

- 1) This is causing rainwater from the roof to absorb into the sidewall of the house structure.
- 2) This is causing rainwater to run down the side of the house along the end of the gutter and cause staining.
- 3) There is evidence that the siding has been painted in this area, likely to cover staining.

If not addressed, there is a very high chance that the stucco siding will become damaged in this area and staining will occur below this area.

Front of House, Left Above Porch, Kick Out Flashing Missing

Recommendation
Contact a qualified roofing professional.

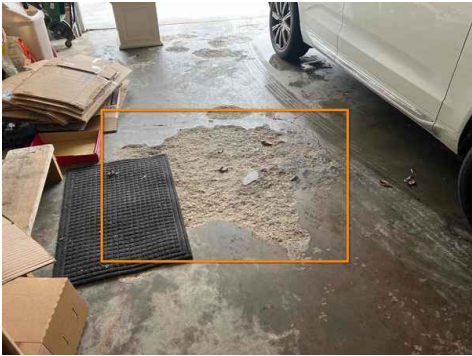
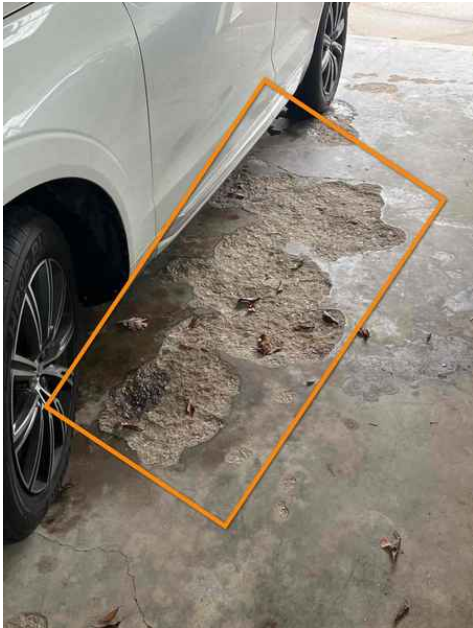
The concrete floor in the garage has severely deteriorated. The concrete appears to have been improperly mixed when it was originally installed. There is a high potential that the concrete will need to be removed and re-poured for proper correction of this issue. Recommend engaging a qualified and licensed concrete professional to further evaluate.

Attached Garage, Concrete Floor Deterioration - Example

Contact a qualified concrete contractor.

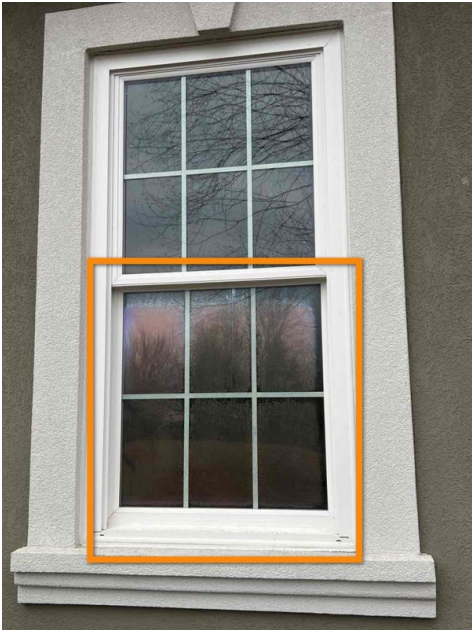
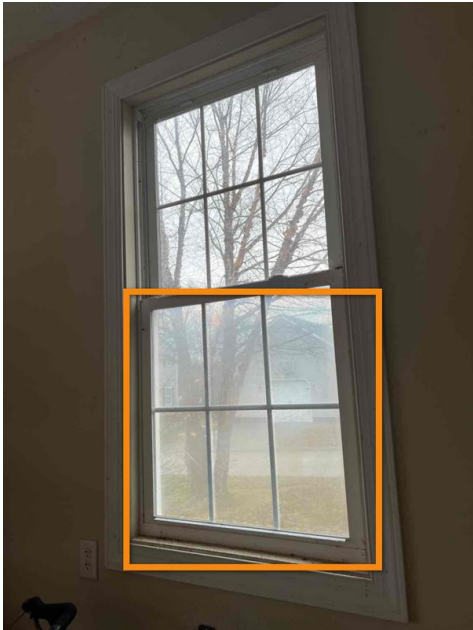
Observed condensation between the window panes for the garage windows identified in the pictures, which indicates a failed seal. The window is no longer insulating correctly. Recommend engaging a qualified window professional to further evaluate and repair/ replace the window.

Attached Garage, Window, Failed Seal

Contact a qualified window repair/installation contractor.

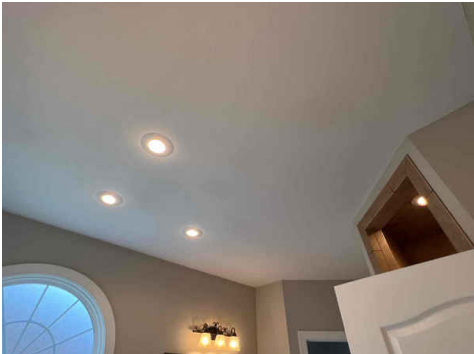
Note to Buyer: There is no bathroom exhaust fan in the shower area of the master bathroom.

Master Bathroom, No Exhaust Fan
Near Shower (In Toilet Room Only)

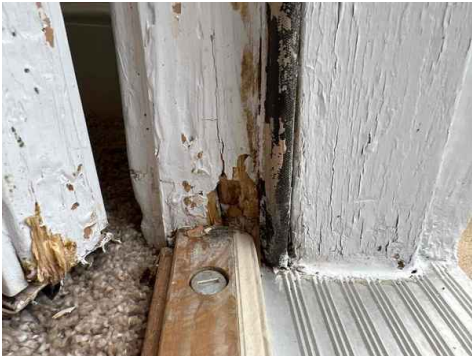
The exterior door from the master bedroom to the rear patio has deteriorated.

- 1) The wood trim is showing signs of excessive weathering and that start of wood rot (it has been painted over).
- 2) The door framing is rotted.
- 3) The baseboard to the left and right of the door on the inside was wet at the time of the inspection.
- 4) There is a small potential that there is flooring damage in this area. A more intrusive investigation would be required to determine the extent of the damage.

Master Bedroom, Rear Door, Severely Deteriorated

The door and door framing will likely need to be replaced to fully and properly resolve the issues that exist.

Contact a qualified door repair/installation contractor.

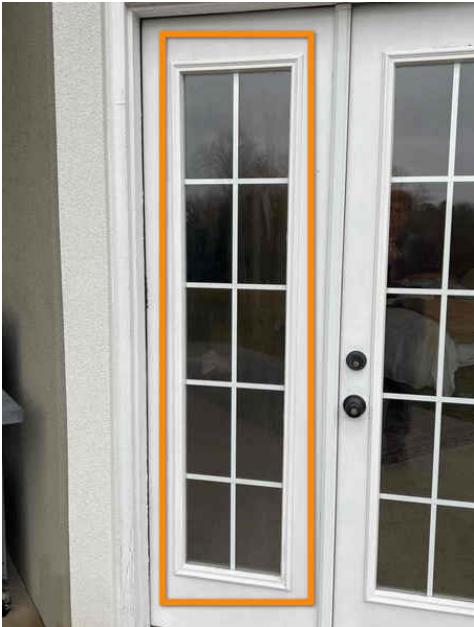
Observed condensation between the window panes for the door windows identified in the pictures, which indicates a failed seal. The windows are no longer insulating correctly.

Master Bedroom, Door to Patio, Failed Window Seal

Contact a qualified door repair/installation contractor.

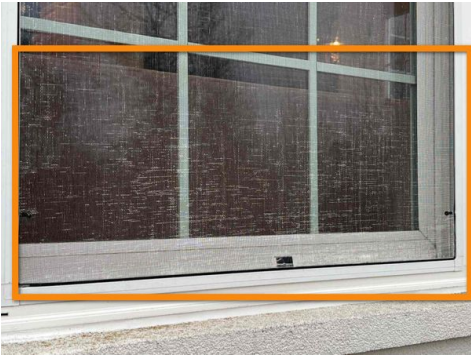
Many of the screens in the house have deteriorated. This is potentially due to improper cleaning with a power washer. (Representative/ Sample Pictures)

Window Screens Deteriorated - Example

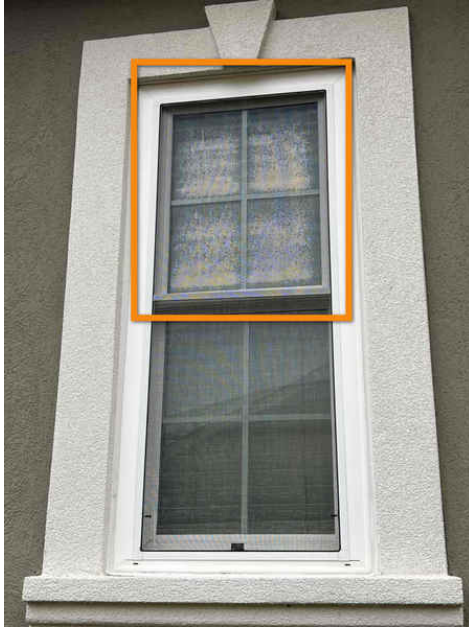
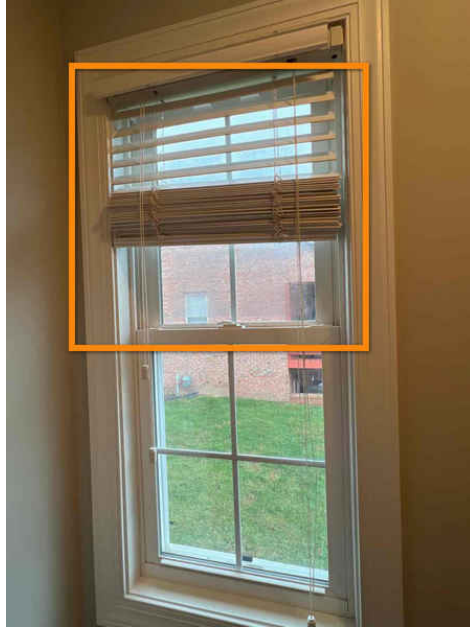
Observed condensation between the window panes for the windows identified in the pictures, which indicates a failed seal. The windows are no longer insulating correctly.

Master Bathroom, Toilet Room,
Window Failed Seal

Contact a qualified window repair/installation contractor.

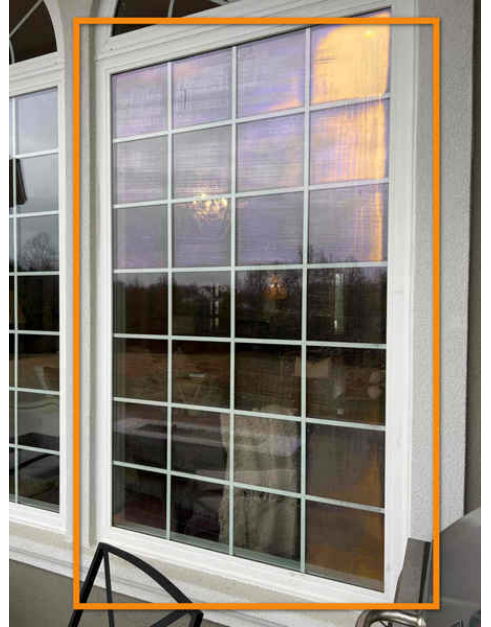
Living Room Rear Window, Failed Seal

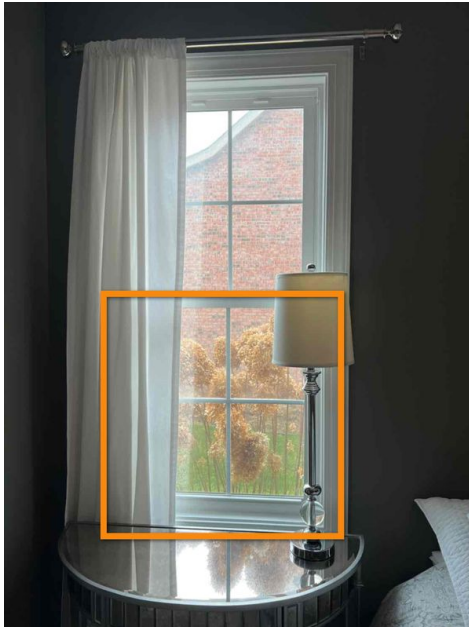
1st Floor End Bedroom, Window Failed Seal

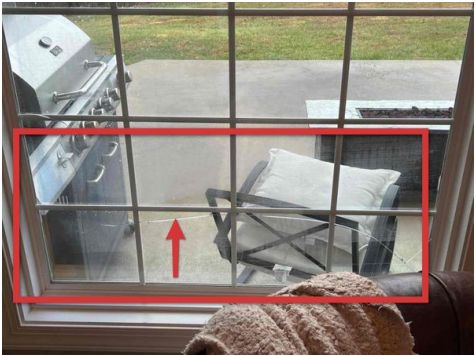
The glass is broken in the windows identified in the pictures. This impacts the insulating ability of the window and could present a safety hazard to residents. Recommend replacement by a qualified and licensed window repair professional.

Living Room, Rear Window, Broken Glass

Contact a qualified window repair/installation contractor.

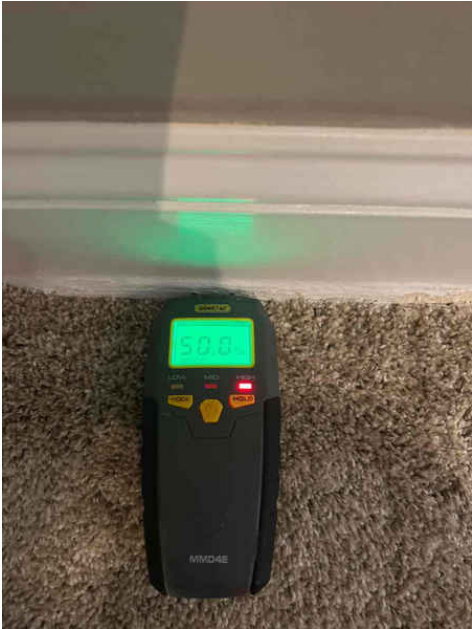
- 1) When tested with a moisture meter the carpeting is wet throughout the room.
- 2) Along the rear wall of the room the baseboard is saturated and has deteriorated.
- 3) In at least two areas, the drywall above the baseboard is visibly wet.
- 4) Further investigation in the attic space behind the rear knee wall found wet sub-flooring.

In the inspectors opinion, there is a potential that excessive shampoo water could be the cause.

2nd Floor Family Room, Wet Areas - Example

Recommend either a more in-depth investigation and/or drying the areas with fans and monitoring for any future presence of water in this room.

Contact a qualified professional.

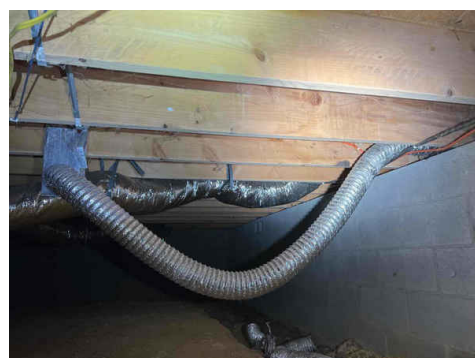
The dryer vent is improperly installed, this is a safety hazard. A flexible dryer vent pipe is being used the entire length of the dryer vent and it is improperly supported. The dryer should vent to the exterior and the flexible vent should only be used for short runs to connect the dryer to the main pipe. The connection to the dryer must be made from aluminum, not plastic. The majority of the vent pipe should be solid and smooth so it does not collect dust, especially for long horizontal runs, vertical runs, and all 90-degree turns in the vent pipe.

Crawlspace, Dryer Vent Improperly Installed

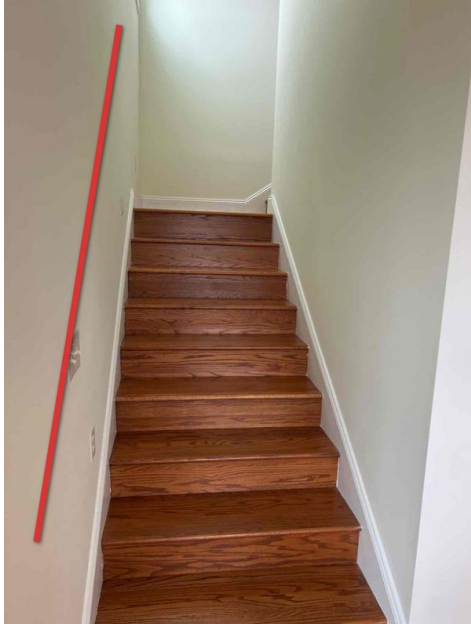
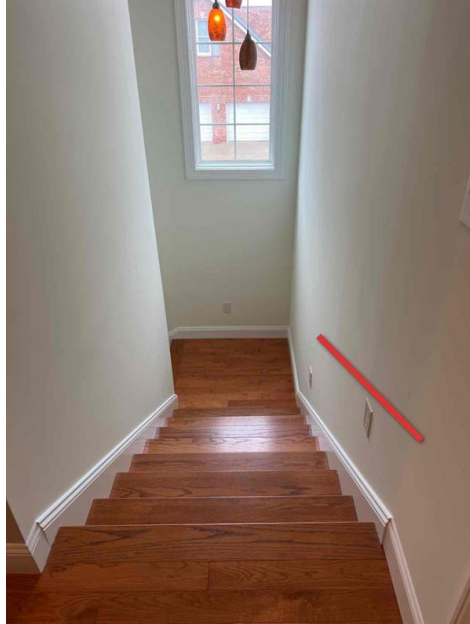
The stairs identified in the pictures are missing recommended handrails.

Stairs to 2nd Floor, Missing Handrail

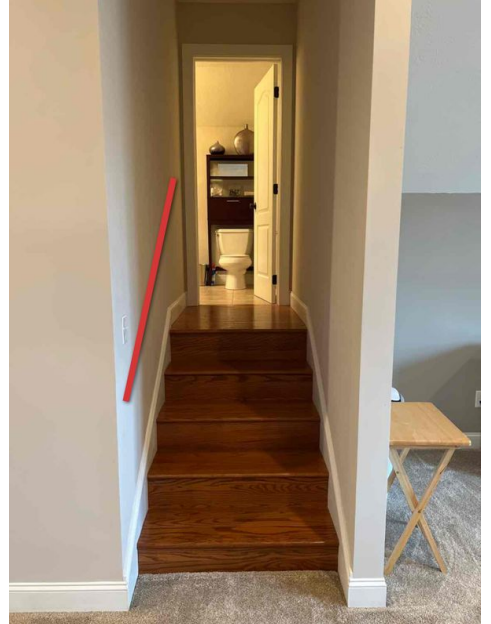
2nd Floor Bathroom to Family Room, Missing Handrail

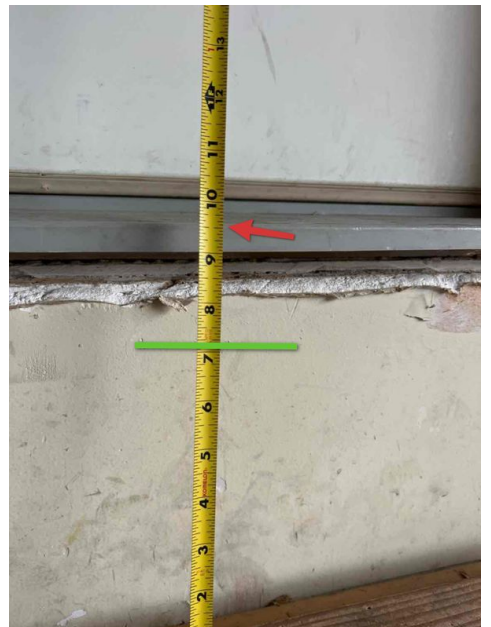
The stairs from the garage to the house have an excessive step height. Ideally, the step height should be no taller than 7 3/8 inches, the top step exceeds 9 inches. These steps are a safety hazard.

Steps From Attached Garage, Excessive Step Height

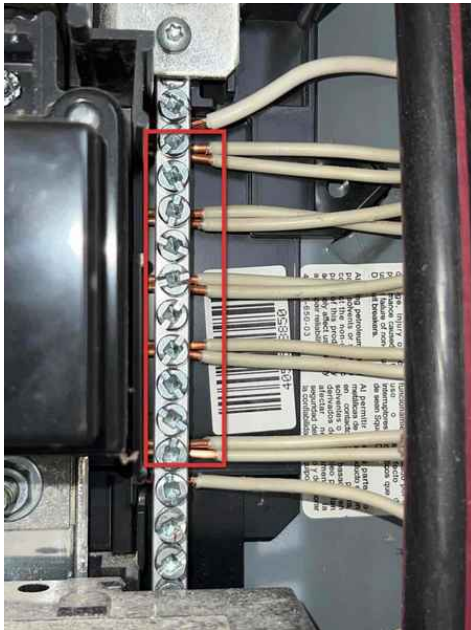
Each white wire must be under a terminal screw by itself. No other wires (white, copper, etc) can be under the same screw as the white wire. As identified in the pictures, this panel does not meet these requirements. Adding additional wires with the white wire can cause loose connections and cause arcing.

Attached Garage, Right Electrical Panel,
Multiple Wires Under Single Screw

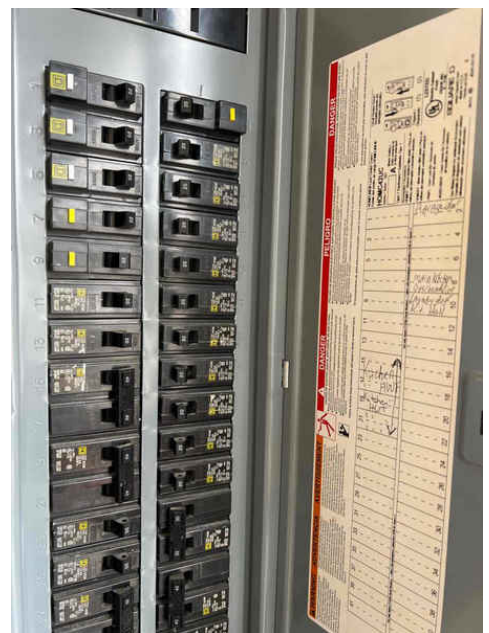
The electrical panel is missing complete permanent labeling. Recommend properly labeling the entire panel for quick and efficient use. There are times when it's important to identify the proper breaker and labeling the breakers will improve the accuracy of identification.

Attached Garage, Right Electrical Panel,
Missing Full and Permanent Labeling

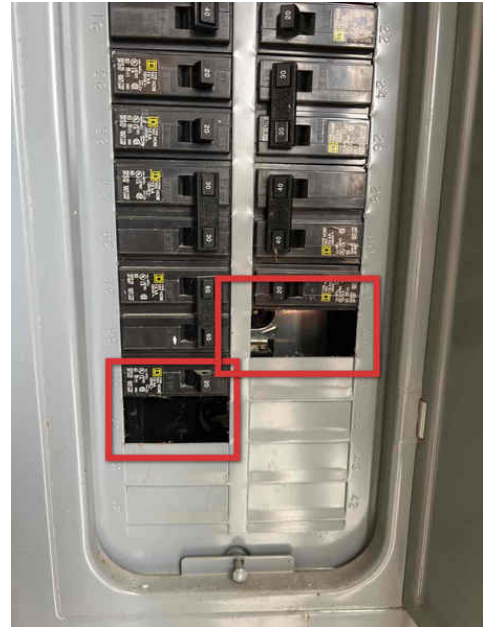
There are openings in the cover of the electrical panel where breakers previously were installed. This can allow inadvertent access to energized electrical components creating a fire and safety hazard. There are plastic items called "Knockouts" that are designed to fill these openings.

Attached Garage, Right Electrical Panel, Missing Knockouts

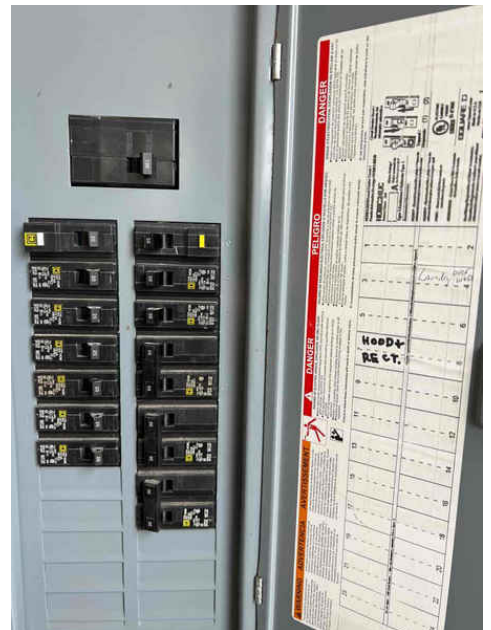
The electrical panel is missing complete permanent labeling. Recommend properly labeling the entire panel for quick and efficient use. There are times when it's important to identify the proper breaker and labeling the breakers will improve the accuracy of identification.

Attached Garage, Left Electrical Panel, Missing Full and Permanent Labeling

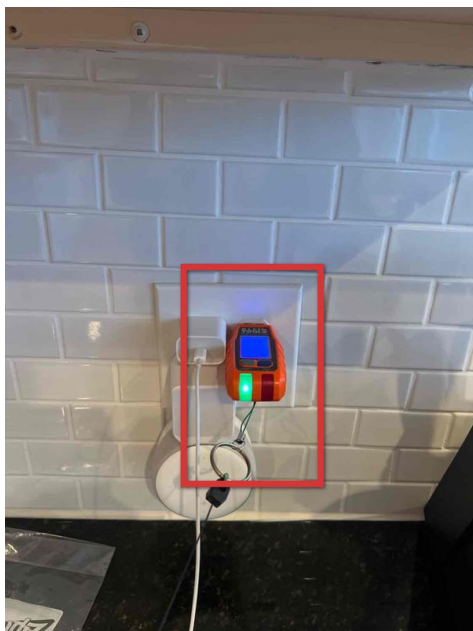
GFCI protection is recommended for all receptacles that can be reached when standing outdoors on dirt, grass, etc, and when standing on concrete such as in garages, outbuildings, basements, etc. In addition, all interior receptacles within 5 1/2 feet of a water source such as a sink, bathtub, washtub, etc inside the house including the kitchen, bathrooms, laundry rooms, wet bars, etc.

Kitchen, Not GFCI Protected

Contact a qualified electrical contractor.

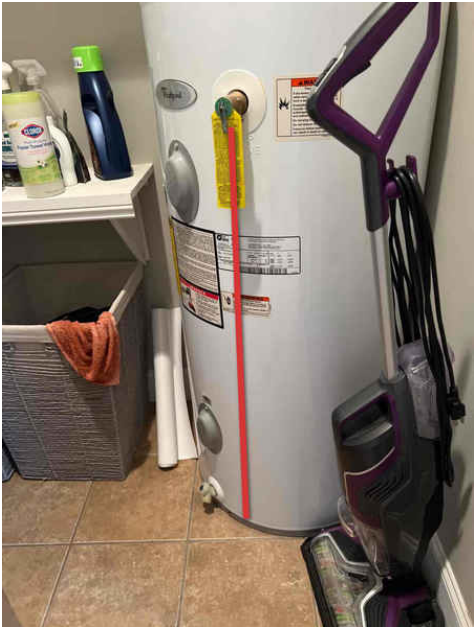
TEMPERATURE/ PRESSURE RELIEF (TPR) VALVE
MASTER BATHROOM CLOSET
The Temperature/ Pressure Relief (TPR) valve needs a pipe extending it to within 6 inches of the floor.
Recommendation
Contact a handyman or DIY project

Master Bathroom Closet, Hot Water Tank, TPR Extension Missing

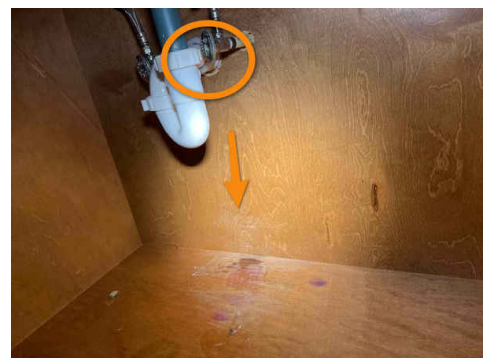
There is an active drain pipe leak. Water was dripping from the pipe at the time of the inspection. Recommend engaging a qualified and licensed plumbing professional to further evaluate and repair.

Master Bathroom, Right Sink, Drain Leaking

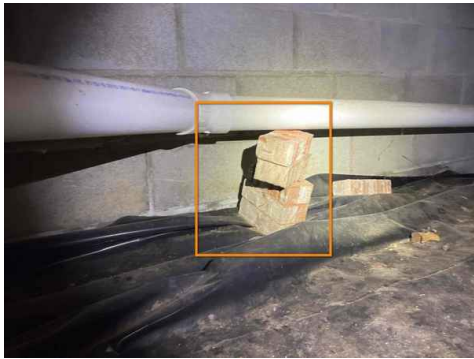
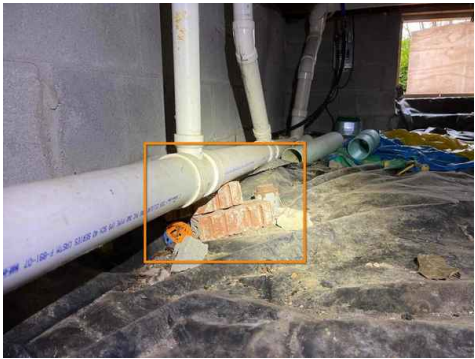
In the crawlspace, the main plumbing drain line is improperly supported. The materials being used are improper and are already failing. This will cause the plumbing drain issues for the house if not addressed.

Crawlspace, Drain Line Improperly Supported

Contact a qualified plumbing contractor.

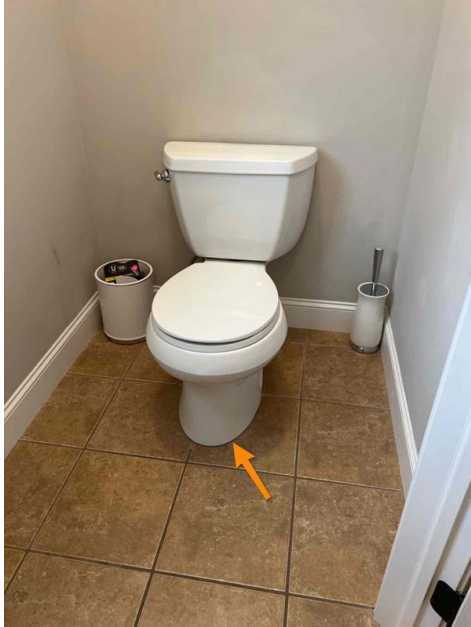
The toilets in the pictures are loose and not properly secured to the floor. This could cause plumbing leaks and other flooring damage.

Owner Suite, Toilet Not Secure

Contact a qualified plumbing contractor.

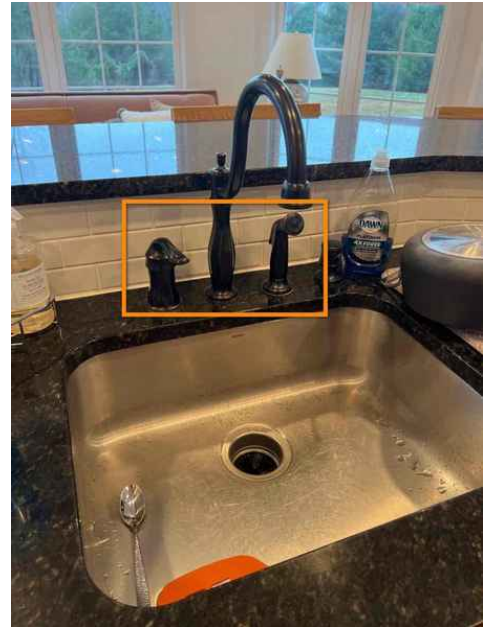
Kitchen Sink, Faucet Not Working Properly

Contact a qualified plumbing contractor.

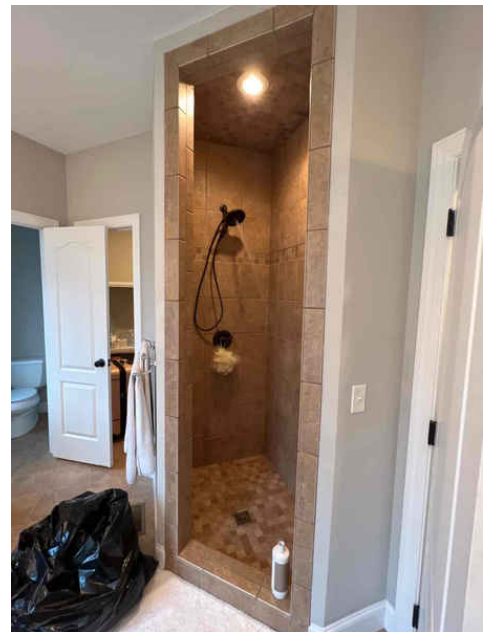
There is no door on the master bathroom shower. This will cause shower water to spray onto the floor creating a slip-and-fall hazard.

Master Bathroom Shower - Door Missing

Contact a qualified professional.

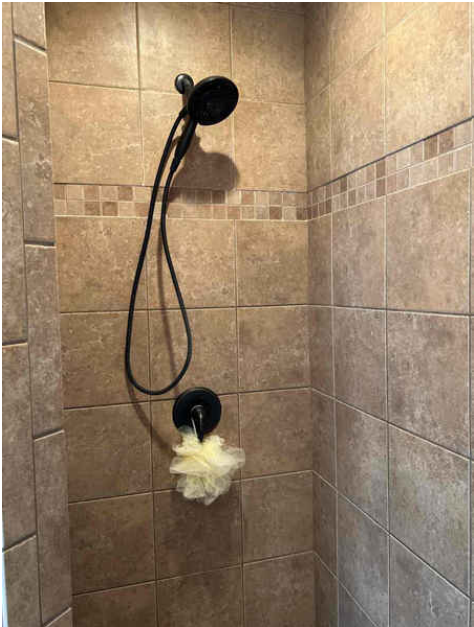
In the master bathroom shower, there is no way to turn on the water and adjust the temperature of the water, without getting wet. This can be a burn hazard or at least, a major inconvenience. The showerhead spray should be 90 degrees to the door/ entrance.

Master Bathroom Shower, Improper Design

Recommendation
Contact a qualified professional.

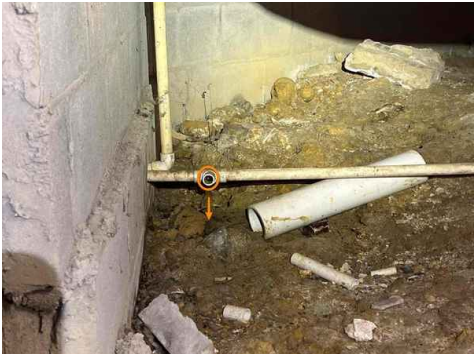
The condensate line from the furnace in the crawlspace has been improperly installed. It drains into the crawlspace. The dirt below the pipe was wet at the time of the inspection. Recommend engaging a qualified licensed HVAC professional to further valuation and repair.

Crawlspace, HVAC Condensate Drains to Crawlspace

Contact a qualified HVAC professional.

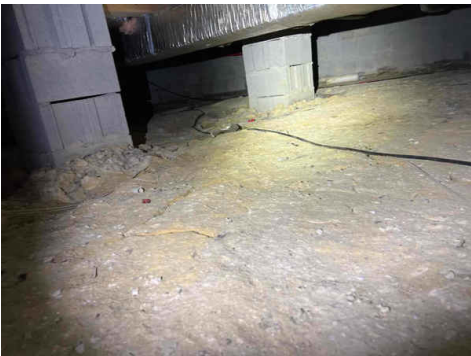
- 1) **High Moisture Levels** - High levels of moisture were noted in the crawlspace. This can lead to mold, wood rot, premature rusting of the metal components (framing, HVAC, and Iron Plumbing), etc.
- 2) **Vapor Barrier** - The crawlspace has a dirt floor and a partial vapor barrier. This can contribute to high moisture levels in the crawlspace and potentially mold.
- 3) **Efflorescence/ Water Intrusion** - Efflorescence was noted on the exterior crawlspace foundation surfaces. This is a white, powdery deposit that is consistent with moisture intrusion through the foundation. This is an indication that water is present on the outside of the foundation.
- 4) **Inadequate Crawlspace Ventilation** - There is insufficient ventilation in the crawlspace. There are crawlspace vents however, they were not all fully open at the time of the inspection.

Crawlspace - Missing Vapor Barrier - Example

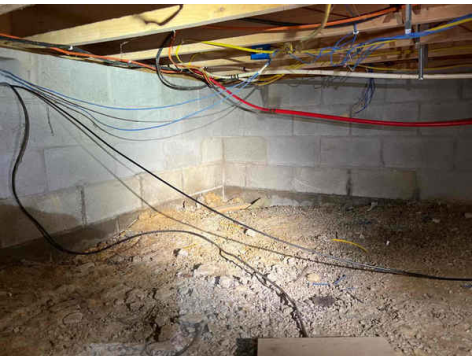
Crawlspace - Efflorescence, Water Intrusion - Example

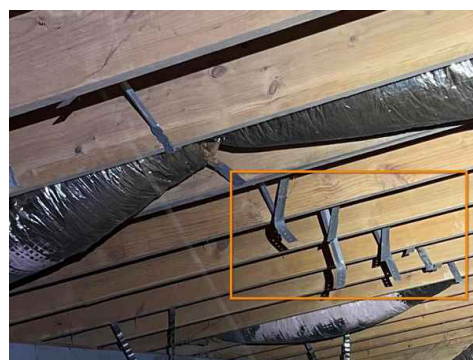
The cross-bracing in the ceiling of the crawlspace is not secured to the entire floor structure of the house. They do not appear to have been attached during the original construction of the house. Cross-bracing the floor joists makes the wood frame floor system stiffer, consequently preventing twisting, deflection, squeaking, sagging and bouncing. This is a structural concern, recommend engaging a qualified professional to further evaluate and properly install the cross-bracing.

Crawlspace - Cross-bracing Not Installed - Small Example Only

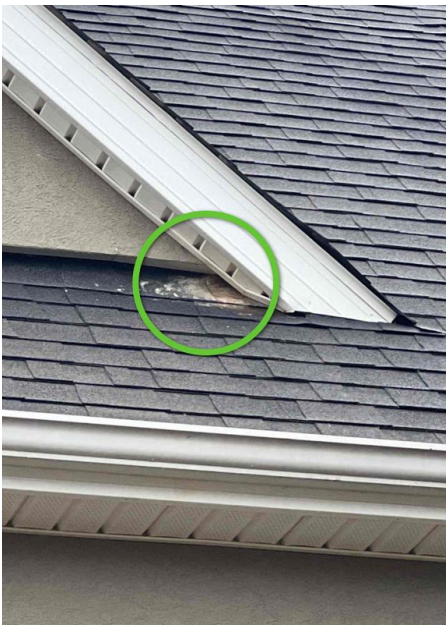
Front of House, Birds Nest

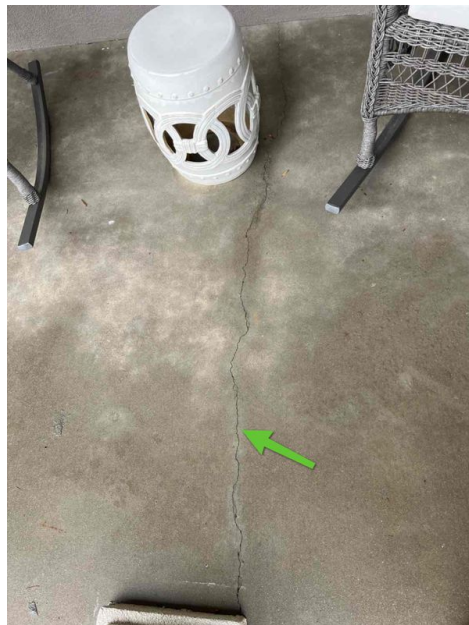
Front Porch, Cosmetic Cracks, Recommend Sealing

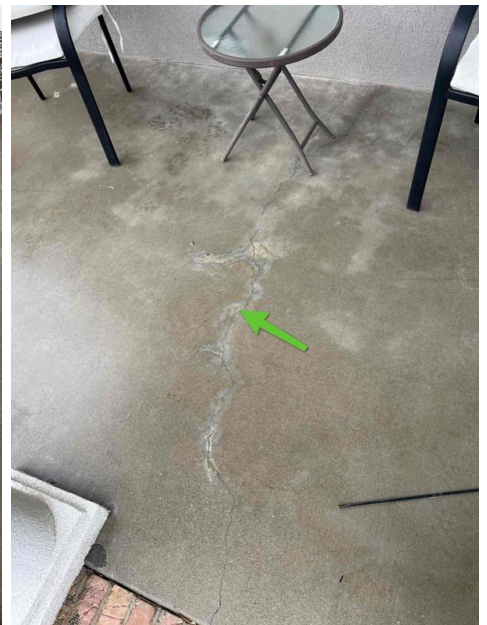
Front Porch, Cosmetic Cracks, Recommend Sealing

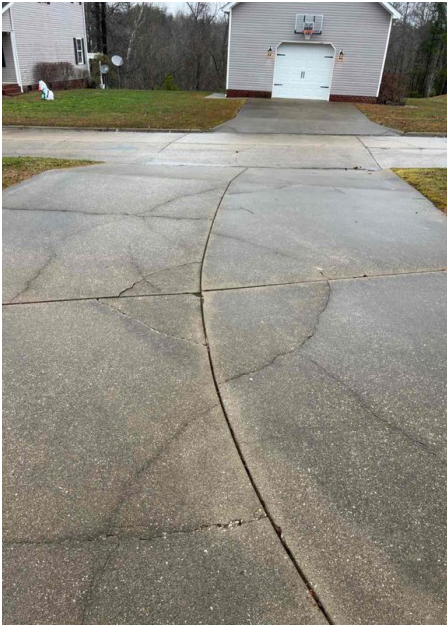
Driveway Cracks, Cosmetic,
Recommend Sealing

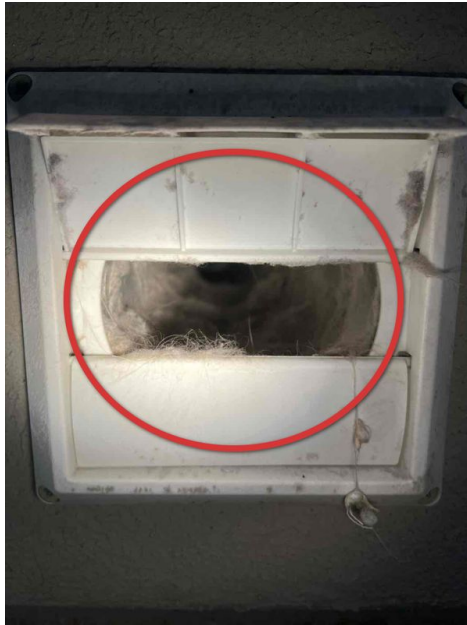
Dryer Vent Needs Cleaning

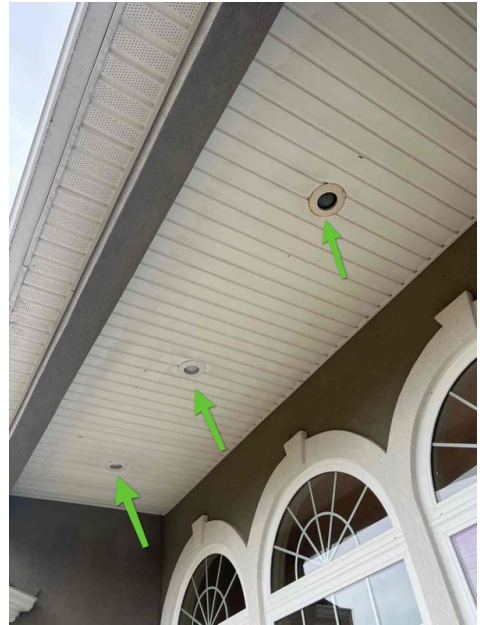
Rear Patio, Light Rings Rusting

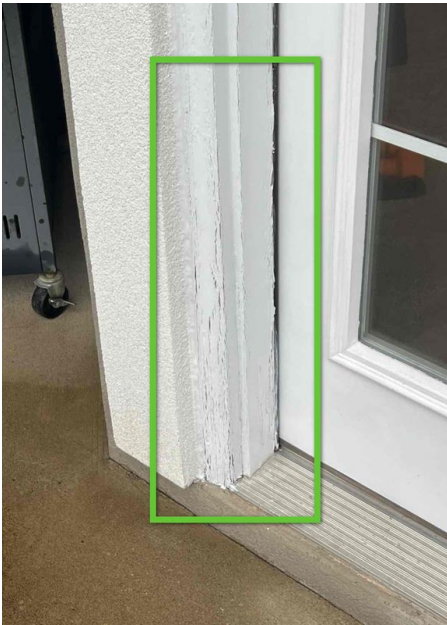
Exterior Trim Needs Painted -
Example

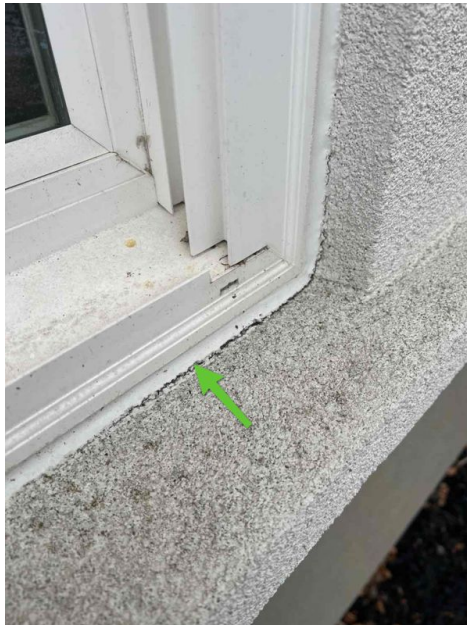
Recommend Sealing Exterior of
Windows - Example

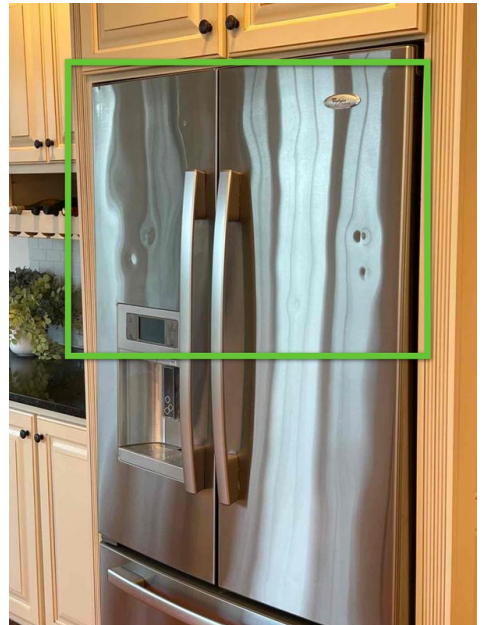
Cosmetic, Refrigerator Damaged

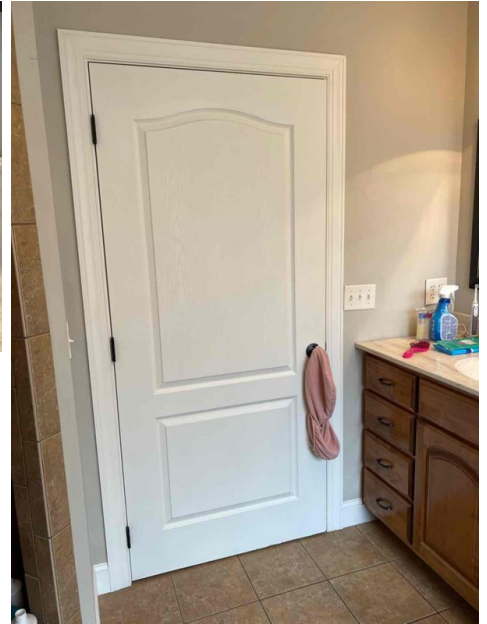
Owner Suite, Bathroom Door Does
Not Latch

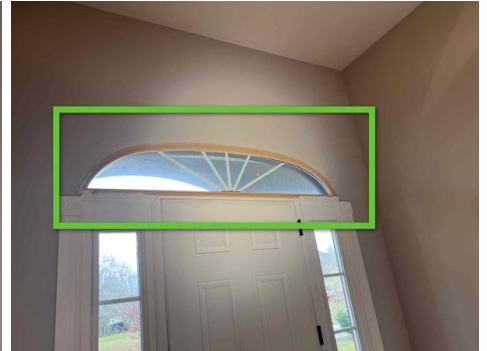
Front Door, Interior Trim Missing

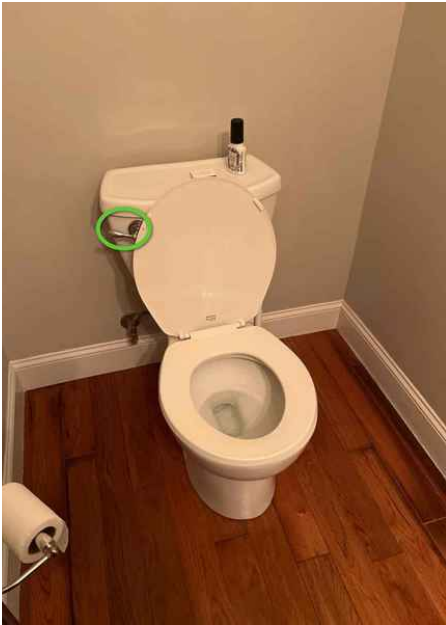
1st Floor 1/2 Bathroom, Toilet Not Flushing Correctly

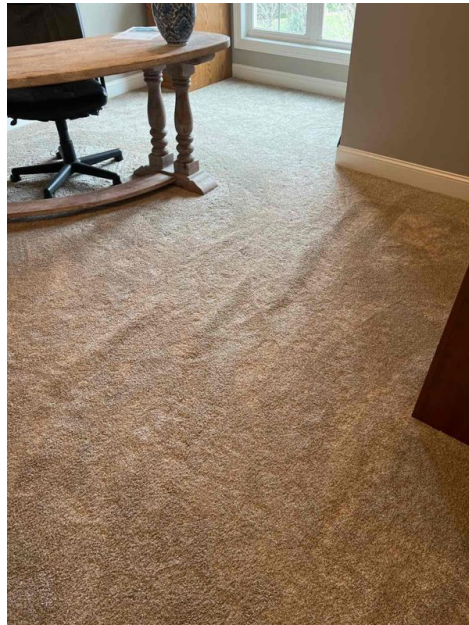
2nd Floor Family Room, Carpet Deterioration - Example

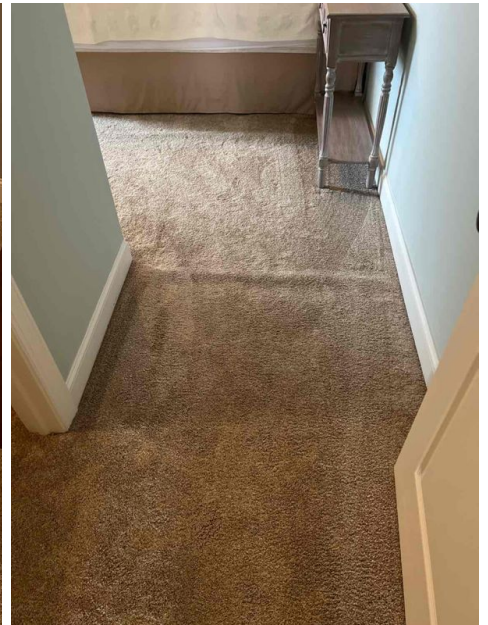
2nd Floor Bedroom, Carpet Deterioration - Example

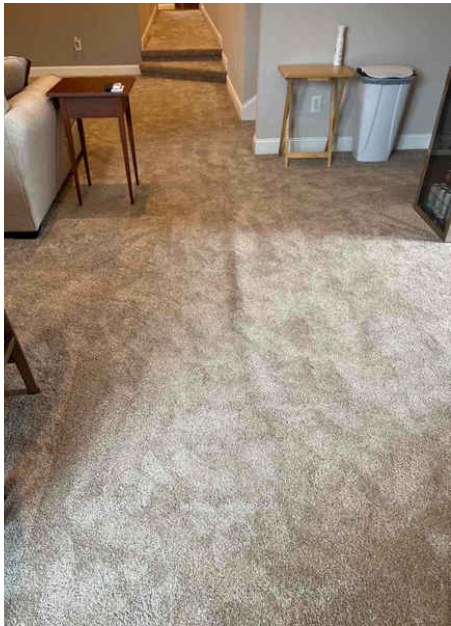
2nd Floor Family Room, Carpet
Deterioration - Example
