TRI-STATE SMART HOME SOLUTIONS LLC

## INSPECTION REPORT

1234 Main Street  
Gallipolis, OH 45631

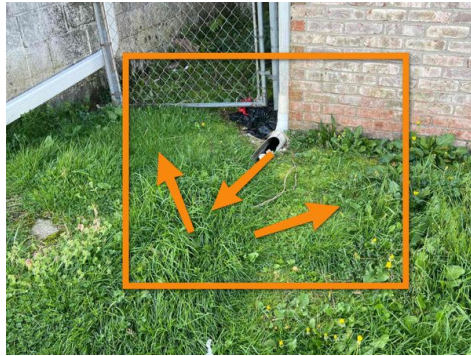
Rear Downspout Drains Near Building

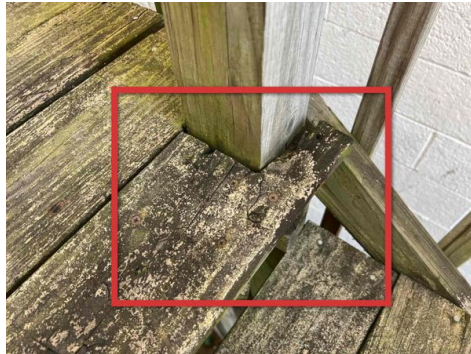
The normal life expectancy of an exposed wooden deck/steps is 15 to 25 years if properly maintained. The side and rear steps on the building appear to be beyond 25 years old and have not been well maintained. They are showing signs of general deterioration, wood rot, insect damage, etc.

Side Steps, Nearing End of Life

Recommend further evaluation by a licensed and qualified deck contractor to determine whether repair or replacement is appropriate. Use with caution until this evaluation and their recommendations are complete.

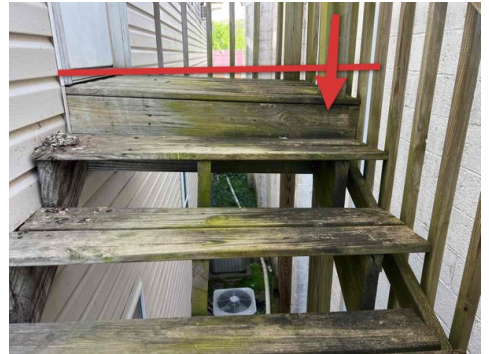
Side Steps, Nearing End of Life

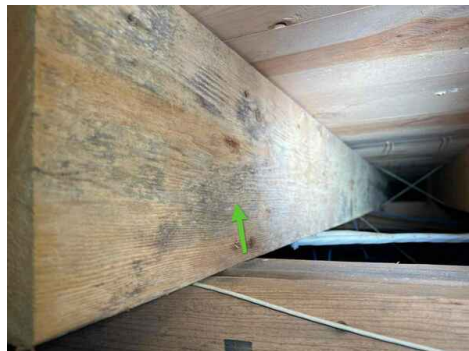
Potential Mold - Crawlspace Example

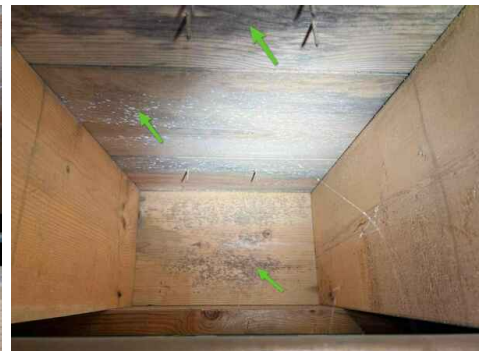
Potential Mold - Crawlspace Example

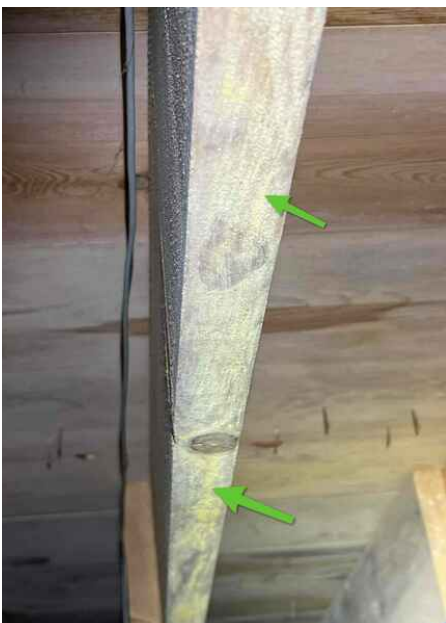
Potential Mold - Crawlspace Example

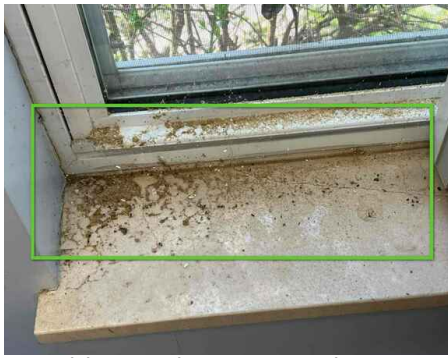
There is evidence of potential wood-destroying insects (WDI) in one location, the lobby window. There is a potential that this is from carpenter ants.

Lobby Window, Potential WDI

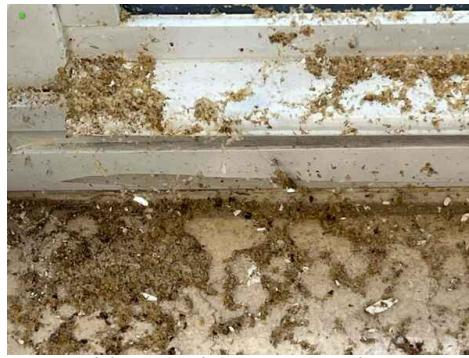
Lobby Window, Potential WDI

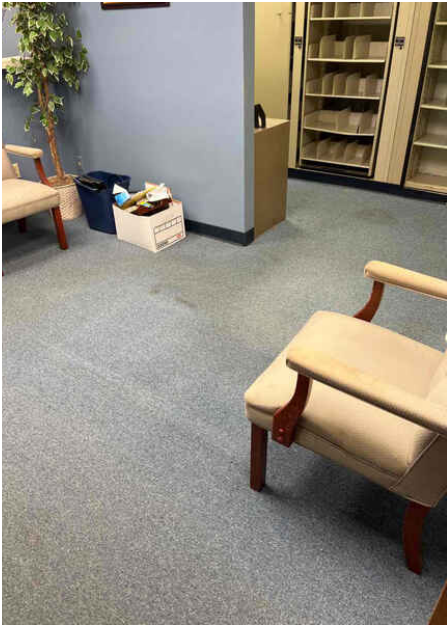
Reception Area, Carpet Needs Cleaning
