## HOME ENERGY AUDIT

## 1234 Main Street Gallipolis, OH 45631

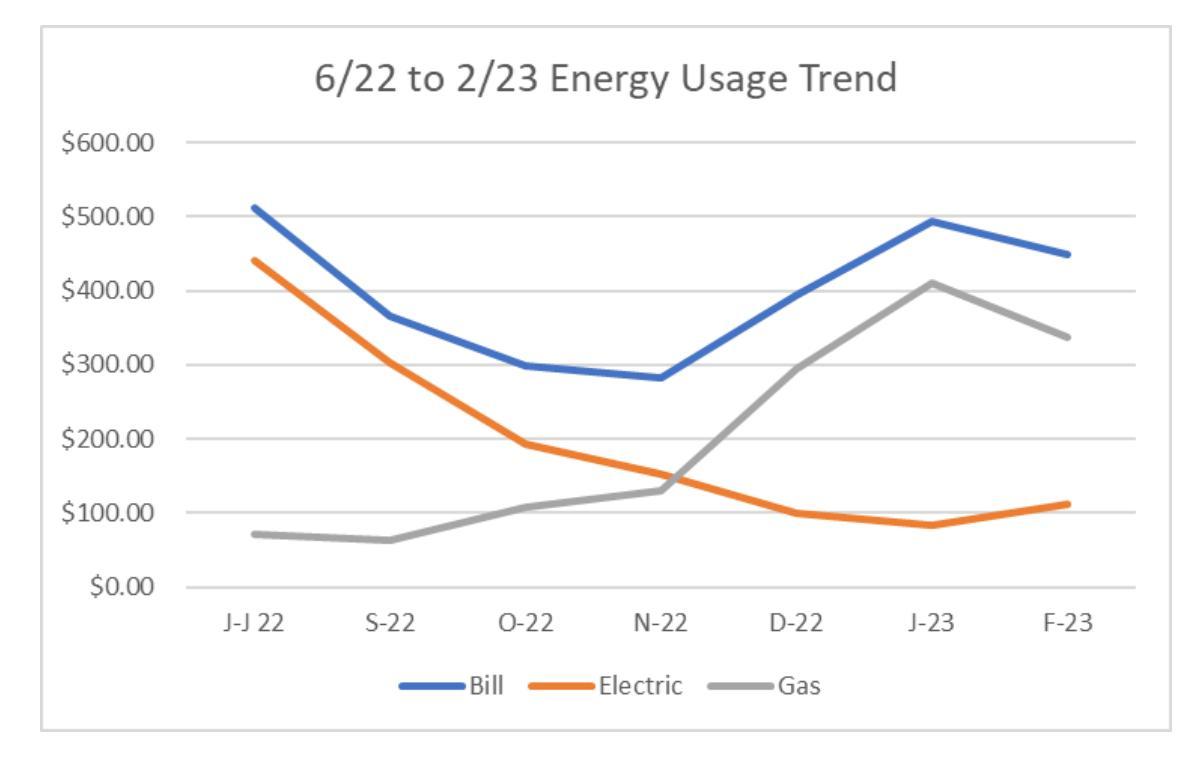
#### **Energy Usage Analysis**

- Central heating and air conditioning systems (HVAC) are the single largest consumers of electricity and gas in your home. On average, 65% of a household's utility bills are typically associated with HVAC. This percentage appears to be higher in your home.

- Your July 2022 summer utility bill was ~\$500, 86% electric/ 14% gas. The two central air conditioning units use electricity, no gas. The nominal gas usage would be from the pool heater, hot water tank, and cooktop in the kitchen.

- Your January 2023 winter utility bill was ~\$500, 17% electric/ 83% gas. The furnaces use gas for heating and a lesser amount of electricity to run the blower. This indicates that electricity usage in the home is relatively low when the air conditioner is not running.

- The October 2022 fall weather bill was ~\$300, 64% electricity/ 36% gas. The pool heater was turned off this month and the heat was turned on as the cooler weather arrived. This bill is more indicative of your usage when HVAC is less of a factor. This will likely occur again through March-April-May for the summer heat arrives.

This analysis alone points to insulation and air tightness as having a large impact on your utility bills.

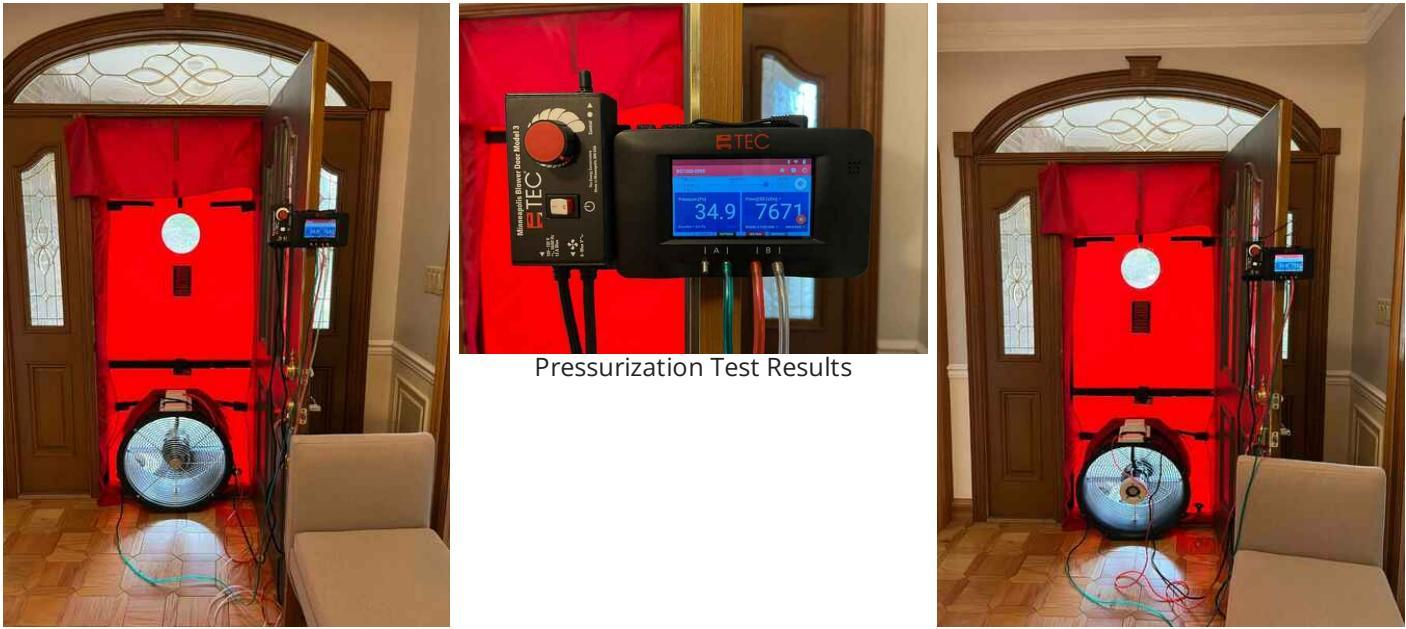
#### **Blower Door Pictures**

Pressurization Test

Depressurization Test

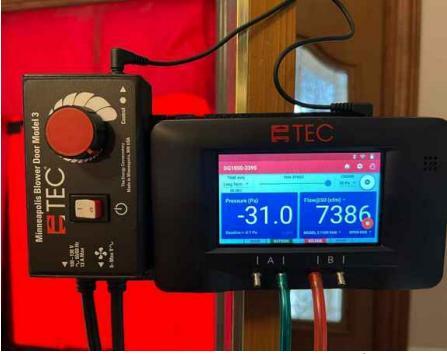
Depressurization Test Results

Test	<u>Target</u>	Actual Reading
Pressurization Test	4651	7671
Depressurization Test	4651	7386

• Your ~7528(avg) cfm50 blower door number is about 5.22 square feet of air leakage across the home. That is like having a large window wide open all the time. (7528/10 = 752 square inches/144 square inches/square foot = 5.22 square foot)

• Your home is ~4651 square feet with a blower door number of ~7528 (avg). A target blower door number of ~4651 is a great place to start, that would reduce your number by nearly 40%.

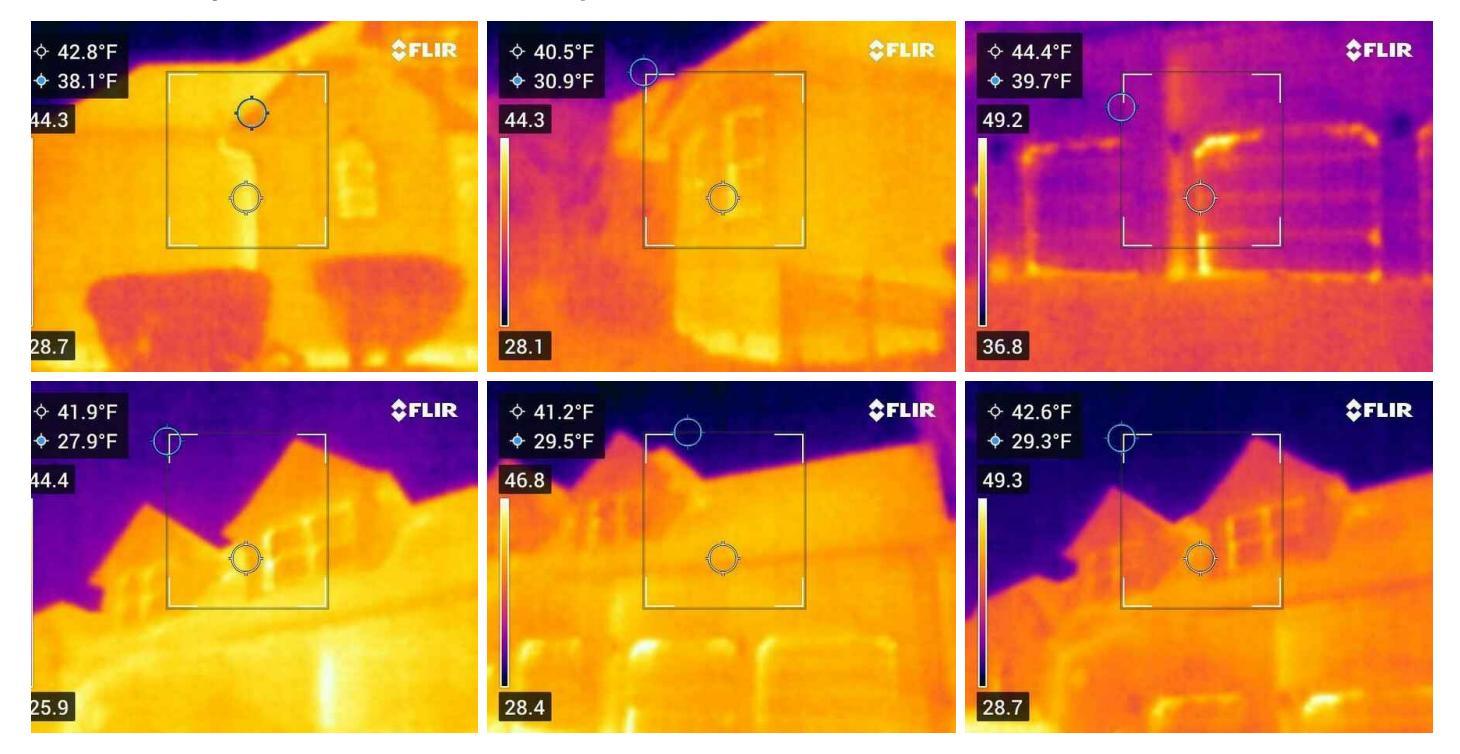
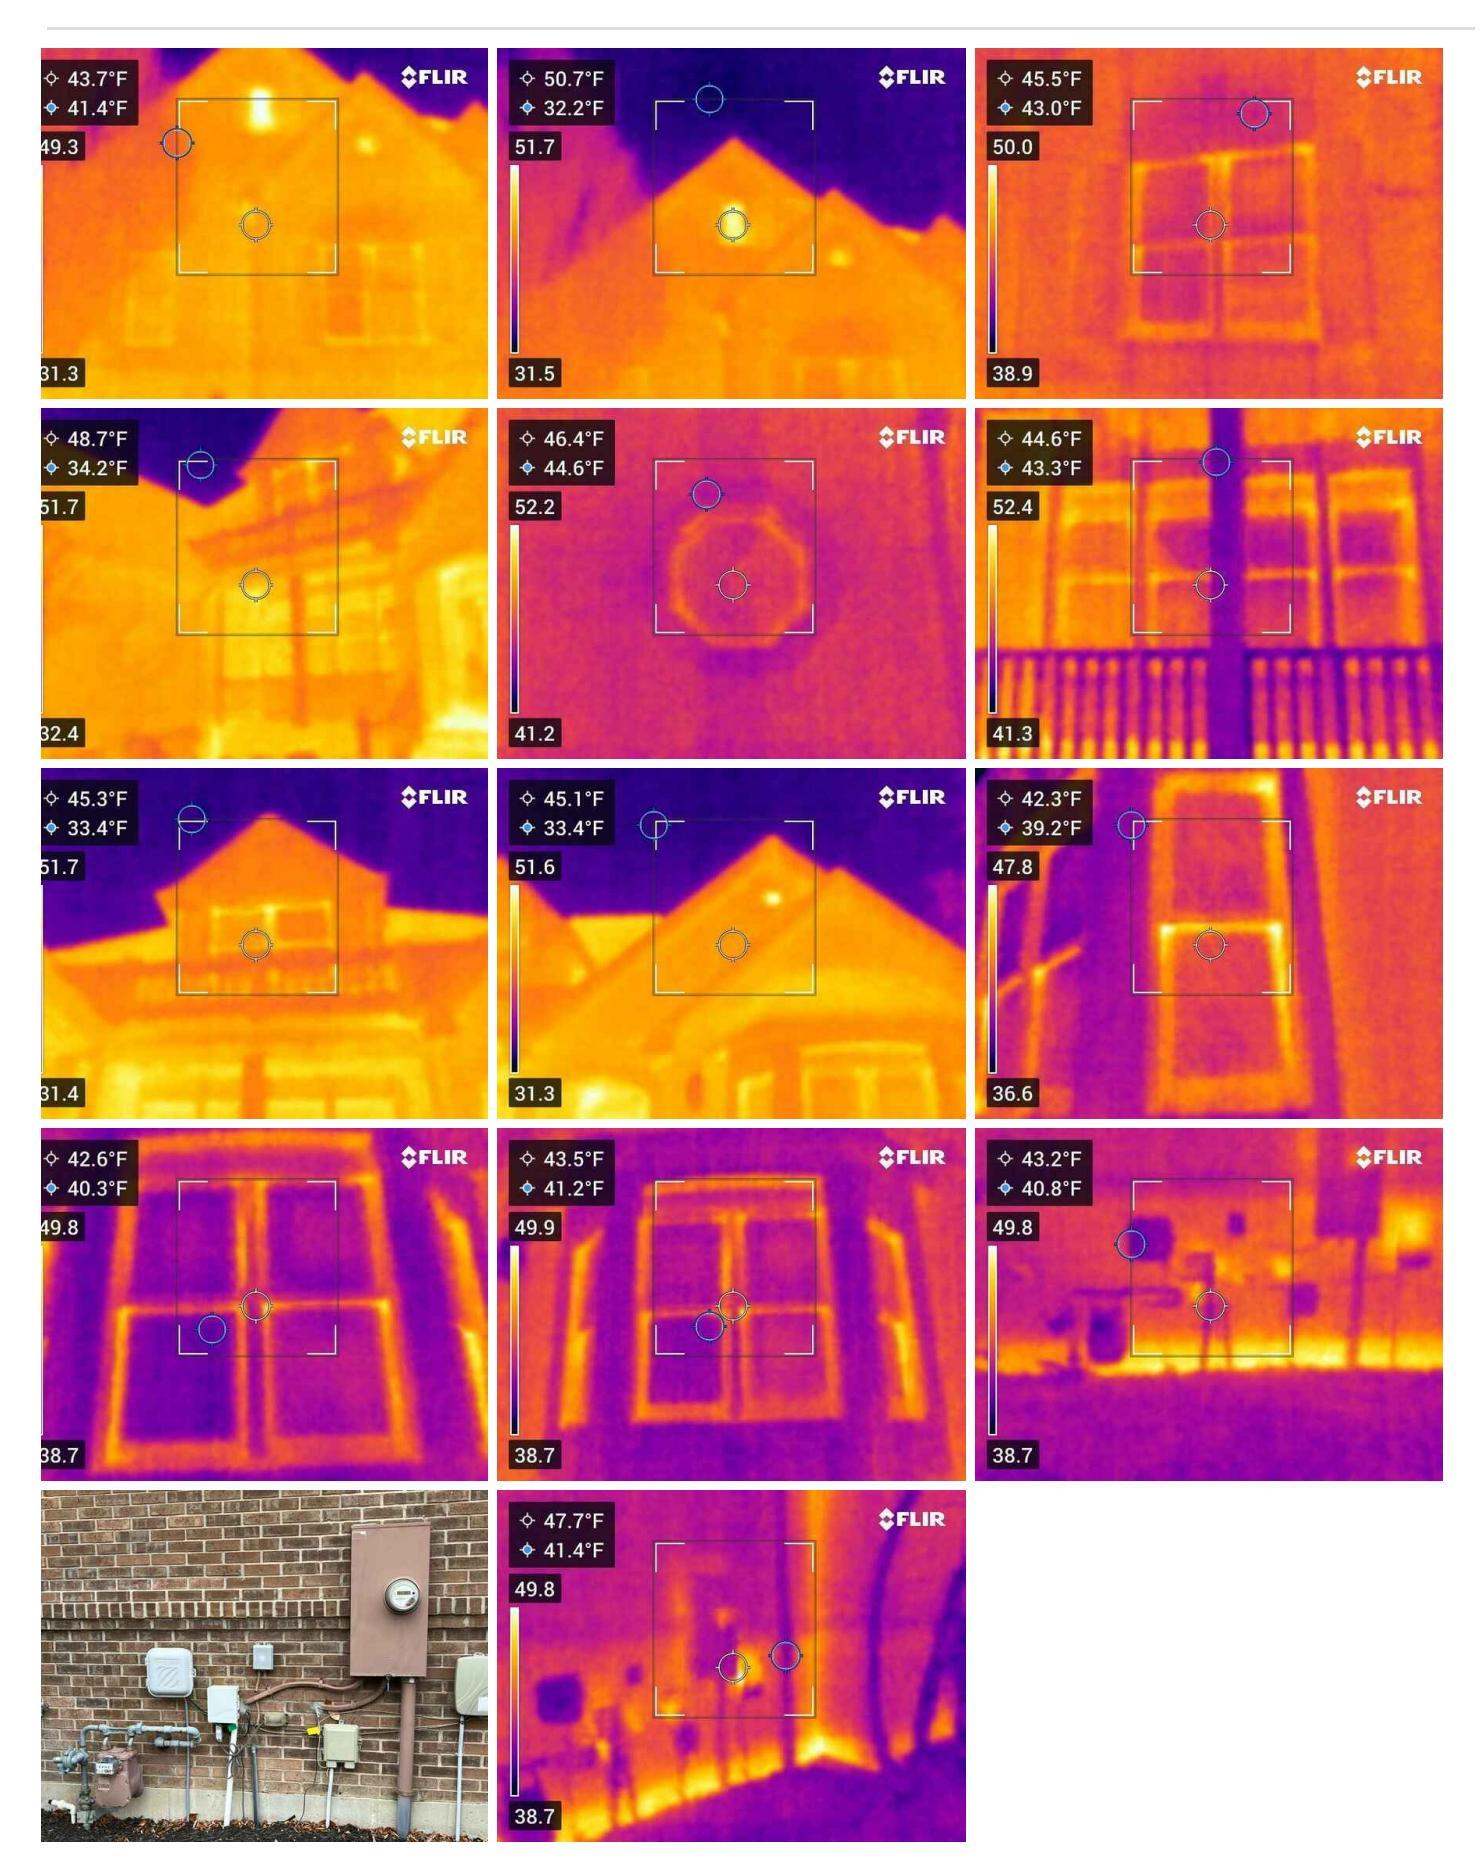
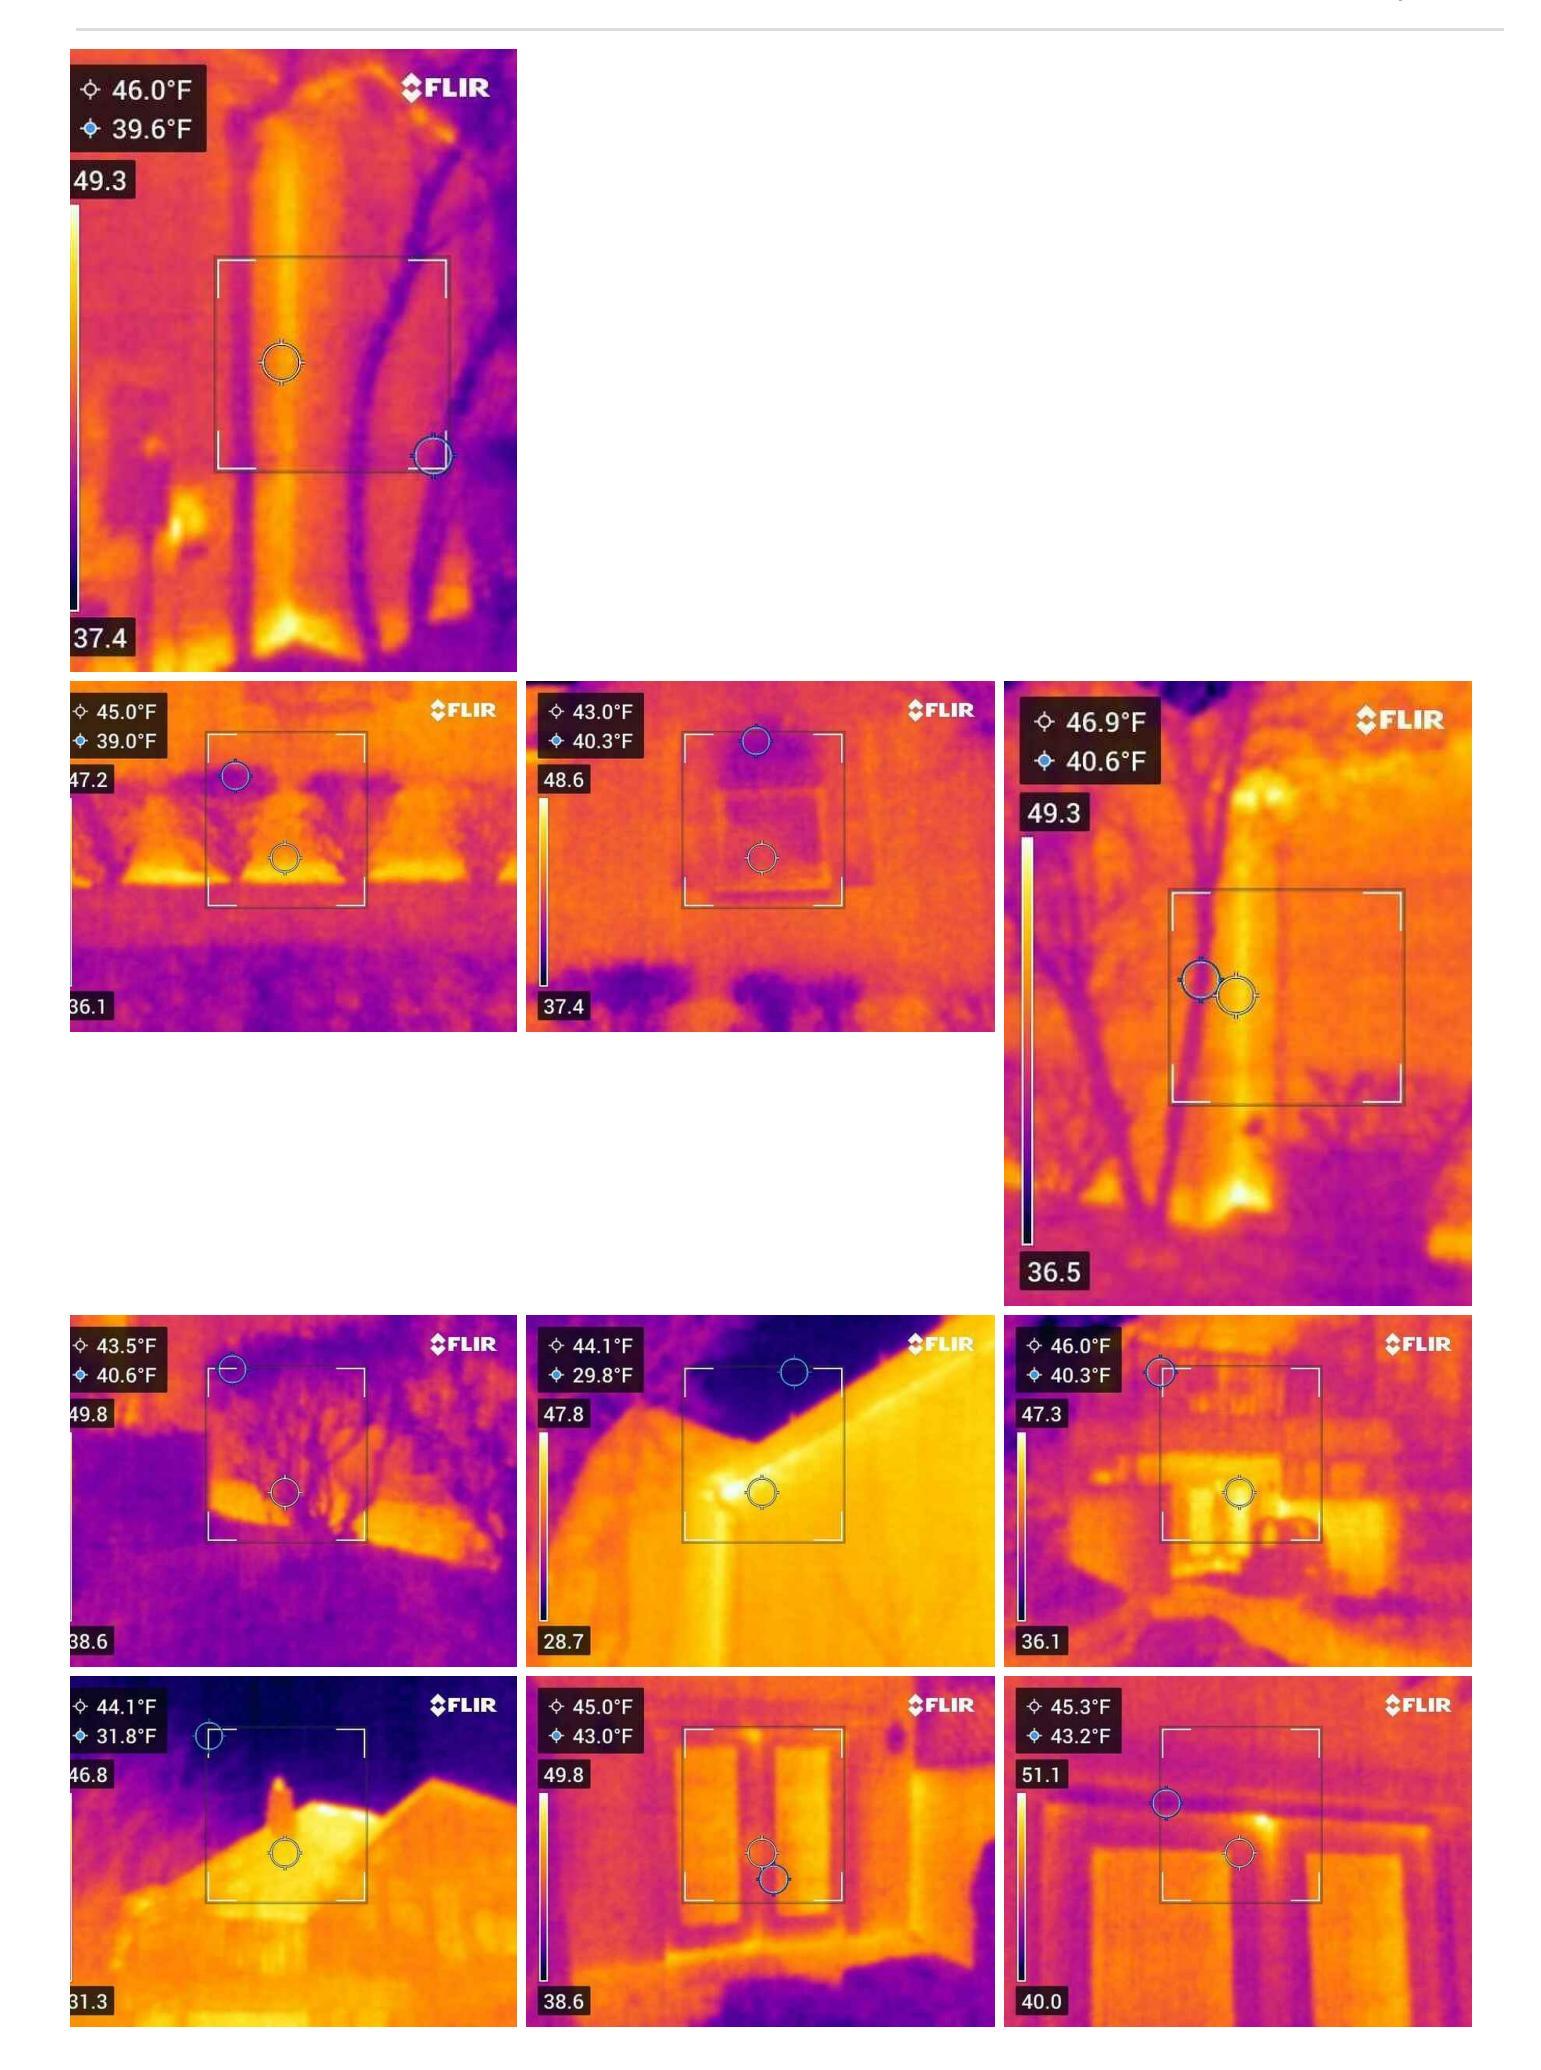
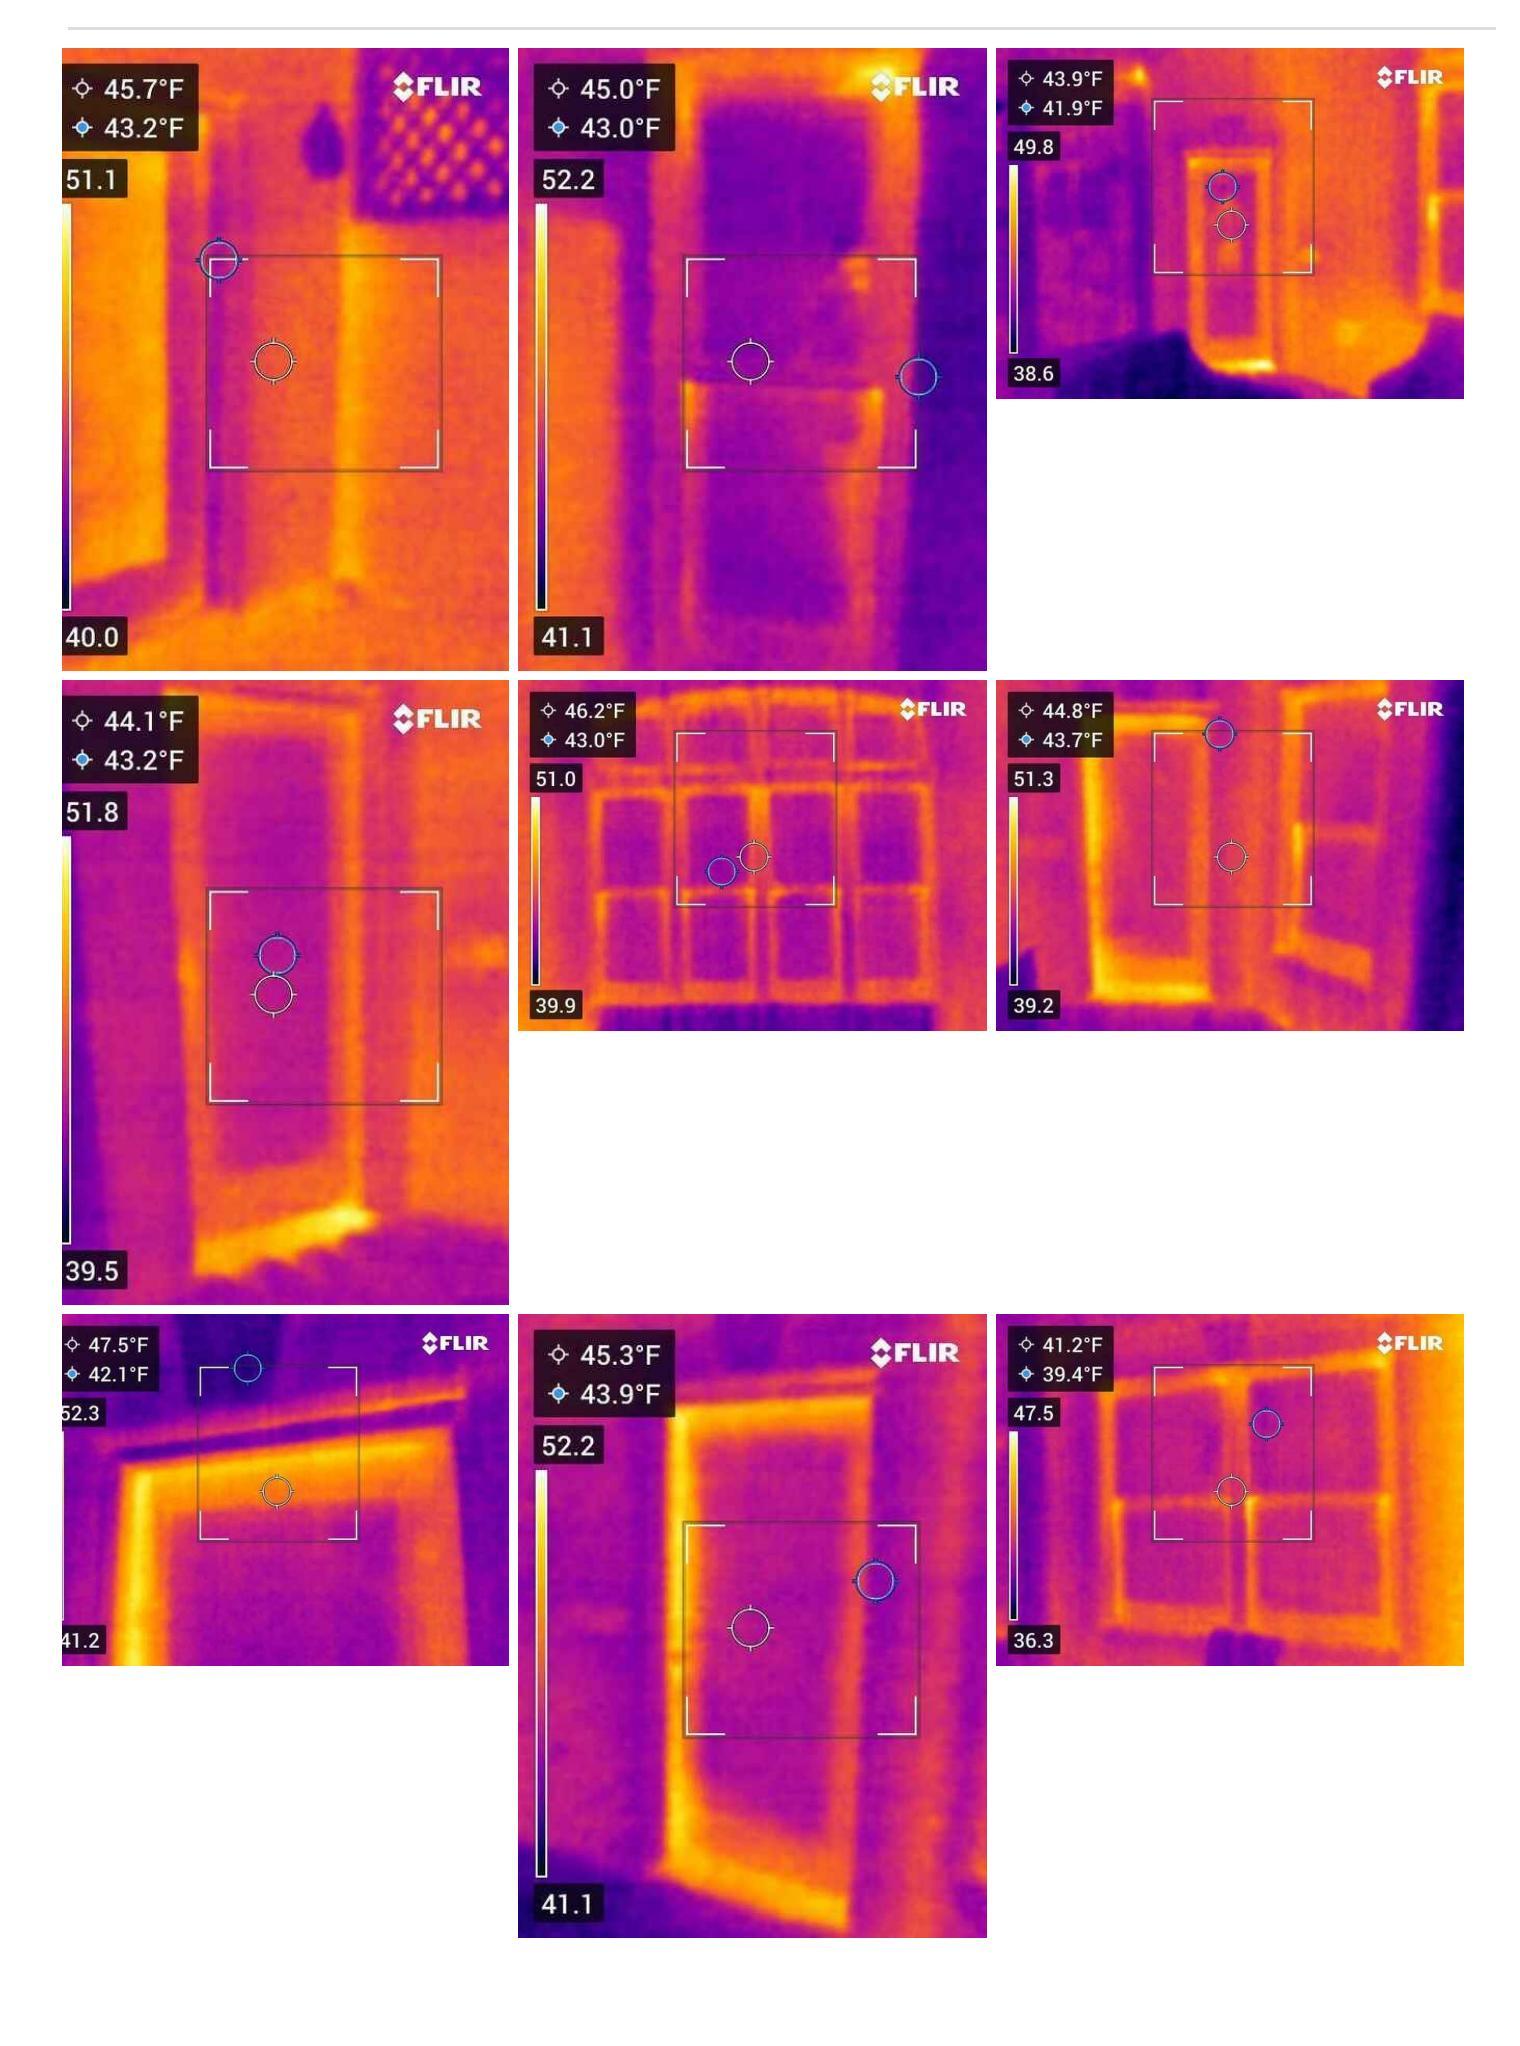
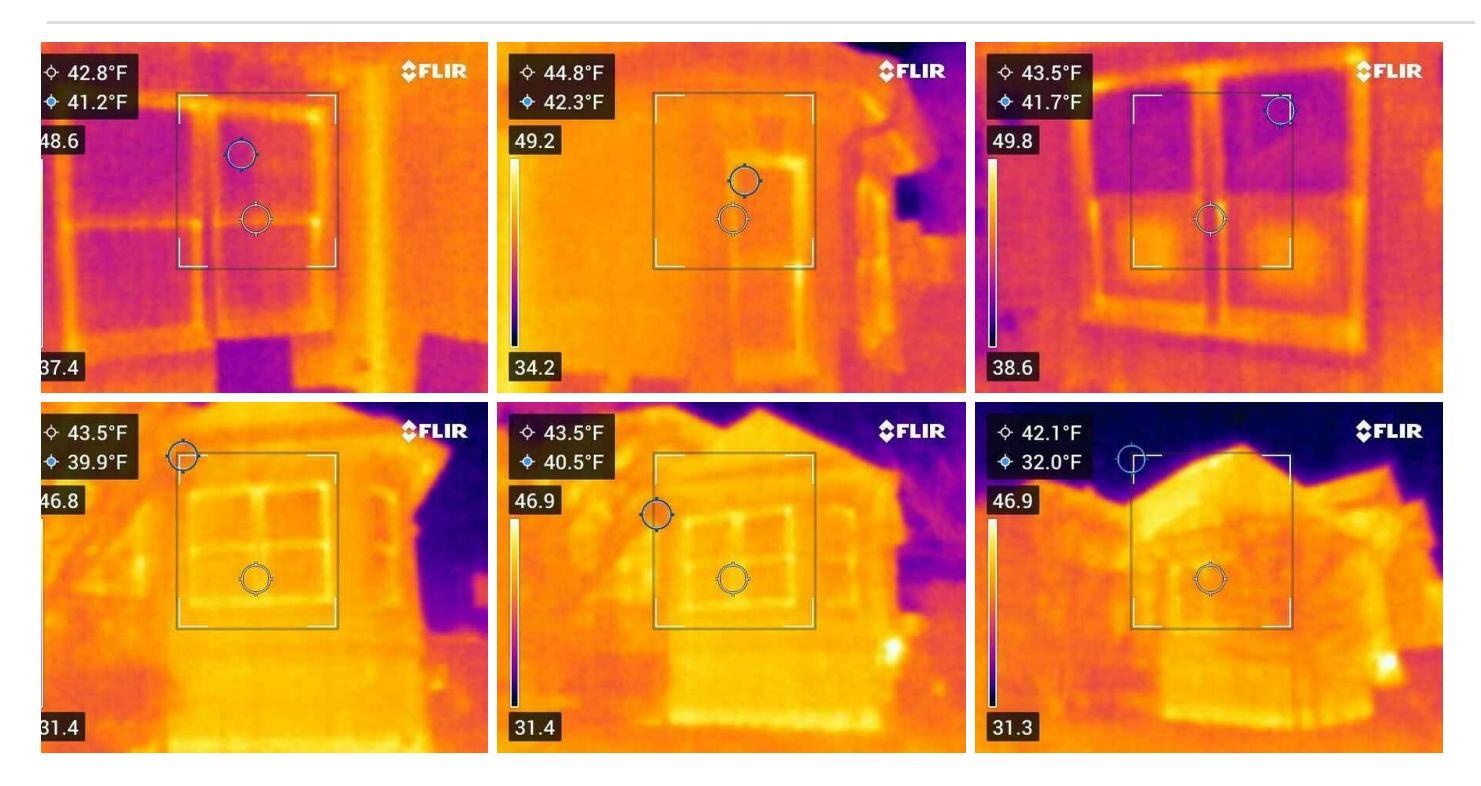
#### **Exterior Analysis: Exterior Infrared Analysis Reference Pictures**

- Insulation is missing and is out of place in both attic spaces.
- The exterior walls in the basement do not appear to be insulated. Looking inside the area where the main electrical panels are located, no insulation is present.
- It appears that there is no insulation present in the cavities at the end of the floor joists in the ceiling of the basement. The infrared analysis on the exterior of the home indicates a large amount of heat loss around the ground-level concrete of the house.

The bright orange to yellow colors indicates "warm". The brighter the yellow the warmer the temperature. The dark purple color indicates "cold". The darker the purple the colder the temperature. When inside the house on a colder day (such as the day of the audit, it was ~55 degrees), you do not want to see purple or very little of it.
