## HOME ENERGY AUDIT

## 1234 Main Street Gallipolis, OH 45631

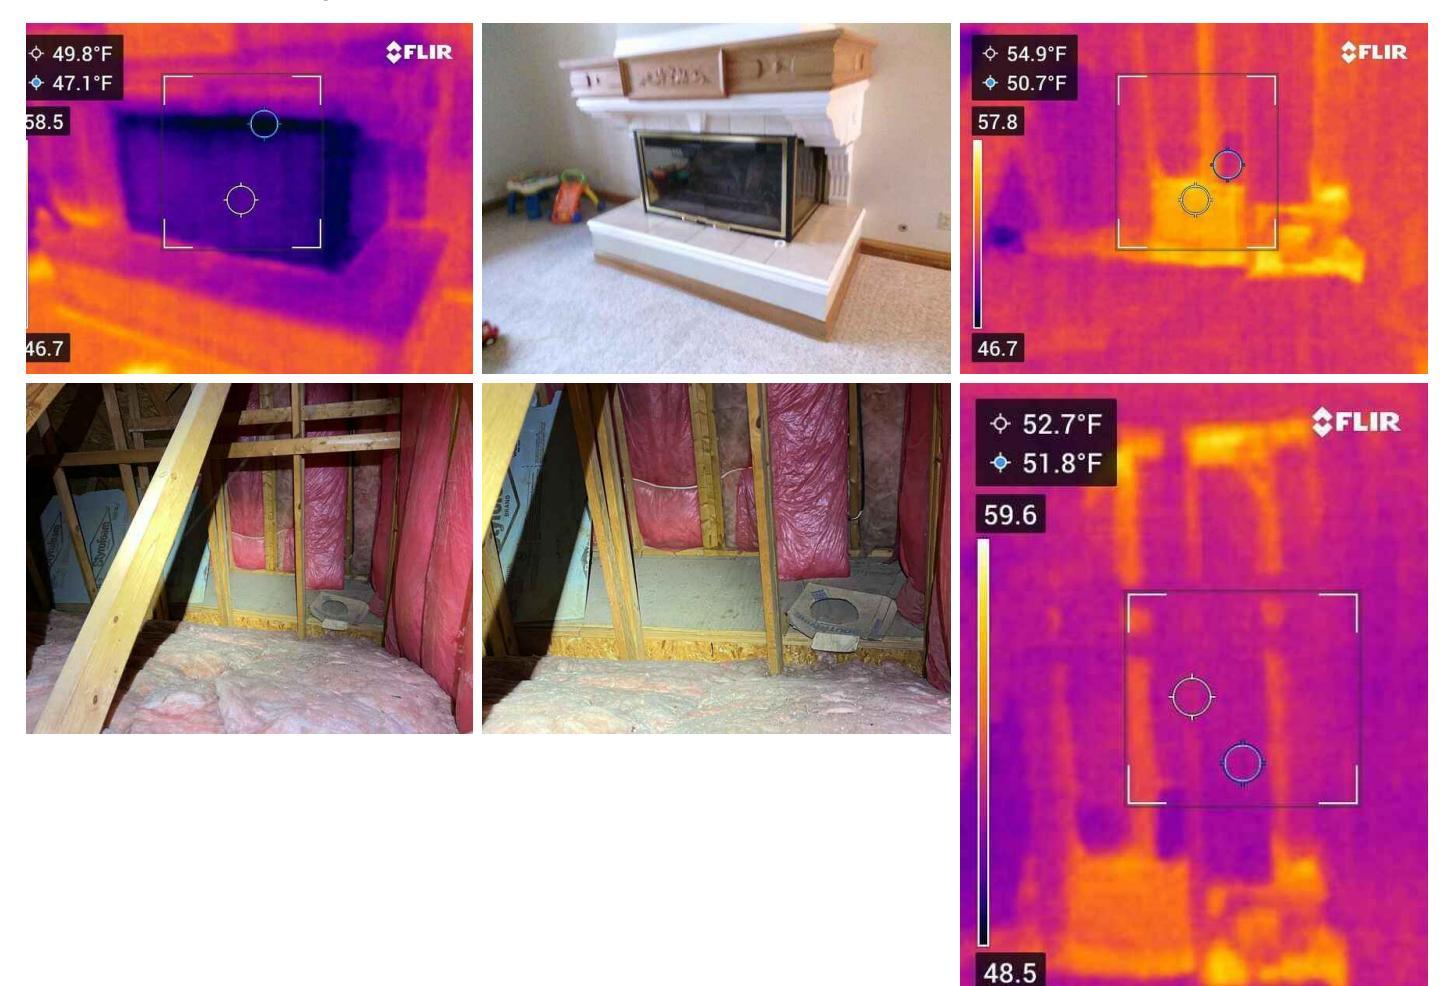
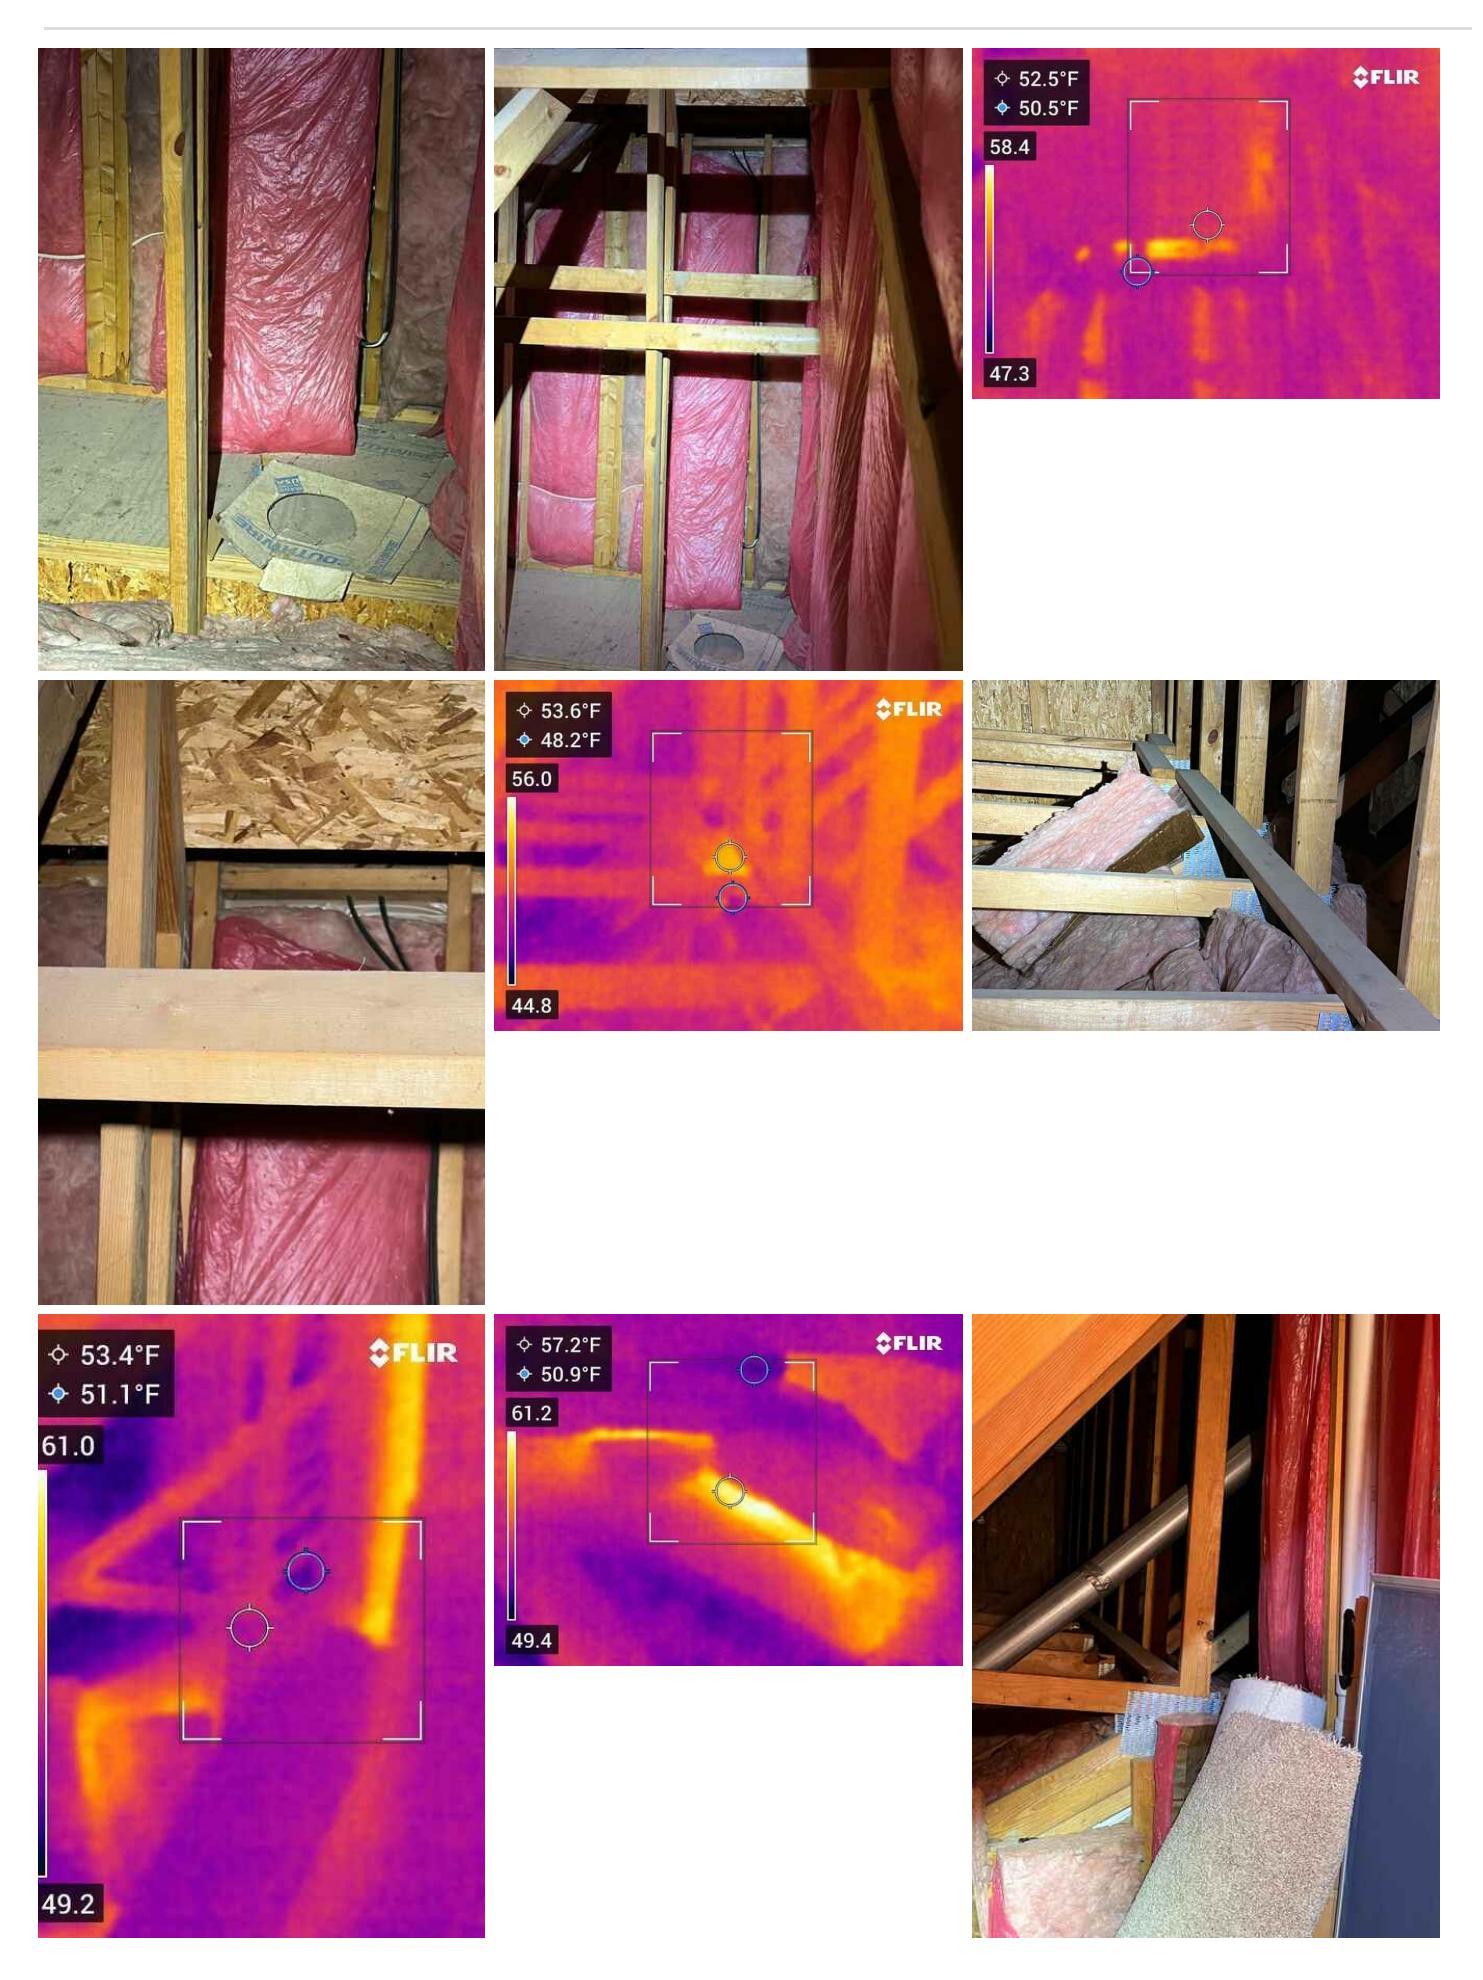
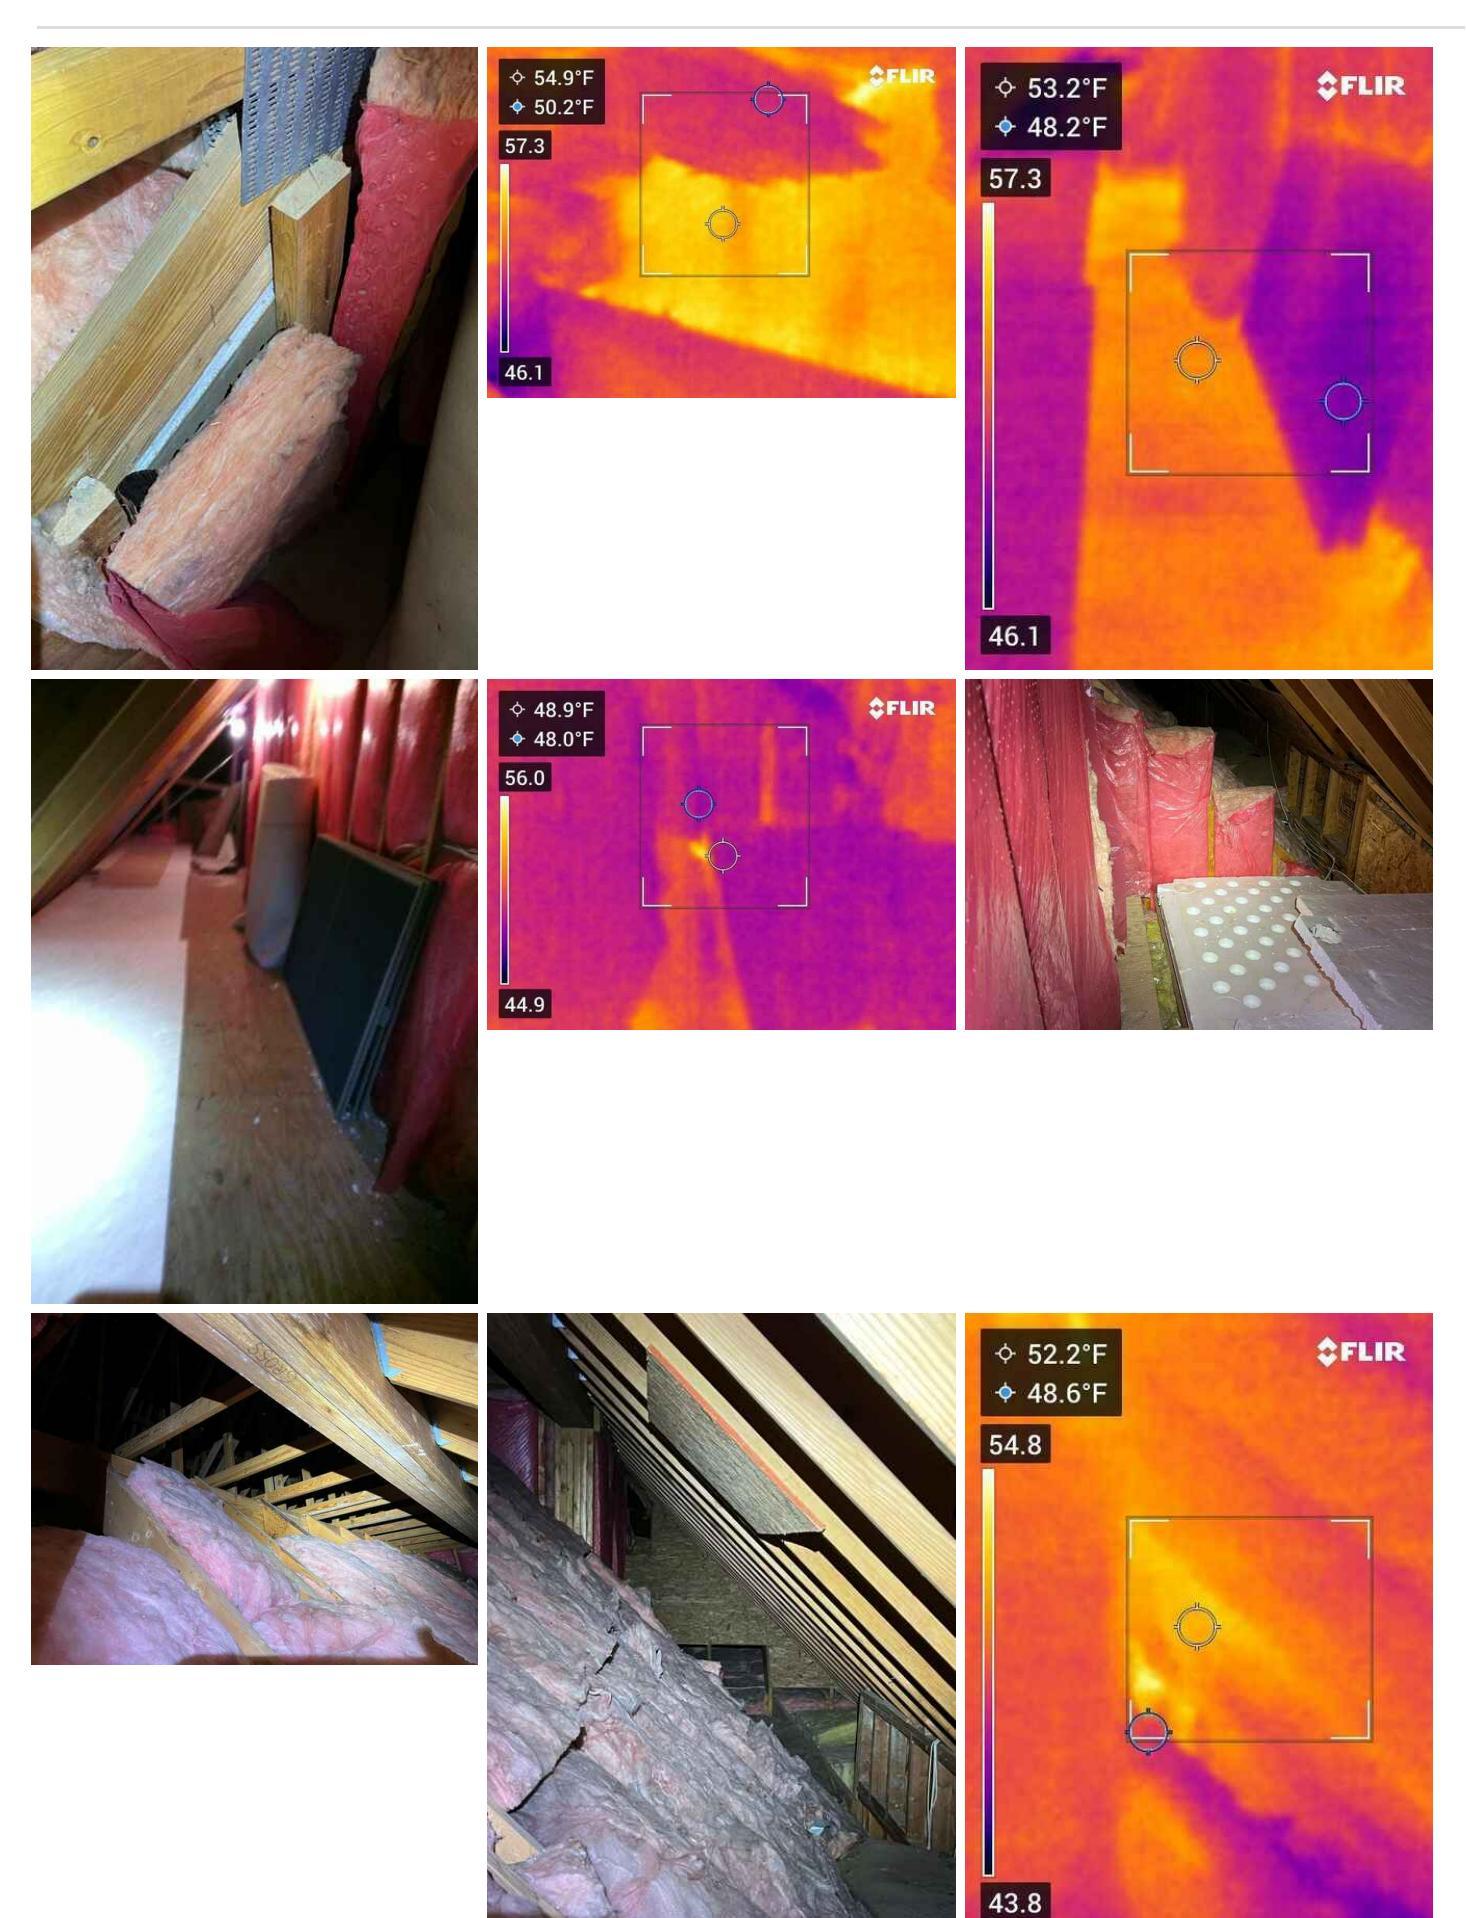
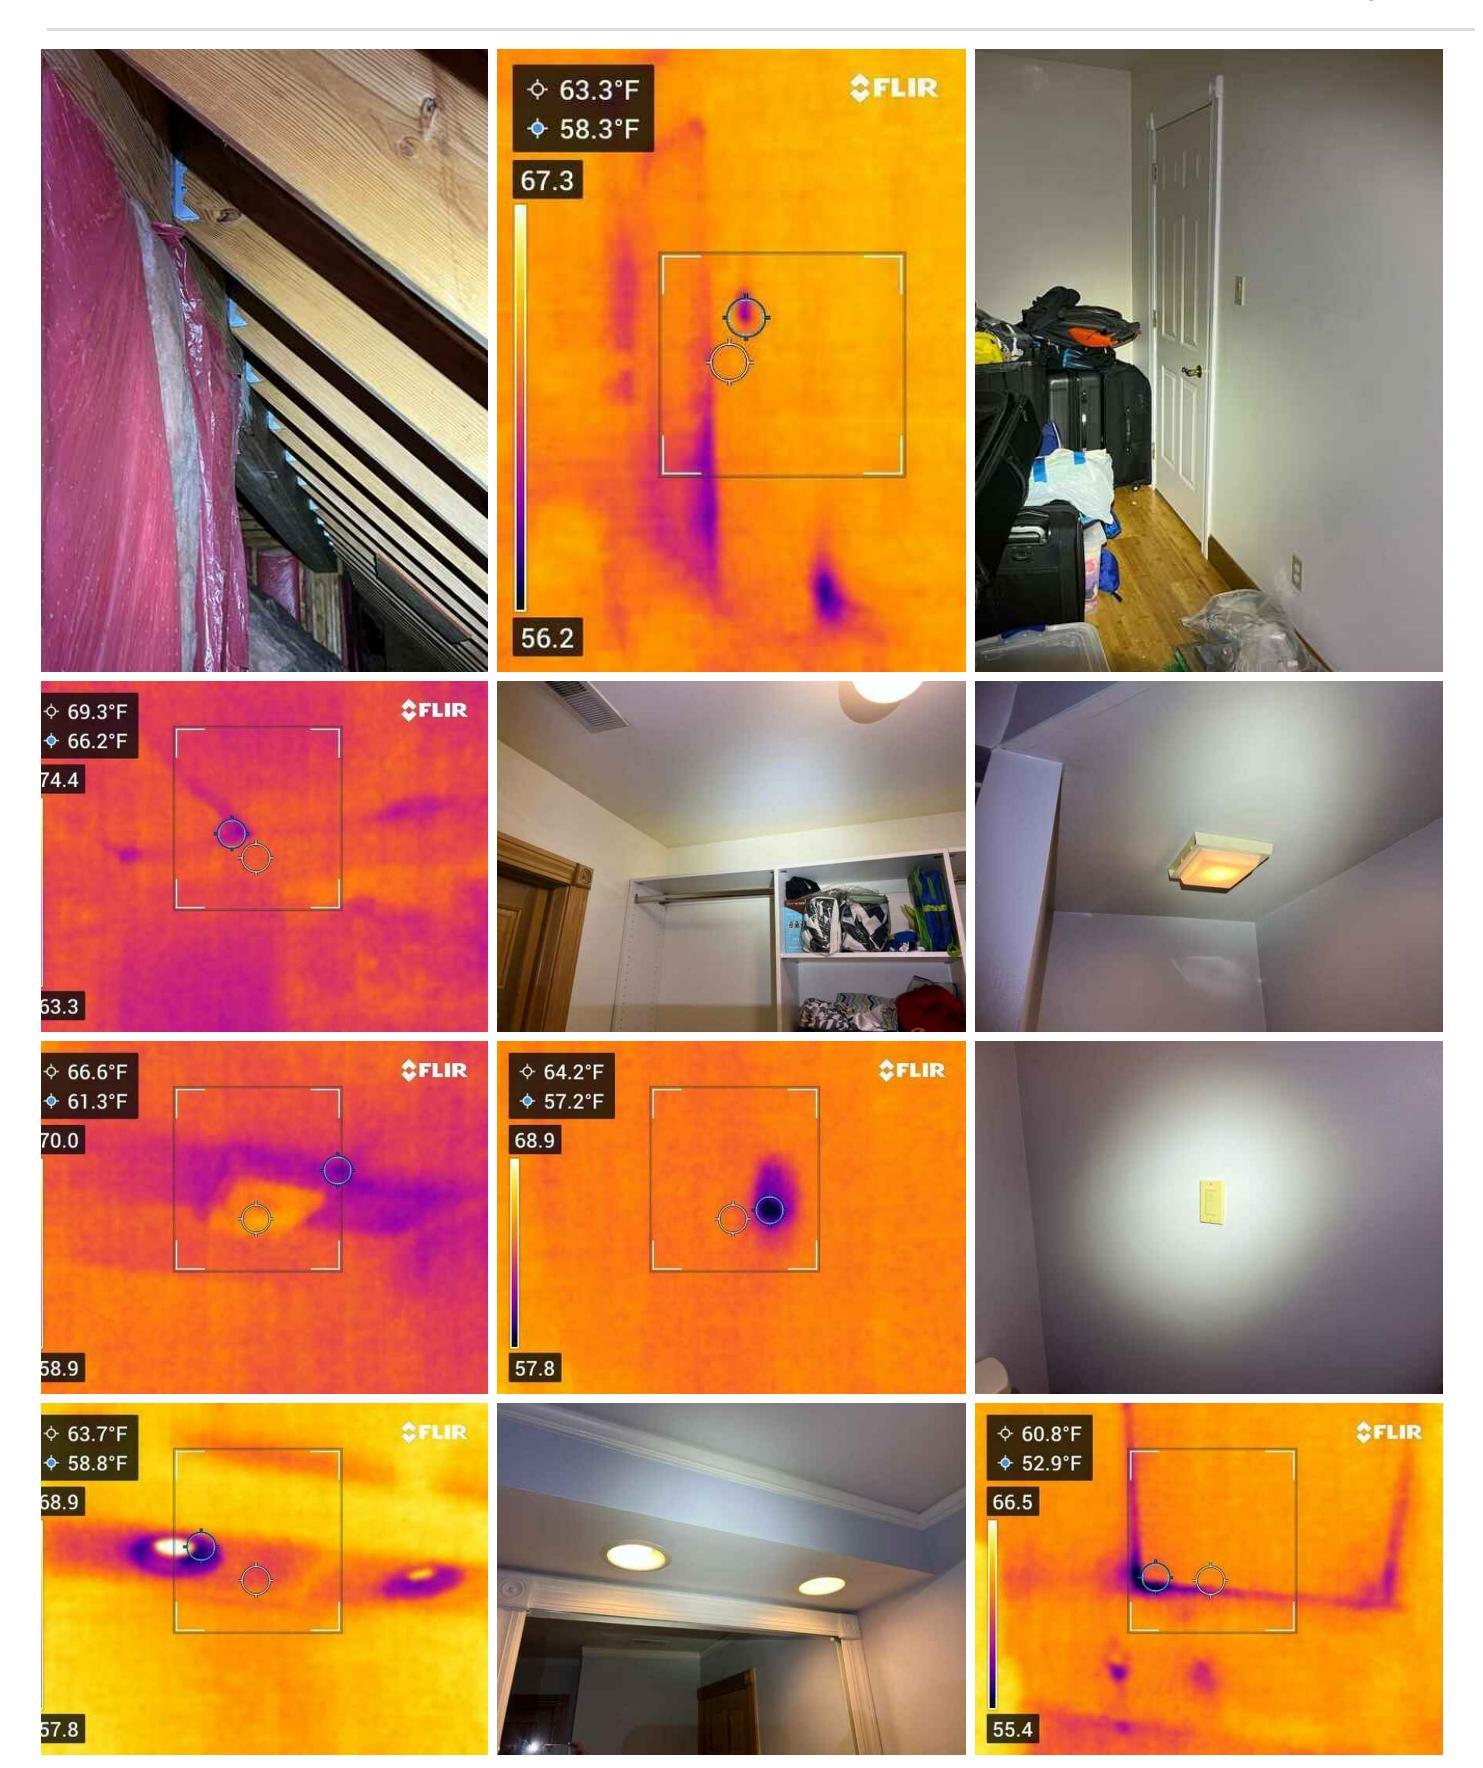
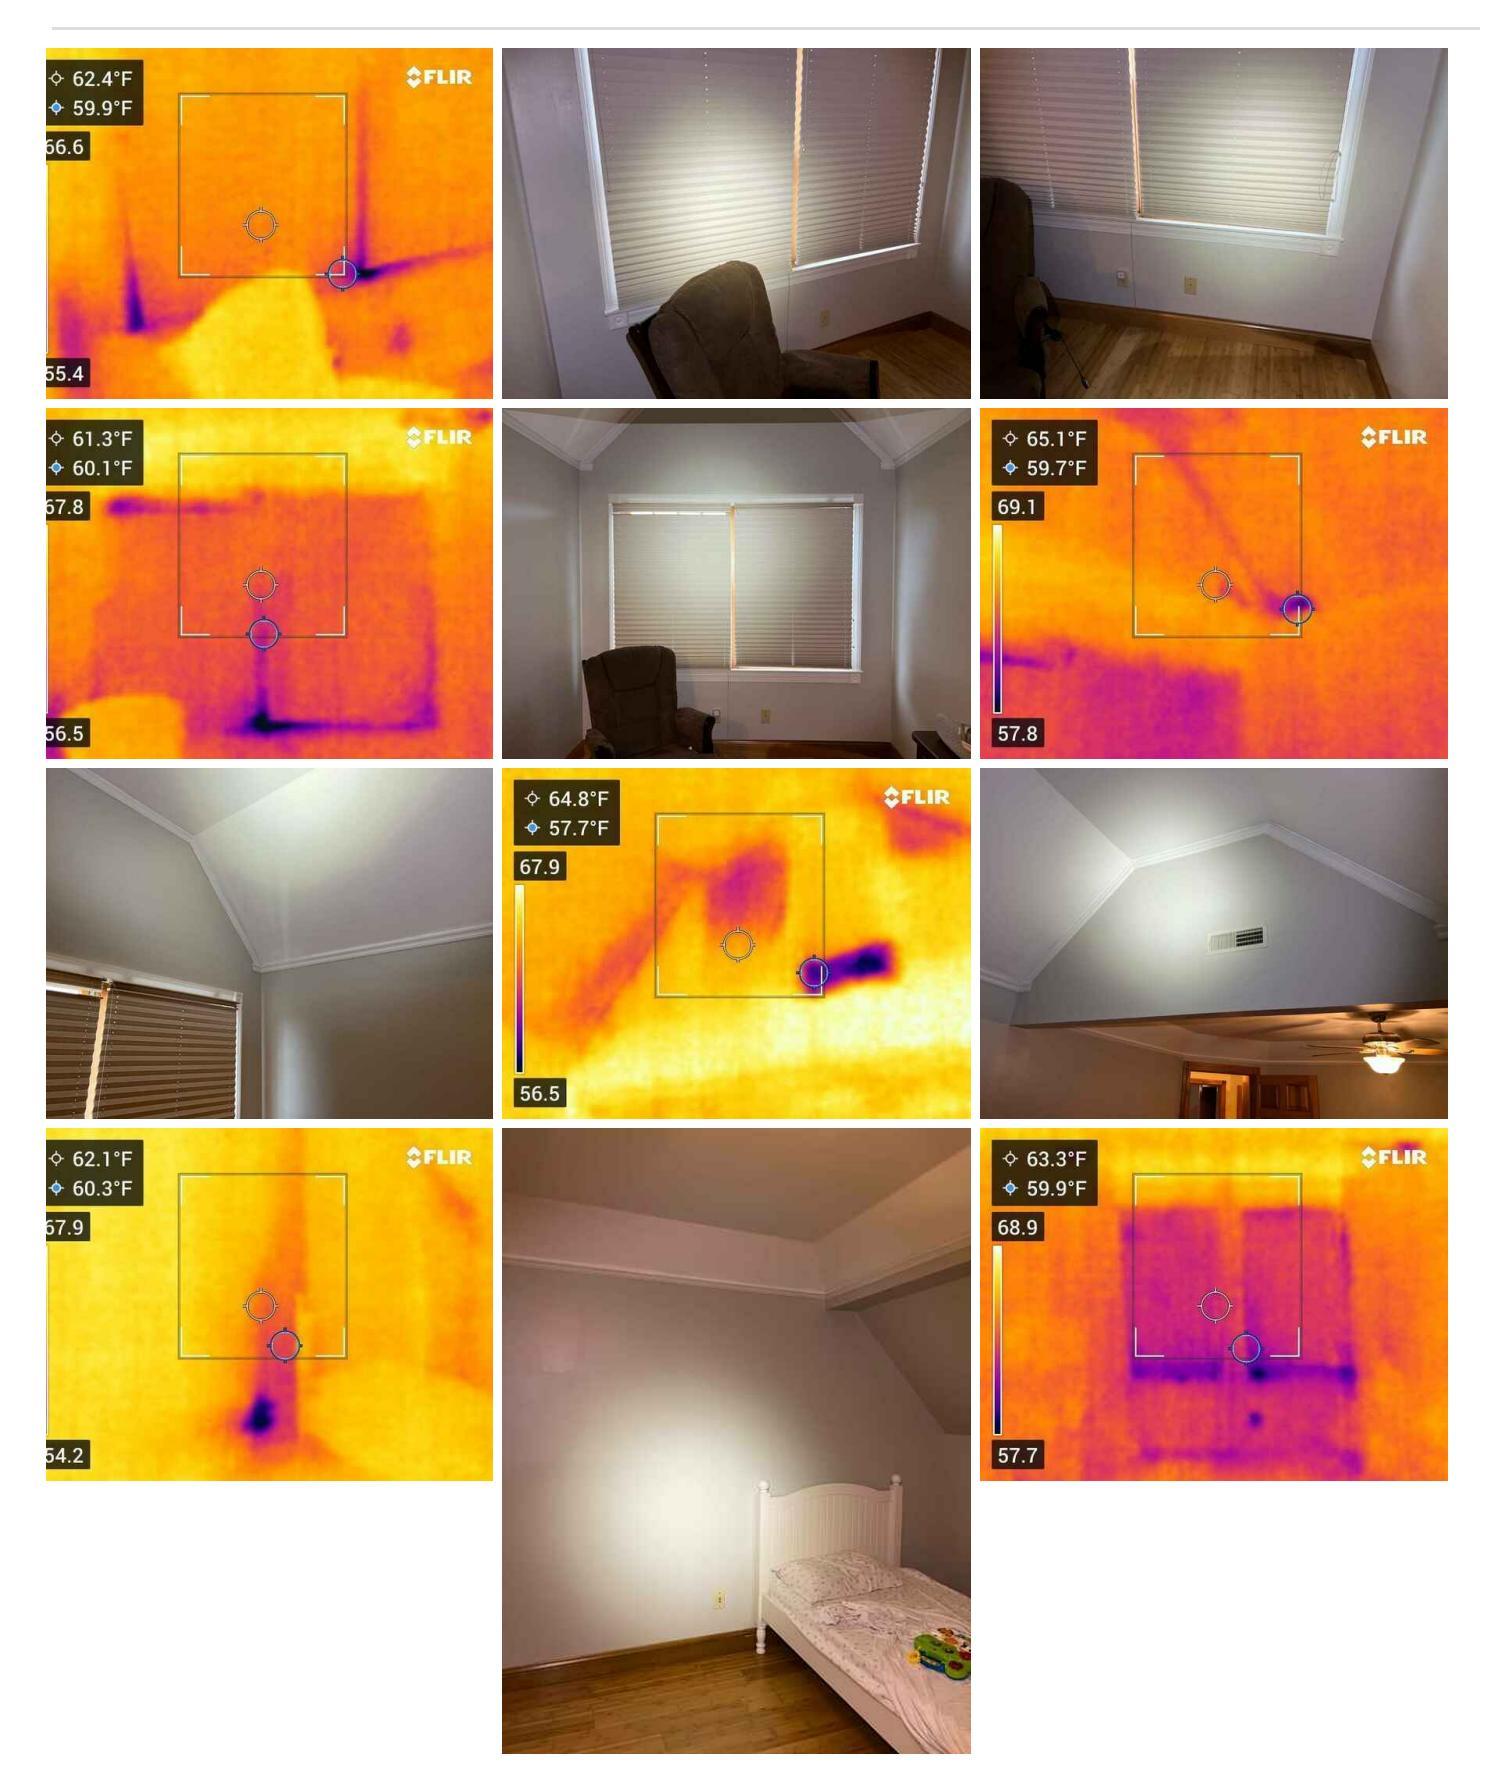
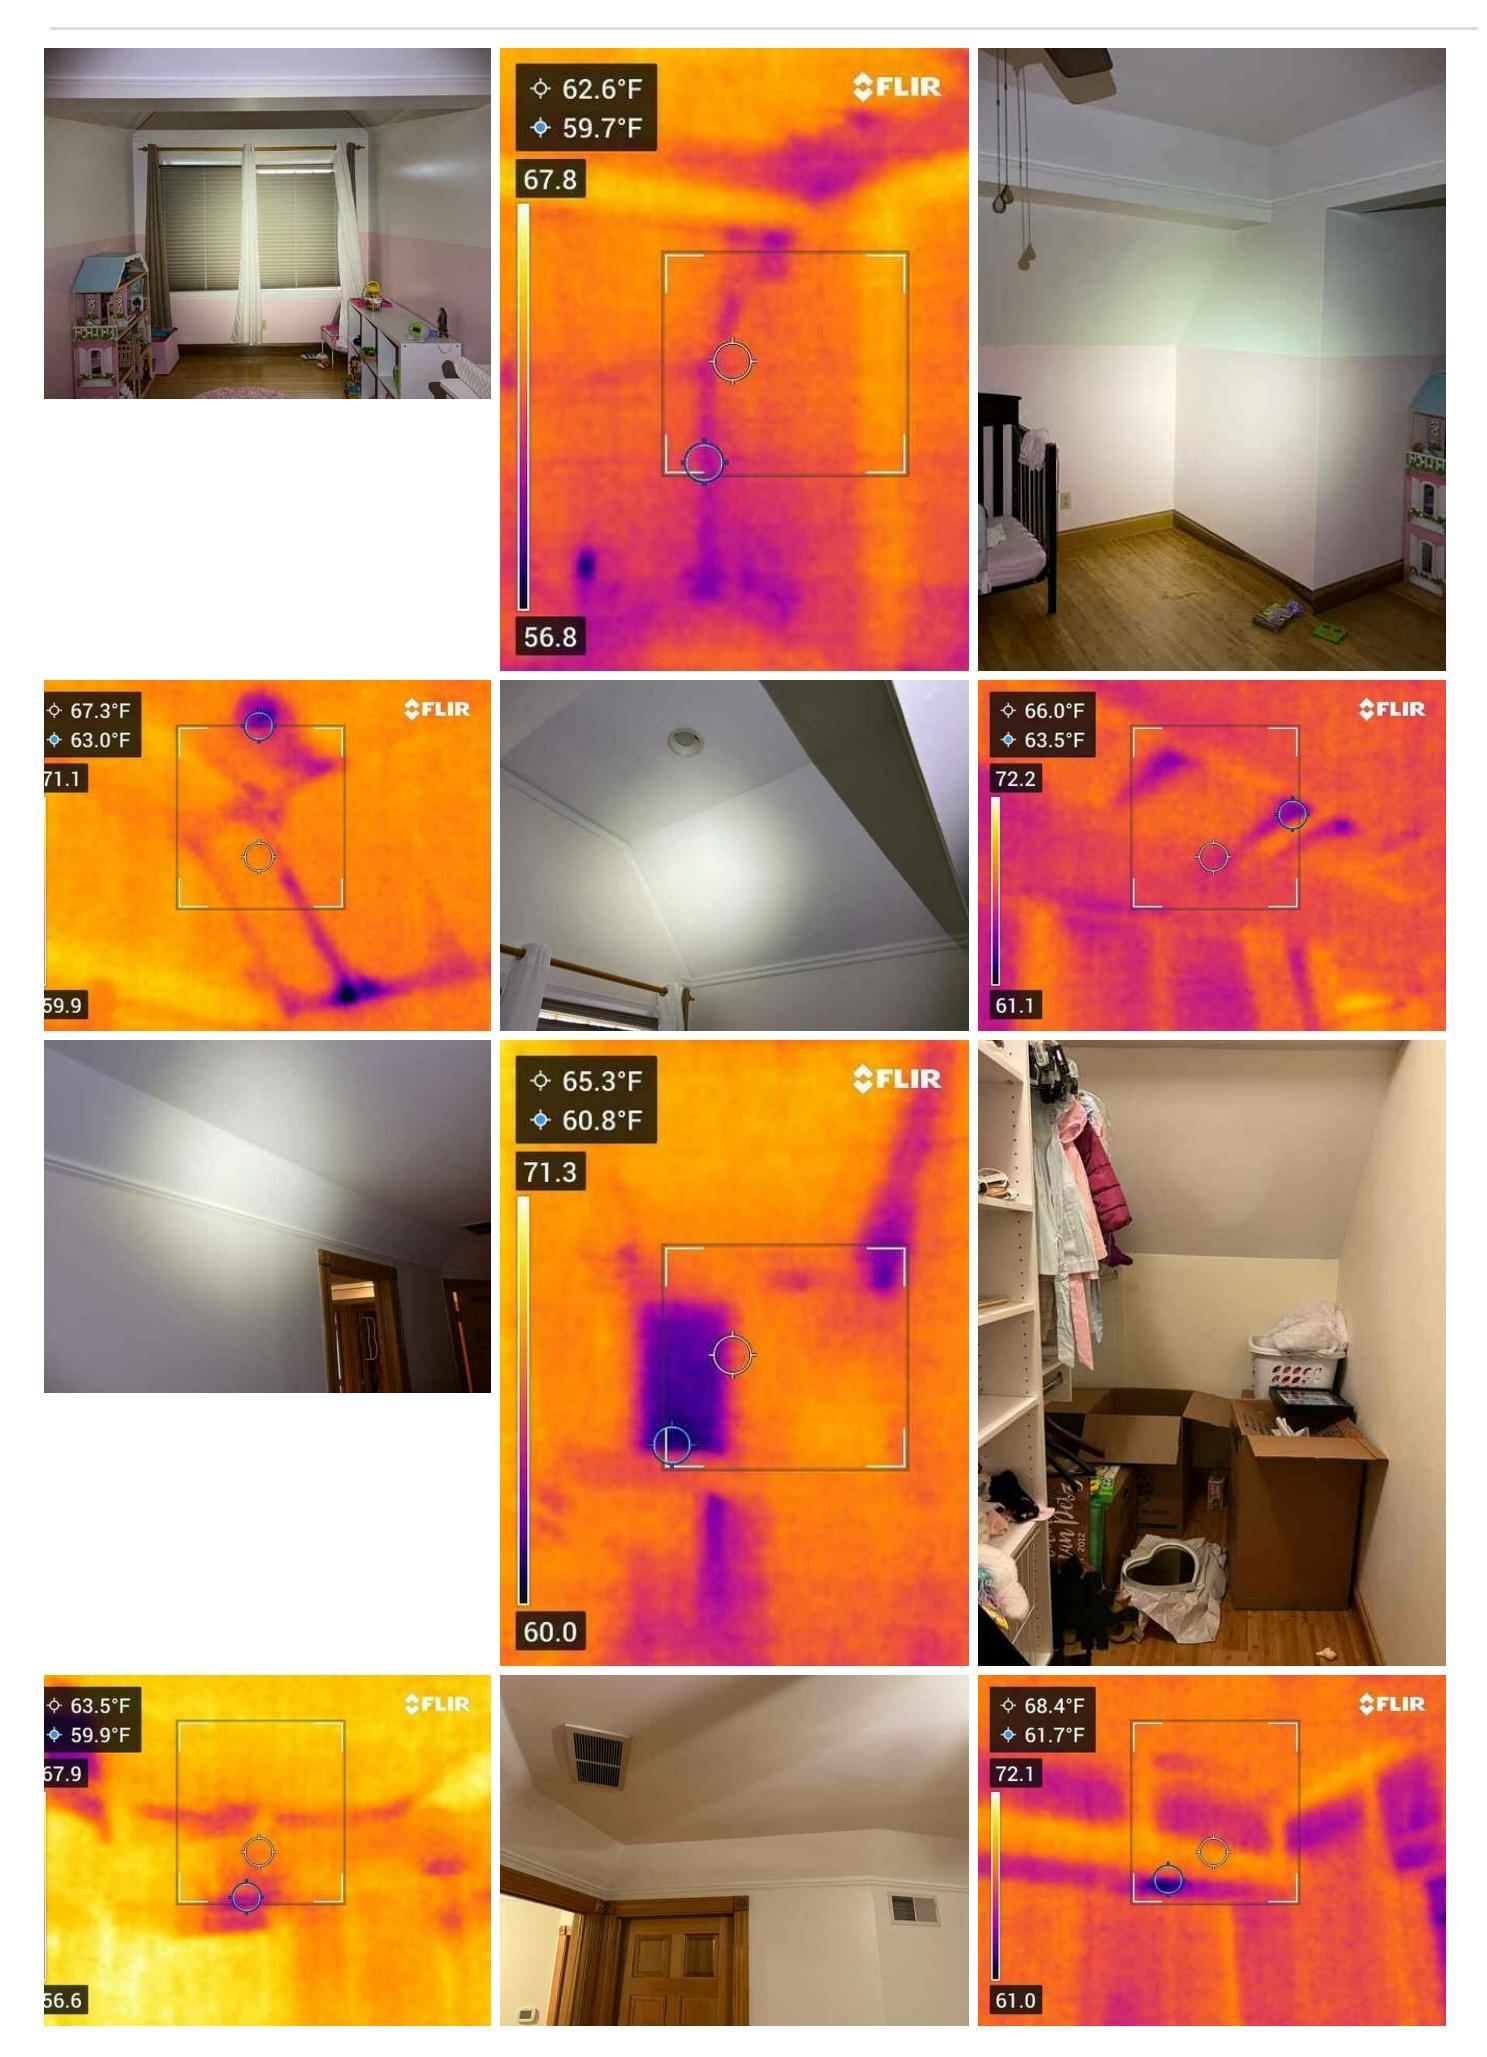
### **Interior Infrared Analysis Reference Pictures**

There is an extensive amount of "purple" inside the house. Mostly from poorly insulated ceilings, walls, and leaks around exterior doors, and windows.

The interior pictures below are in pairs. The first picture is the infrared picture, the second is a digital picture so you can identify the location of the picture more accurately.
