TRI-STATE SMART HOME SOLUTIONS LLC

## INSPECTION REPORT

1234 Main Street  
Gallipolis, OH 45631

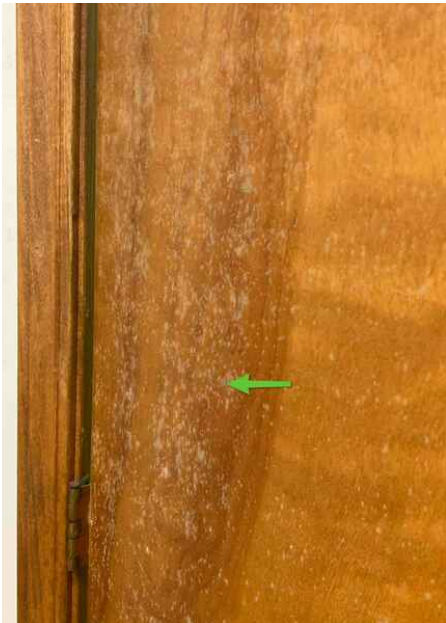
Potential Mold - Inside Example

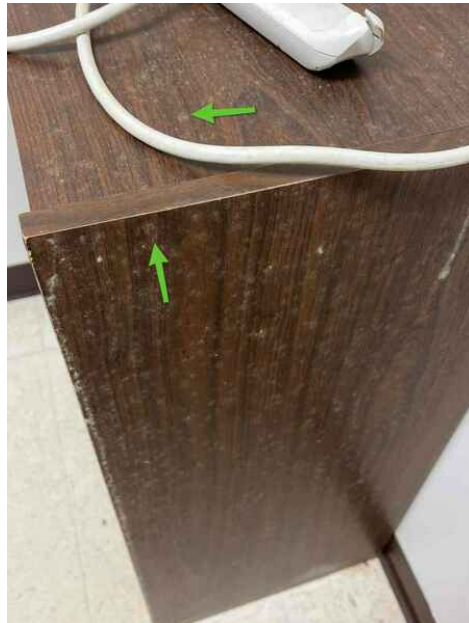
Potential Mold - Inside Example

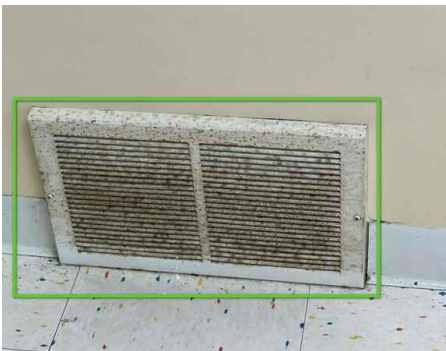
Potential Mold - Inside Example
