TRI-STATE SMART HOME SOLUTIONS LLC

INSPECTION REPORT

1234 Main Street
Gallipolis, OH 45631

07/31/2023 9:00AM

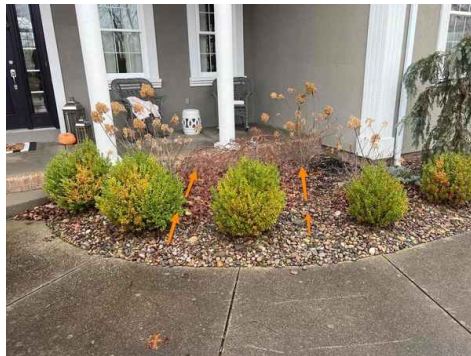
- 1) This is causing active water intrusion into the crawlspace.
- 2) If not addressed, this can lead to potential foundation issues.

The yard and landscaping should slope away from the house to prevent these conditions in the future, ideally 6 inches of drop in the first 10 feet.

Front of House, Negative Grading - Example

Recommend engaging a landscaping or excavation company to further evaluate (Representative/ Sample Pictures)

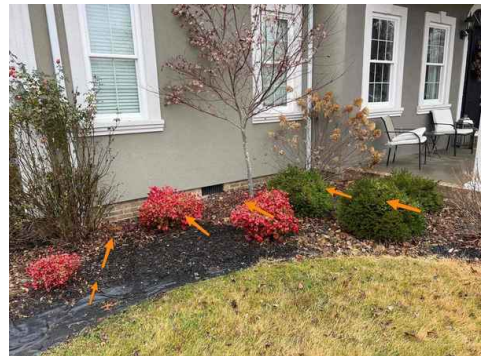
Front of House, Negative Grading - Example

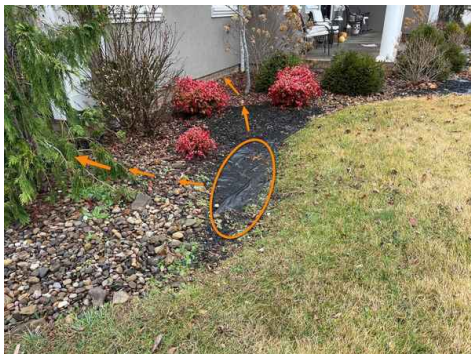
Front of House, Negative Grading - Example

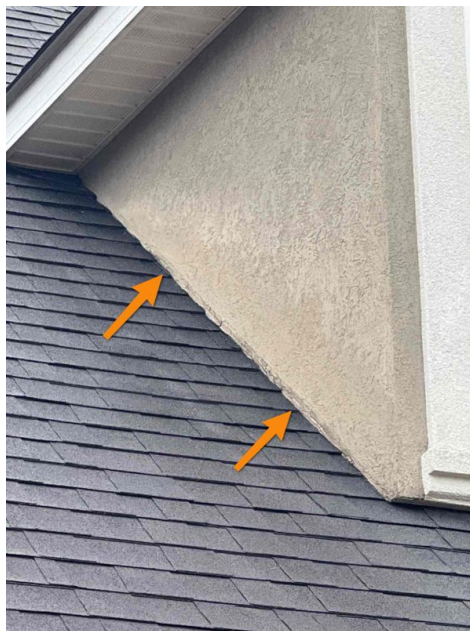
In all areas where the stucco siding is in contact with the roof, there is no air gap to allow the roof to drain and dry without some of the water absorbing into the siding material. This can quickly deteriorate the siding and cause staining.

Front of House, Sides of Dormers - Example

Recommend engaging a qualified siding contractor that has extensive experience with stucco siding (which is less common in this area) to evaluate further.

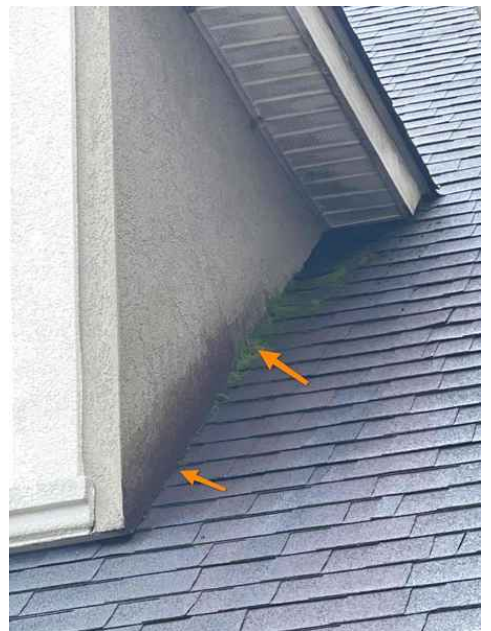
Front of House, Right Side of Smaller Dormer, Siding In Contact With Shingles

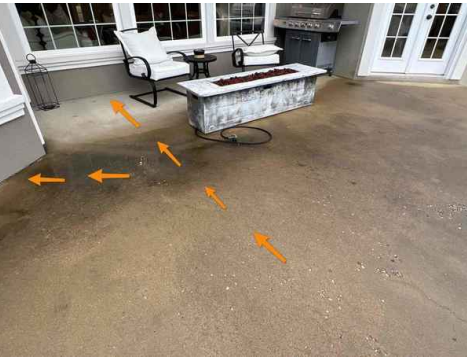
The concrete patio at the rear of the house is sloping towards the house. The patio appears to have settled from its original installation height. This could cause rainwater to drain towards the house at lower levels and around the foundation. Repairing the gutters and sealing around the concrete toward the house will assist in mitigating the impact.

Rear Patio, Slopes Toward House

Contact a qualified concrete contractor.

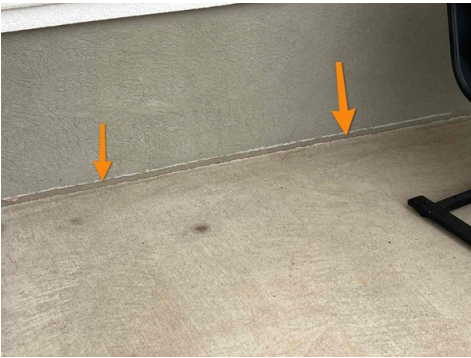
Rear Patio, Settled Since Installation

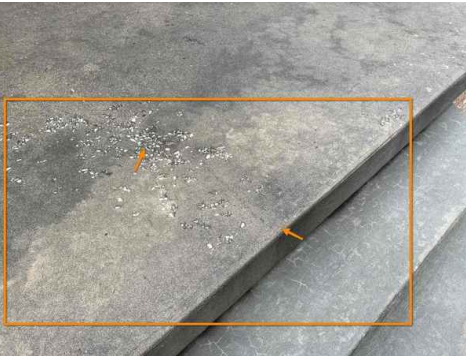
The concrete on the rear patio is deteriorating. It appears the original concrete was improperly mixed and sealed after pouring. This is largely a cosmetic issue. However, if not addressed, the concrete will continue to crack and the steps will deteriorate further.

Rear Patio, Concrete Cracking

Contact a qualified masonry professional.

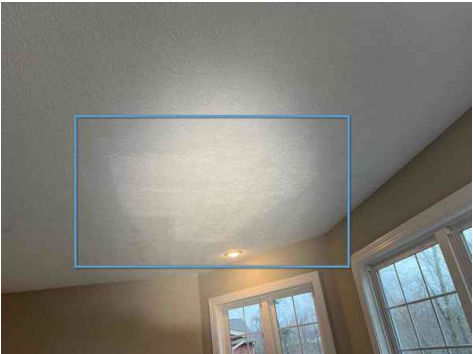
- 1) The repairs appear to have been completed by a qualified professional.
- 2) There is evidence in the master bedroom of ceiling repairs and painting.
- 3) All areas were dry at the time of the inspection.

Master Bedroom, Evidence of Ceiling Repairs, Dry

Recommendation
Recommend monitoring.

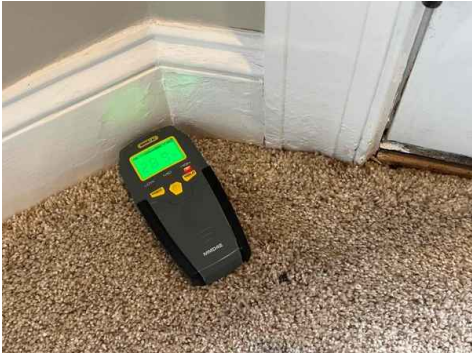
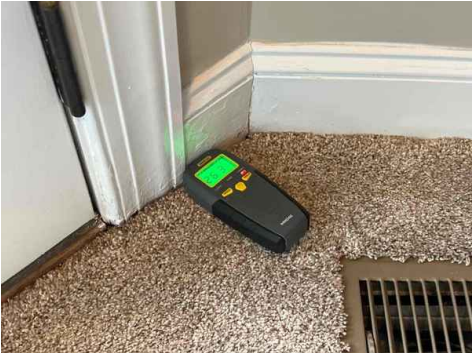
- 1) The wood trim is showing signs of excessive weathering and that start of wood rot (it has been painted over).
- 2) The door framing is rotted.
- 3) The baseboard to the left and right of the door on the inside was wet at the time of the inspection.
- 4) There is a small potential that there is flooring damage in this area. A more intrusive investigation would be required to determine the extent of the damage.

Master Bedroom, Rear Door, Wet & Deteriorated Baseboards

The door and door framing will likely need to be replaced to fully and properly resolve the issues that exist.

Contact a qualified door repair/installation contractor.

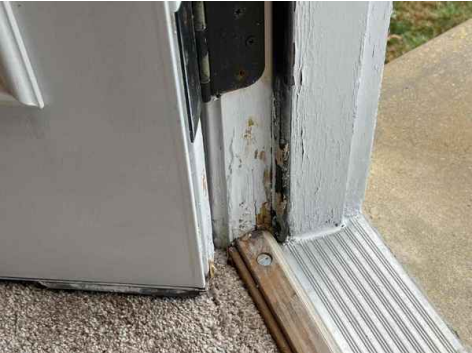
The exterior door from the master bedroom to the rear patio has deteriorated.

Master Bedroom, Rear Door, Severely Deteriorated

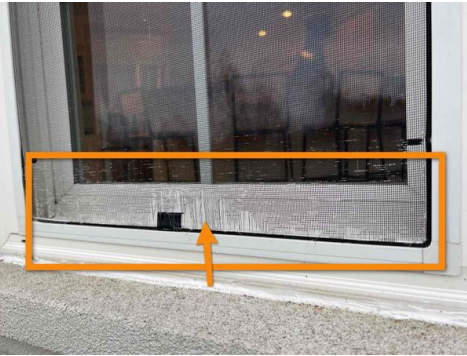
Many of the screens in the house have deteriorated. This is potentially due to improper cleaning with a power washer. (Representative/ Sample Pictures)

Window Screens Deteriorated - Example

Contact a qualified professional.

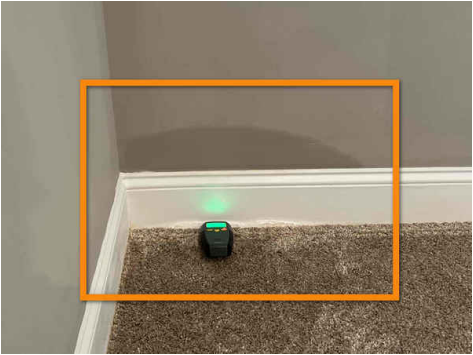
2nd Floor Family Room, Wet Areas - Example

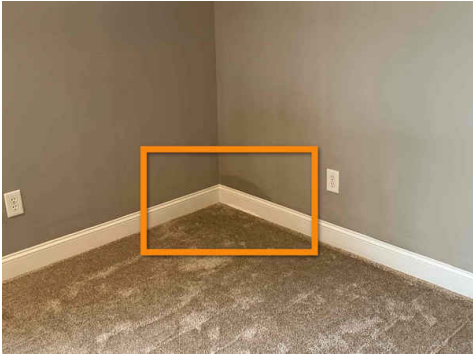
2nd Floor Family Room, Wet Areas - Example

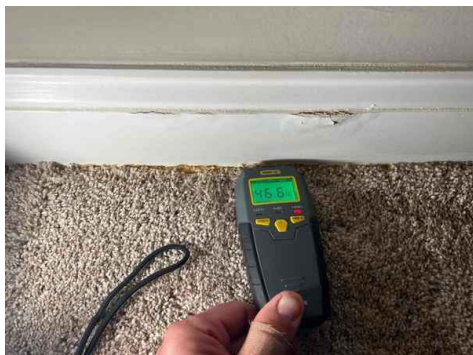
2nd Floor Family Room, Wet Areas - Example

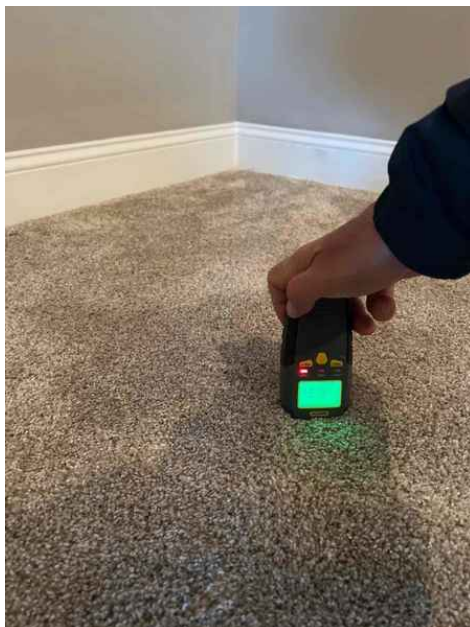
2nd Floor Family Room, Wet Areas - Example

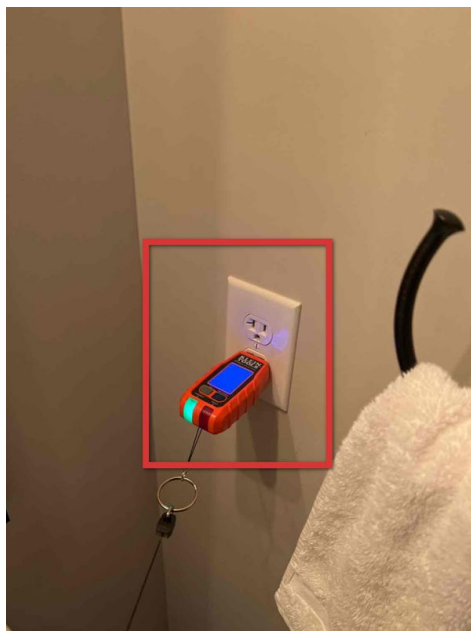
1st Floor 1/2 Bathroom, Receptacle Not GFCI Protected

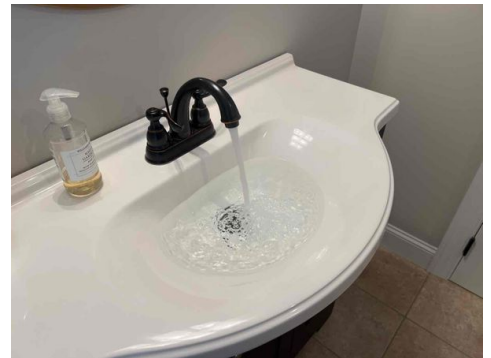
Jack & Jill Bathroom, Sink Not Draining Well

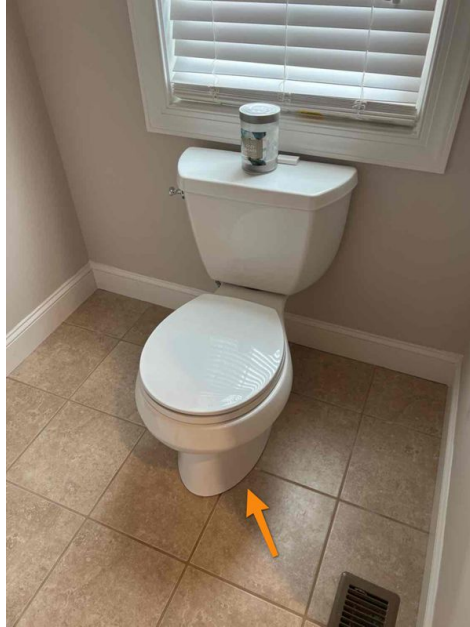
Jack & Jill, Not Secure

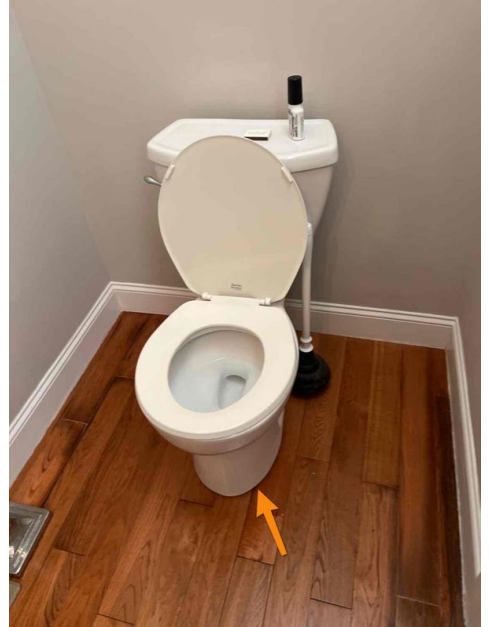
1st Floor 1/2 Bathroom, Toilet Not Secure

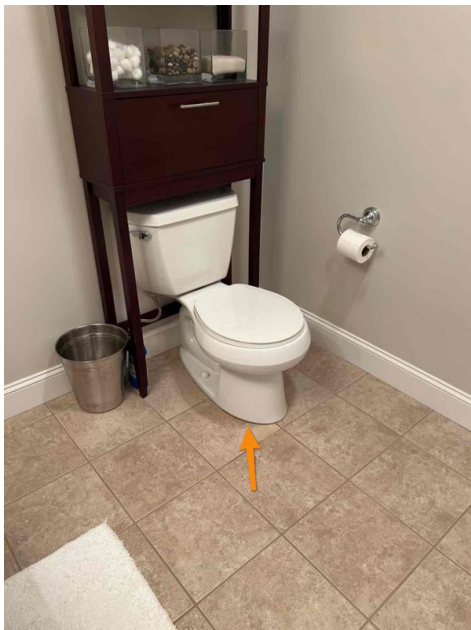
2nd Floor Bathroom, Toilet Not Secure

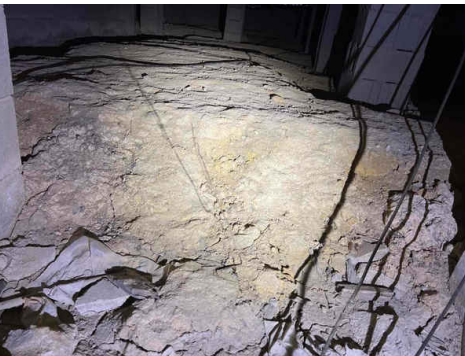
Crawlspace - Missing Vapor Barrier - Example

Contact a qualified professional.

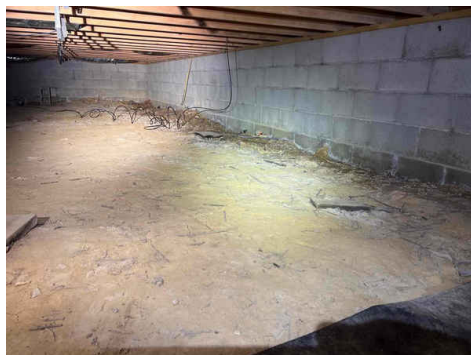
Crawlspace - Efflorescence, Water Intrusion - Example

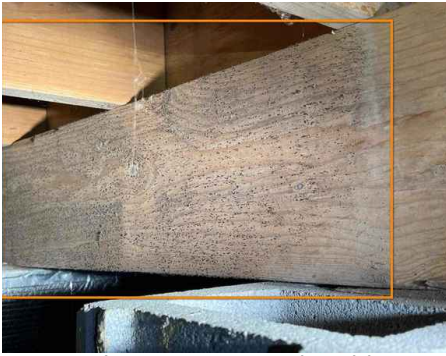
Crawlspace - Potential Mold - Example

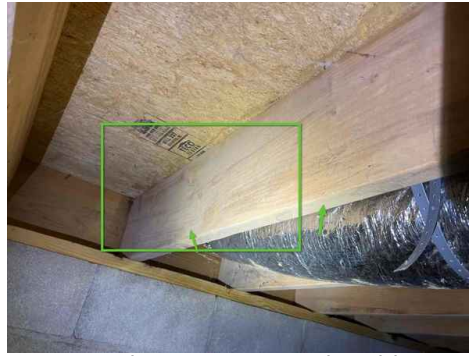
Crawlspace - Potential Mold - Example

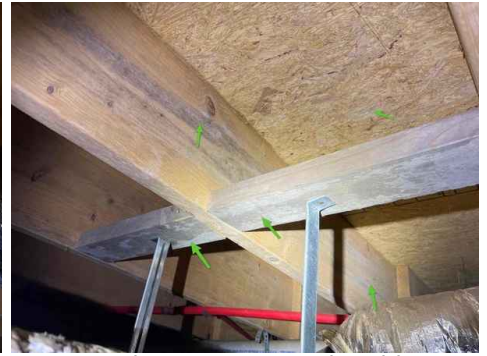
Crawlspace - Potential Mold - Example

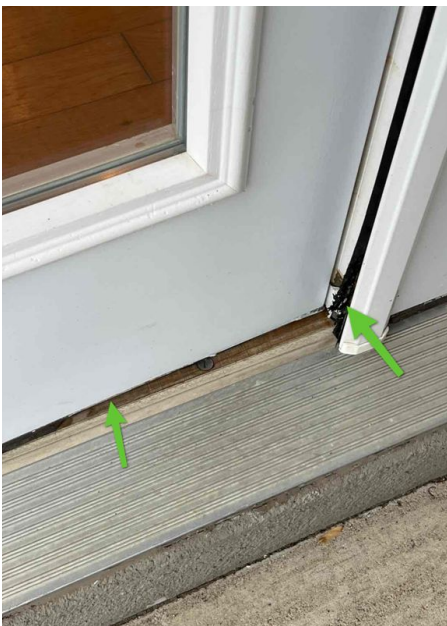
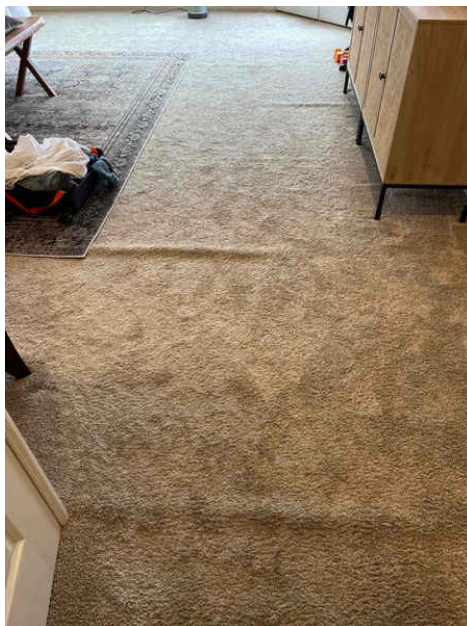
Dining Room to Patio Door,
Weatherstripping Damage

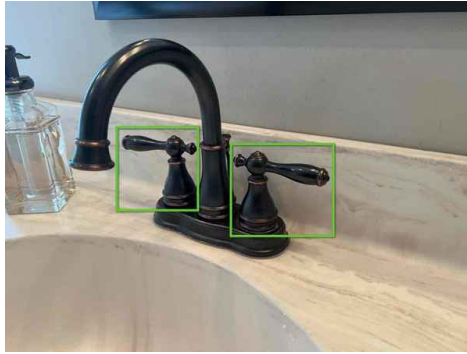
Master Bathroom - Right Sink -
Handles Not Secure

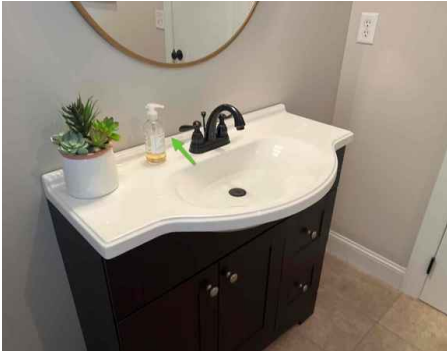
Jack & Jill, Vanity Top Not Secure

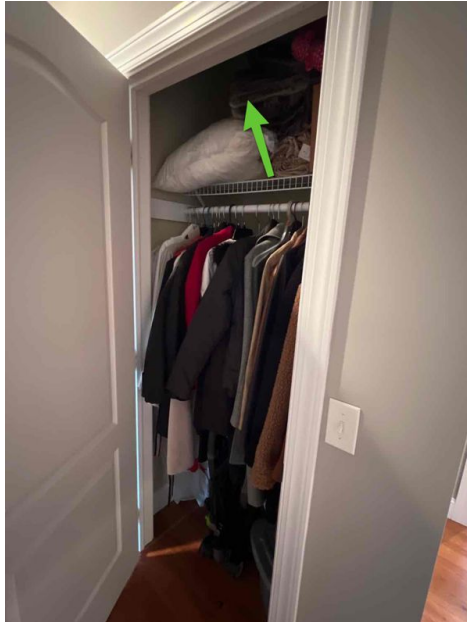
1st Floor, Hallway Closet, Light Not
Working (bulb?)

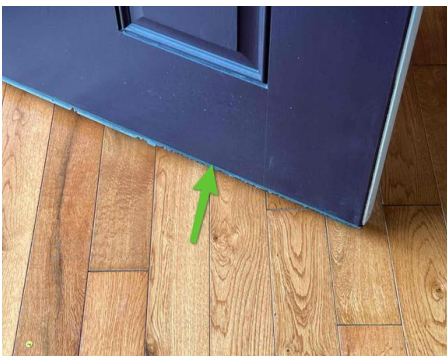
Front Door, Weatherstripping
Damage

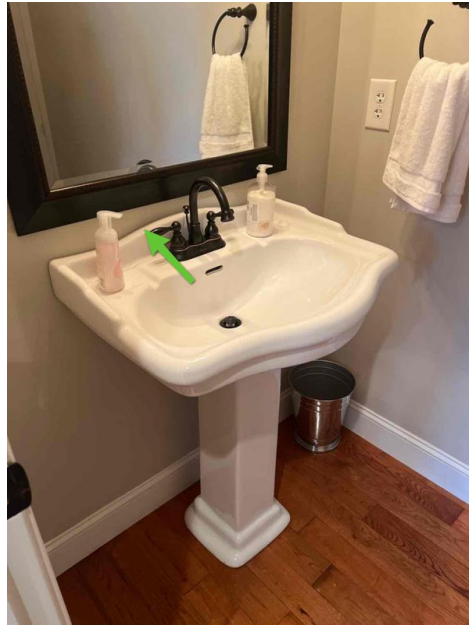
1st Floor 1/2 Bathroom, Sink Not Secure

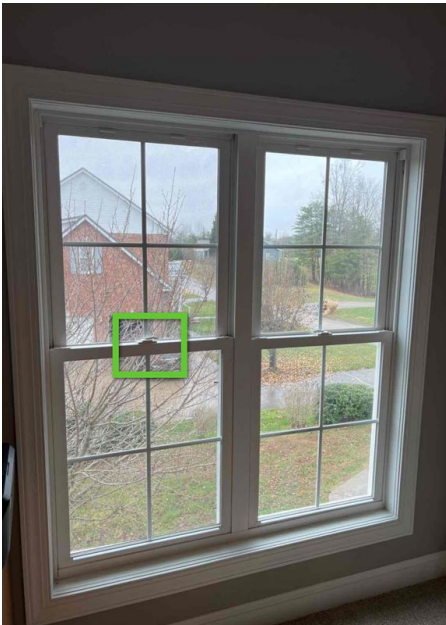
2nd Floor Family Room, Window Does Not Lock

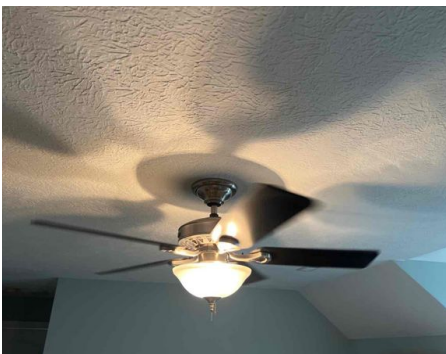
2nd Floor Family Room, Ceiling Fan Noisy
